Standard Building Inspection

Summary Report

Subject Property: Ft. Lauderdale Station and Passenger Loading Platform

Date of Inspection: Wednesday July 7, 2004

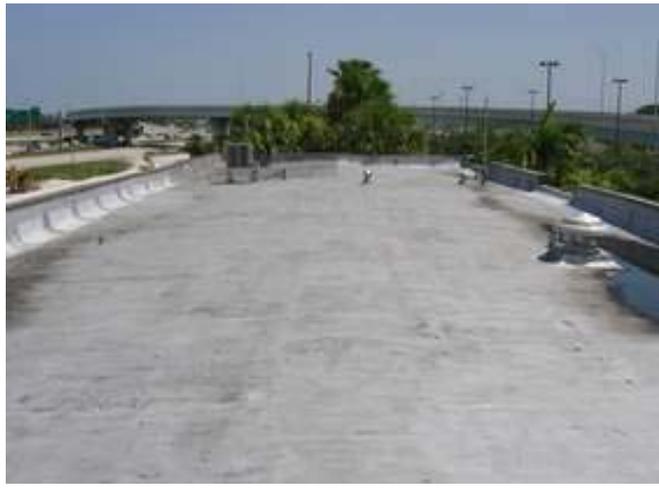
- The flat section of the roof over the Station Building appears to be in reasonably good condition and with proper maintenance could last five years or more.

The flat section of the roof over the Station Building appears to be in fair condition but in need of immediate repairs.

Cost of immediate repairs to the roofs over both structures - \$ 5,000 - \$ 8000

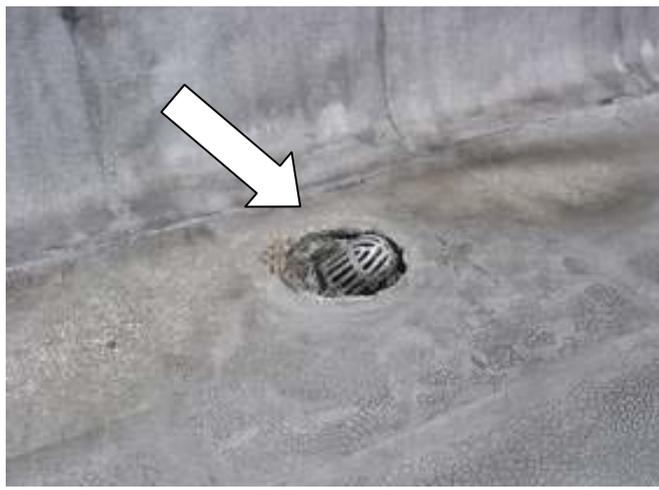
- One roof drain has a screen that is not properly aligned and secured that needs to be repaired. This needs immediate attention.
- One roof drain is partially clogged with debris and is allowing standing water to form a pond around it. This needs immediate attention

This drain screen needs to be secured and properly aligned.

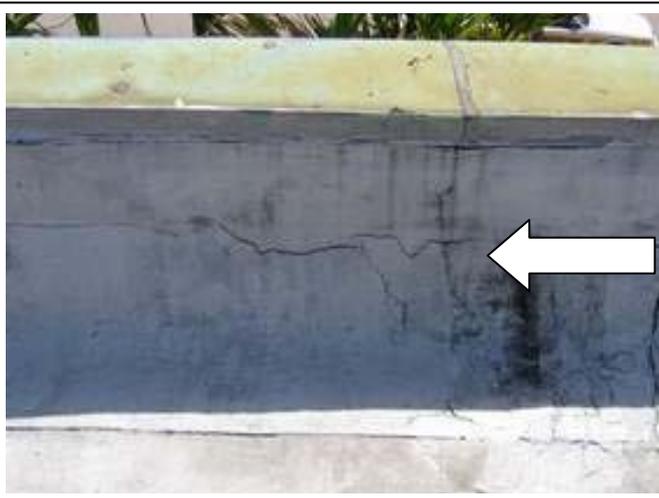
- The surrounding sloped sections of roof over the Station Building appear to be in good condition. No broken tiles were noted.
- The inside surfaces of the parapet surrounding the flat section of this roof is in need of immediate repairs. Splits are forming in the roofing materials where moisture can enter and appear in the ceilings. Several moisture stains were noted in the Amtrak and CSX office areas. Moisture stains were also noted in the wood ceilings between these two areas. It is possible that some moisture is already under the membranes of the flat sections of this roof which may accelerate the need to replace the roof.

There are splits in the water proofing materials along the inside of the parapet surrounding the flat section of the Station Building roof. Water can enter and damage ceilings below and soak any materials under the cap sheets of the roof.

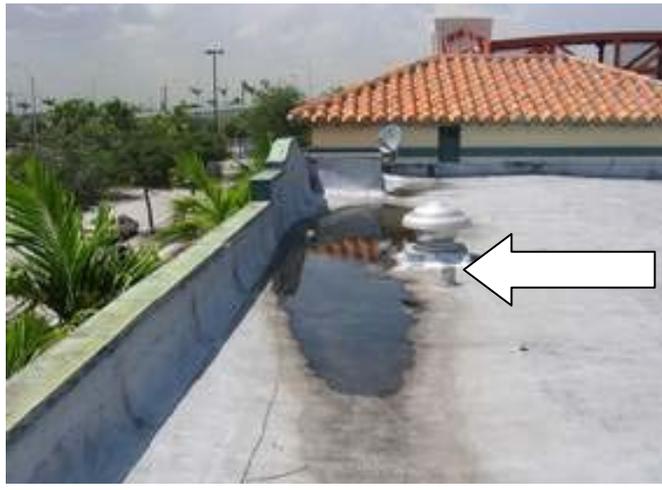
Water pond on Station Building roof. Sloped sections of the roof (in the background) with roofing tiles appear to be in good condition.

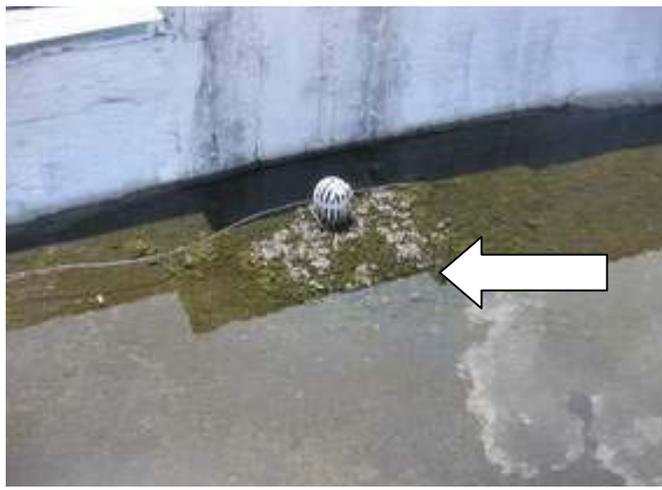
Clogged roof drain area needs to be cleaned and properly pitched to drain properly

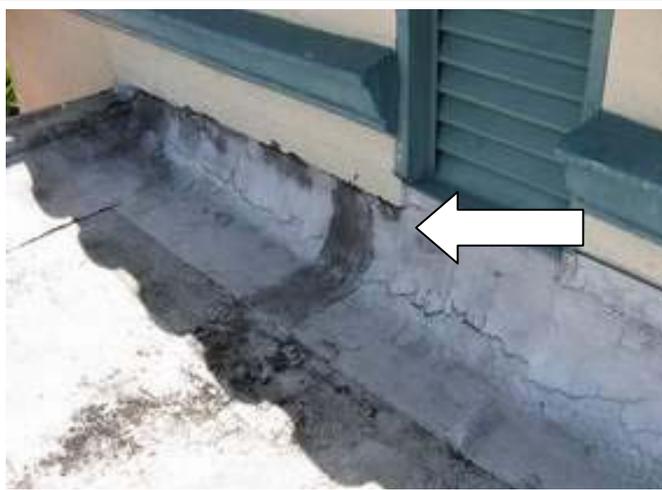
Splits surround the entire flat section of the Station Building roof. There are a few water stains in the Amtrak office area ceilings below this area.

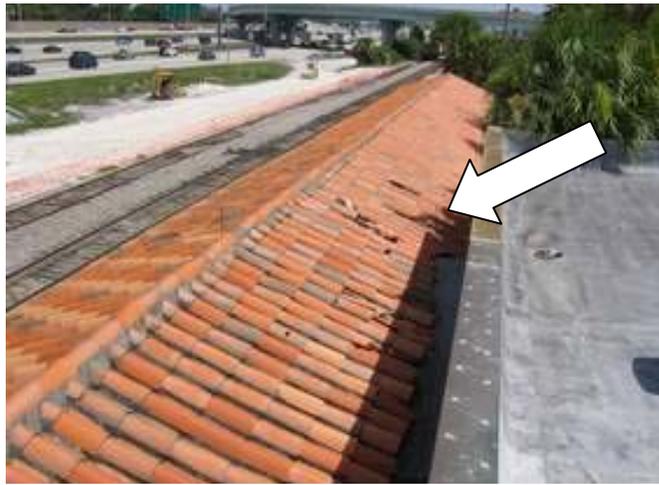
- There are approximately 50 broken tiles in the Loading Platform roof which expose the underlying water proofing materials. A few of these broken tiles are on sections where the slope may cause pieces to slide off the roof. This could cause injury to pedestrian traffic below.
- The roof over this structure appears to be in good condition (except for the broken tiles) and should last more than 5 years. It should be periodically inspected by a roofing contractor and repairs made as necessary.

The adjacent Passenger Loading Platform roof is in need of immediate repairs. This area (looking South) has numerous broken roofing tiles that need to be secured.

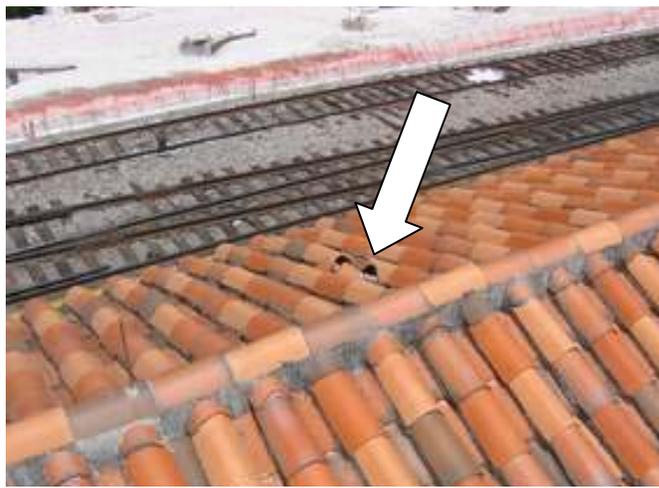
This broken tile can slide off and land on the Passenger Loading Area below

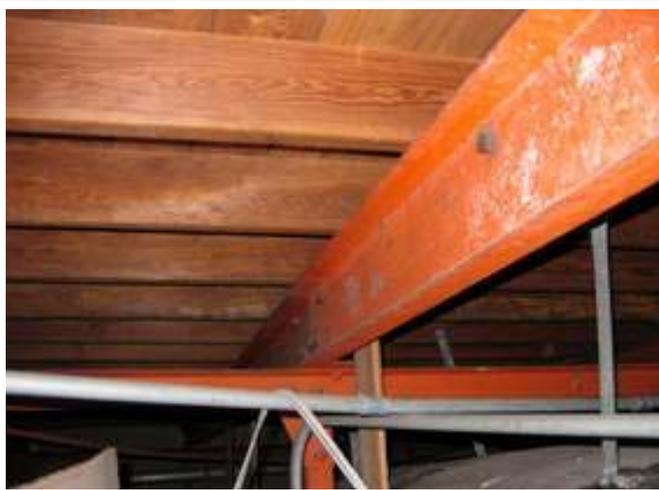
These I-beams supporting the roof do not appear to be from the original construction of the Station Building

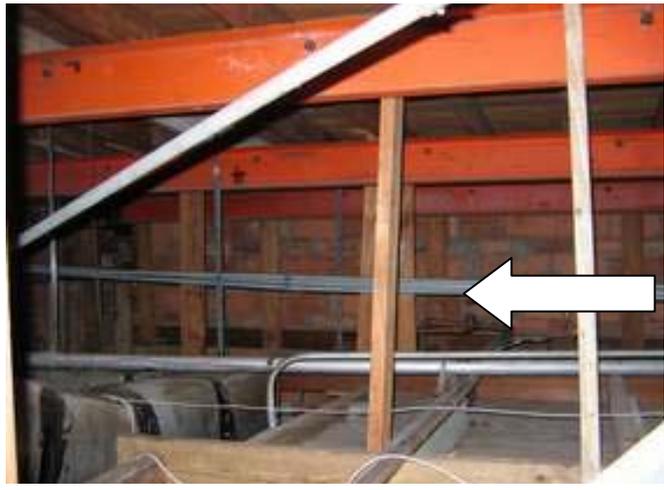
Additional wood bracing and beams have been installed in the attic area supporting the roof and wood plank ceiling below it. Most of this area could not be safely accessed to fully inspect.

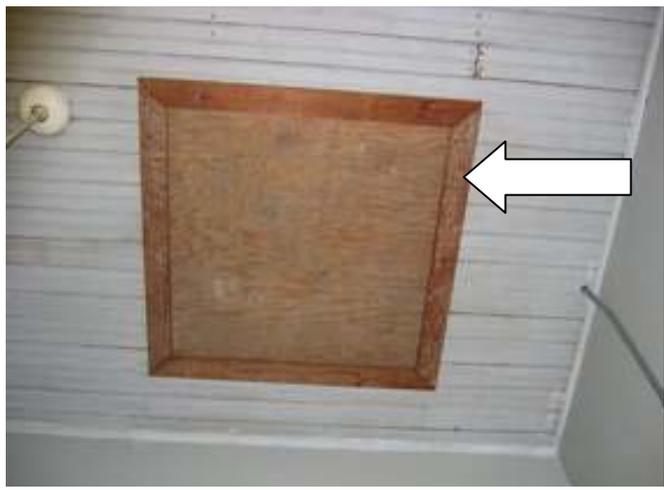
The framing pictures above were taken from the top of this scuttle hatch in the ceiling of the central storage area for Amtrak operations.

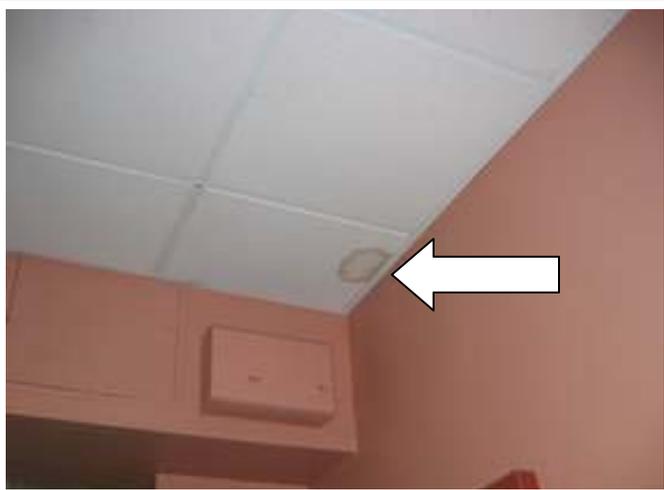
Water stain in ceiling of Amtrak office area is likely from a roof leak

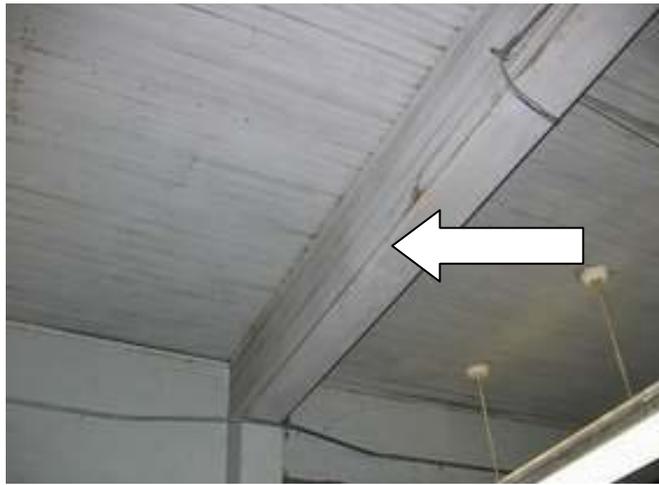
Wood ceilings over the central storage area for Amtrak operations shows sign of past roof leaks

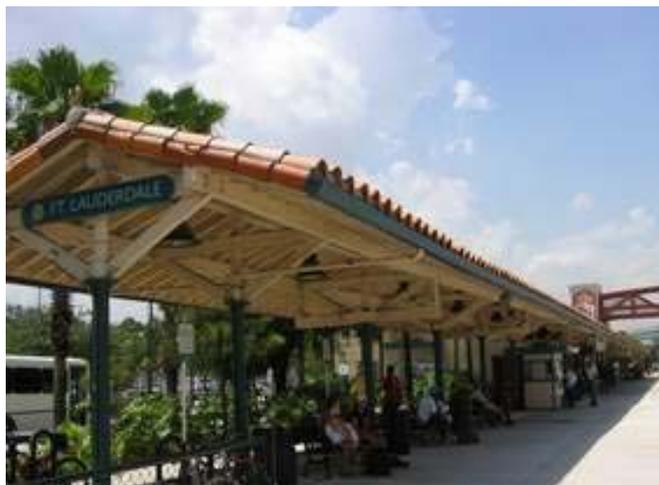
The Passenger Loading Platform is a wood framed structure with steel posts and bolts.

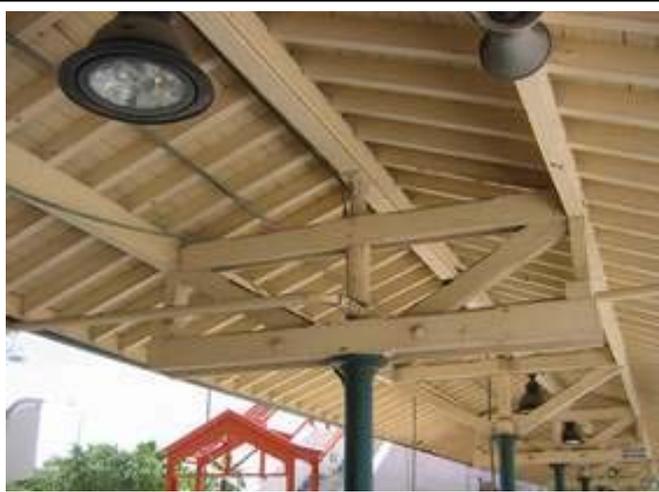
Overall the structure appears to be stable and only has a few elements that need the immediate attention of a structural engineer.

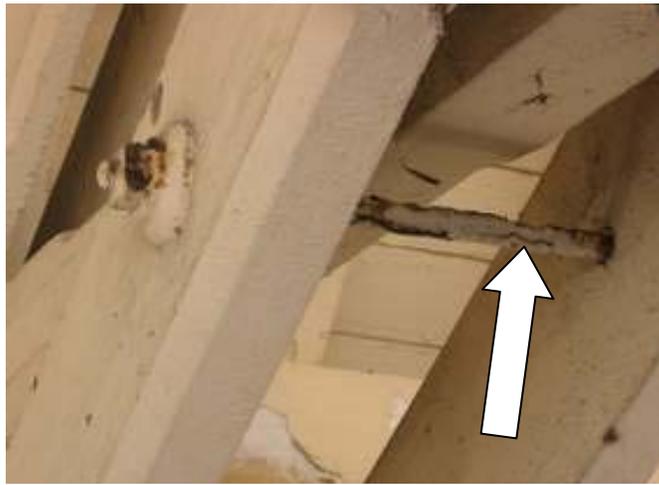
A few of these connecting bolts appear to be significantly rusted and possibly in need of replacement

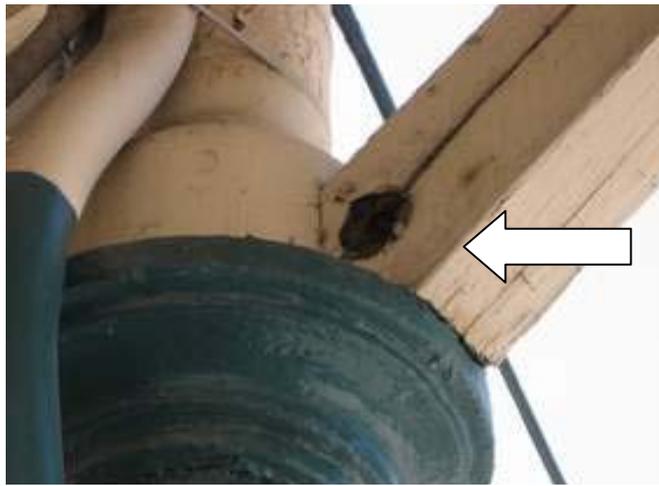
This strut is split and should be further addressed by a structural engineer.

5.	Analysis and construction design documents for removal and replacement of damaged structural elements in the Passenger Loading Platform	\$ 5000	IMMEDIATE

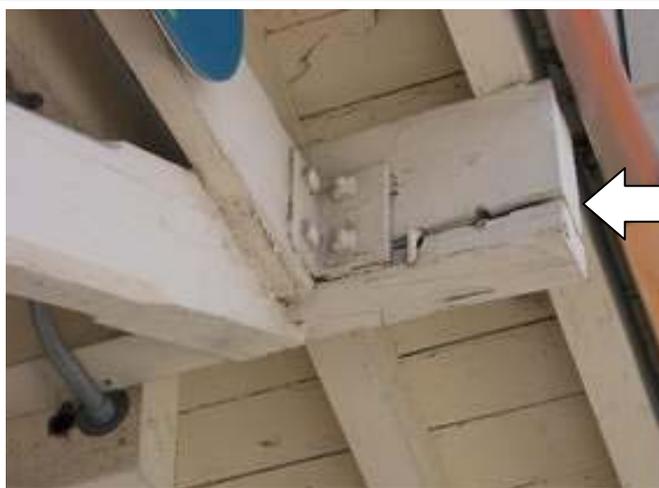
This beam is split at the connection point and needs attention.

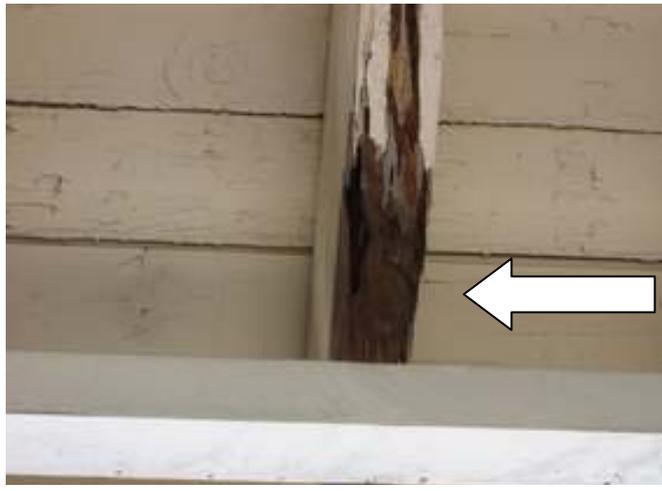
There are a few termite damaged beams but these do not appear to be in danger of failure.

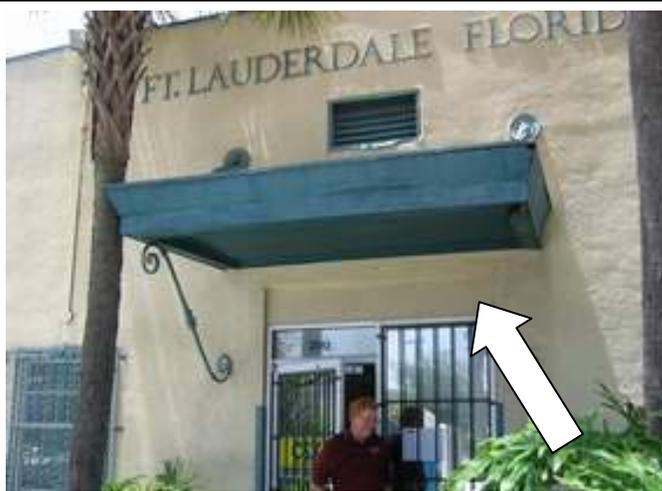
The overhangs are framed out of wood beams and covered with roofing felts. The framing appears to be suffering from wood rot and stress cracks. A decorative strut recently fell from the overhang at the south entrance to the CSX offices. It would be prudent to fully examine these overhangs more thoroughly by removing the trim materials and framing inside the structure covering the connection points. A decision should be made to consider removing these structures and rebuilding them or replacing them with cloth awnings. Cloth awnings have been installed over the entrance doors to the Amtrak office area. It is suspected that these openings were originally similar in appearance to the ones on the south end of the building. They were probably removed and replaced with cloth awnings because of safety concerns.

There are three overhangs like this one still remaining on the building that need to be addressed. Note that the decorative steel strut on right side is missing. The CSX personnel stated that it recently fell

Cost to remove the existing overhangs and replace three awnings with cloth - \$ 4500

Cost to rebuild three overhangs to original appearance - \$ 7500

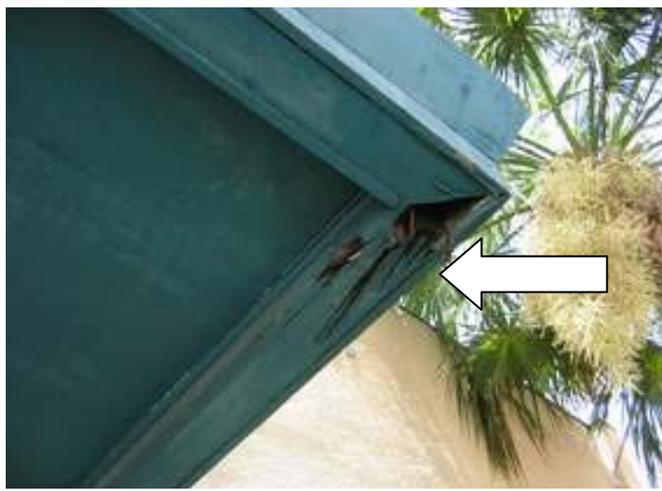
Wood is rotted in these overhangs. There may be concerns hidden where the support chain is connected

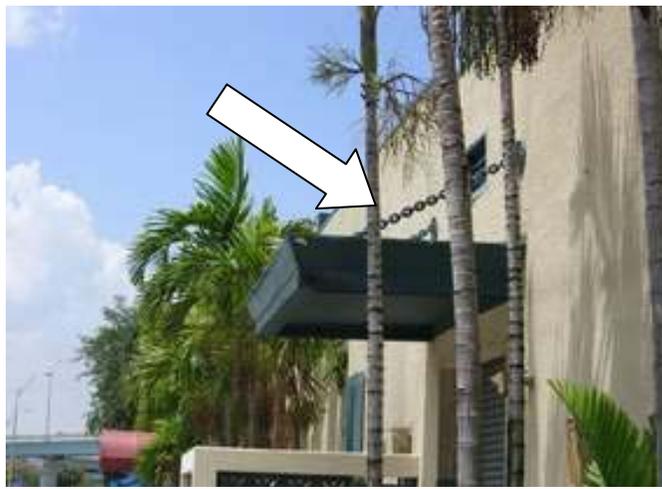
The attachment points for the support chains for these overhangs are not accessible. It is advisable to remove these old structures and replace them with new materials or cloth awnings.

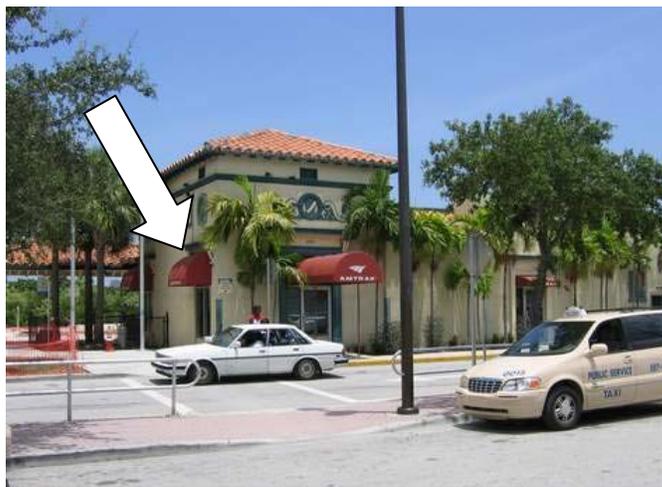
Cloth awnings have been installed over entrances for the Amtrak operations area.

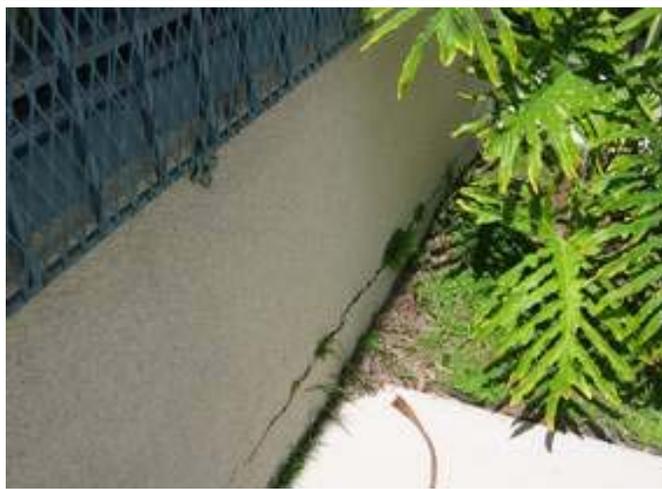
The Station Building shell appears to be in good condition and there were no structural defects noted. The exterior masonry walls appear to be sound. There is only one location where a significant crack has appeared. This is located at the south end of the structure. (see photo) This area appears to be a cosmetic issue.

This crack in the stucco along the south wall of the Station Building needs to be repaired to keep water from entering the interior.

11.	Repair of stucco crack on south side of Station Building	\$ 200	IMMEDIATE
12.	Repair of wood rot on exterior of southwest window frame	\$ 200	IMMEDIATE

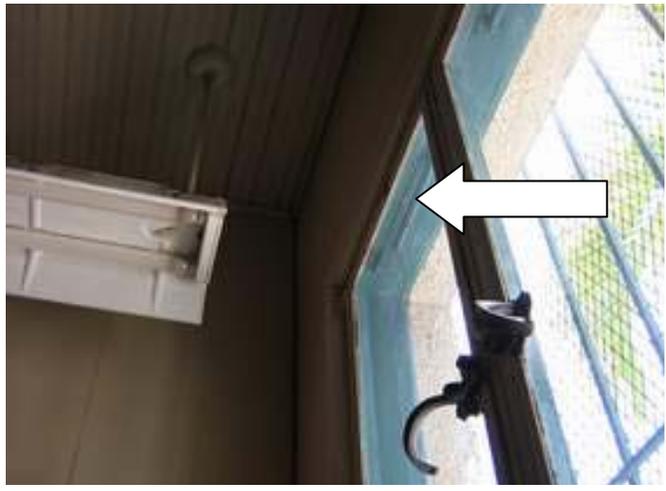
The windows and frames appear to be in good condition in the Station Building

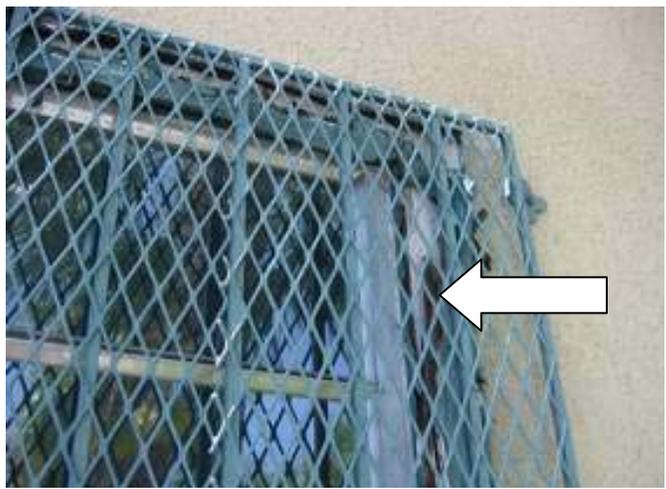
Wood rot along exterior of window on southwest side of the Station Building needs to be repaired.

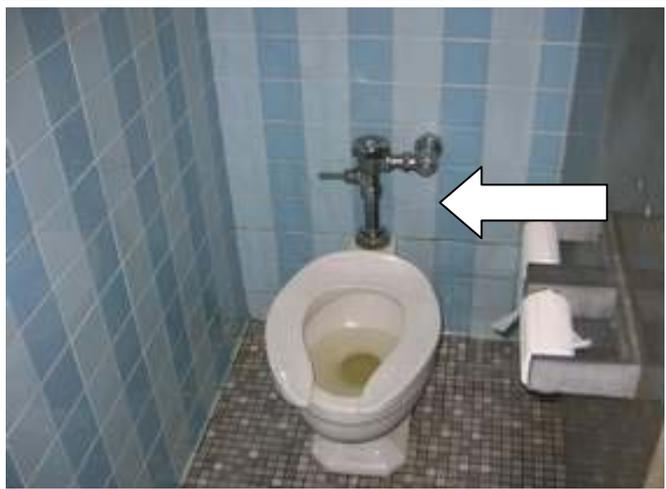
The restrooms in the north and south section are in fair condition but do not appear to meet minimum ADA requirements.

The restrooms in the Station Building are in good repair but do not meet ADA requirements. They are lacking proper clearances, handrails, partitions and fixtures.

Cost for restoration and ADA upgrades to the three restroom facilities - \$ 24,000

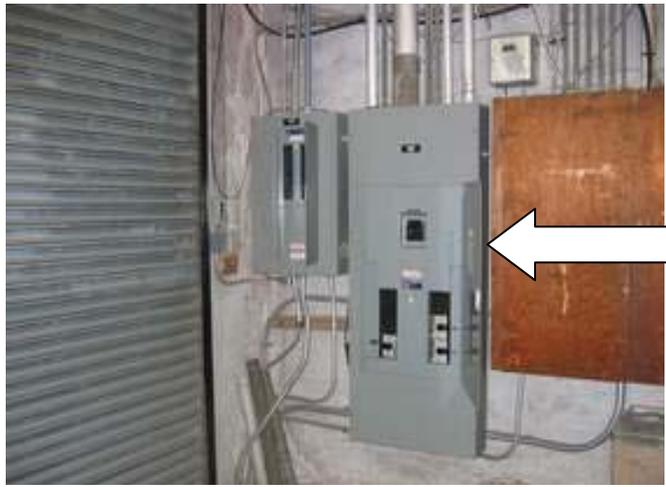
New service panels have been recently added to the Station Building. Overall the electrical system appears to be in good condition.

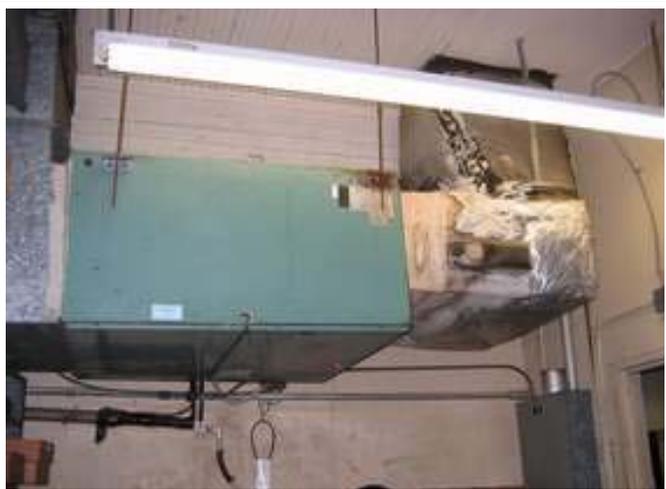
The condensing unit and the air handler serving the Amtrak Office and Customer Service Area are older units. This system appears to be functioning properly but should be considered for replacement to improve efficiency and reliability. A review of any available past service records might assist in making a decision on when to replace the unit.

This old air handler supporting the Amtrak office area may need to be replaced in the near future. It is currently functioning.

Cost of replacement of entire system - \$ 5000 - \$ 7500 (discretionary)

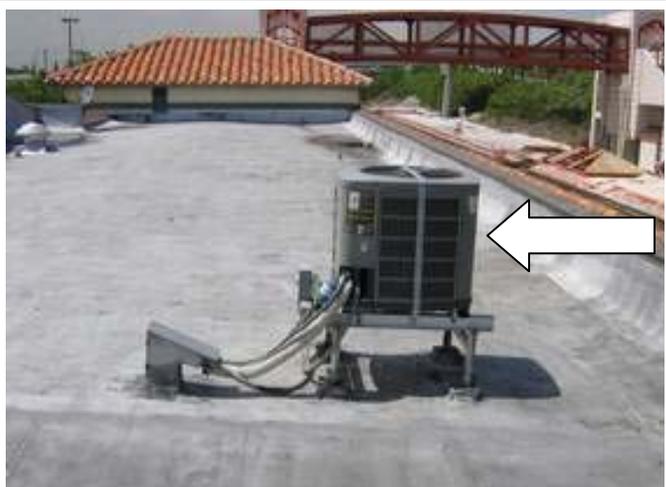
The condensing unit for the A/C system supporting the CSX office area is new and in good condition.

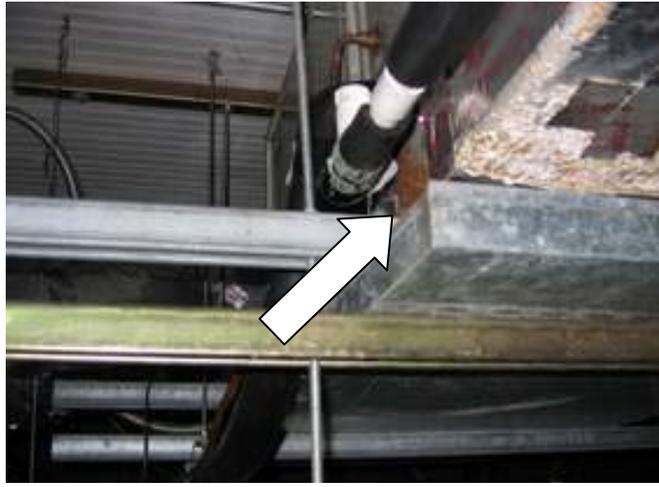
The condensing unit for the CSX office space is new but the air handler for this area is old. The housing is corroded and condensate has leaked onto the ceiling tiles. It is currently not leaking but appears to be in need of immediate replacement.

The air handler over the CSX office area needs to be replaced. It has leaked and the housing is corroded.

Replacement cost - \$ 1500 - \$ 2000 (immediate need)

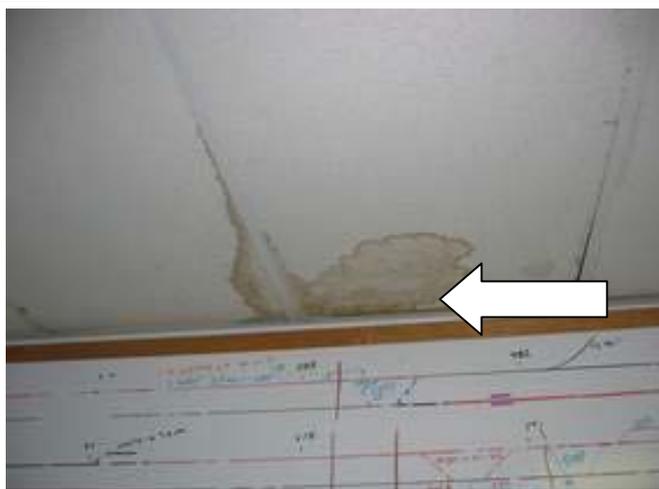
Condensate stains from the air handler above the ceiling in the CSX office area.

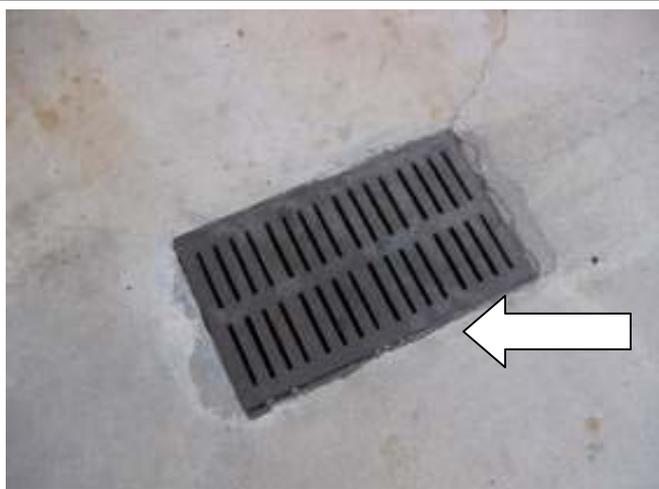
Site drains appear to be clear on the Passenger Loading Platform and in the parking areas. These need periodic cleaning and flushing to remove silt or they will clog and the lines will need replacement

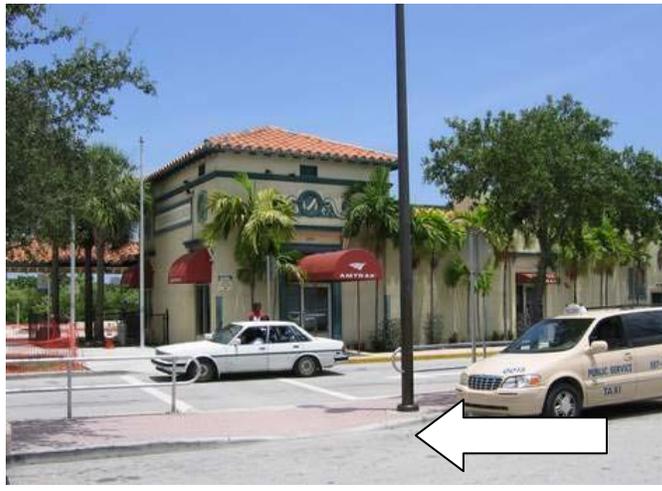
The parking facilities appear to be designed for Accessibility requirements with proper ramps and parking spaces.

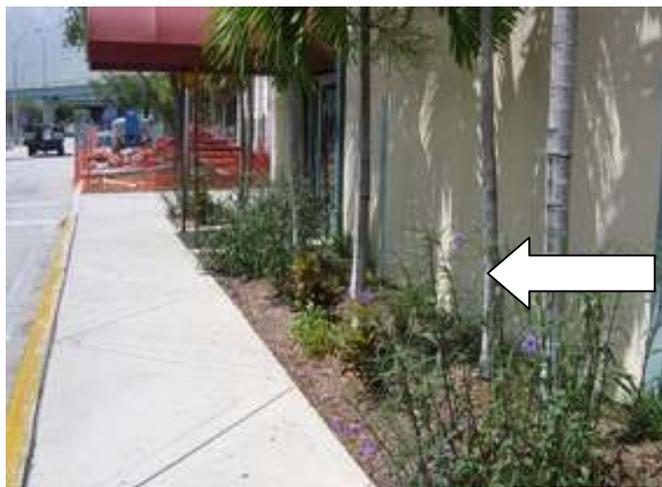
Landscape near the front entrance to the Amtrak operations is in need of attention.
