Property Condition Assessment Summary Report

File Number: 05-15-005

Inspector: Craig Milliken, PE
CPM Real Estate Inspections, Inc.

Date of Inspection: Monday, August 1, 2005

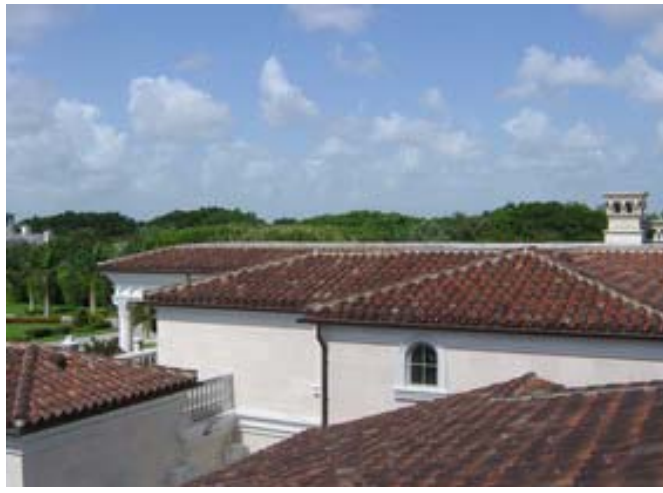
Photo # 1

Overall the roofs appear to be in a water tight condition. There may be some warranty left on the roofing work.

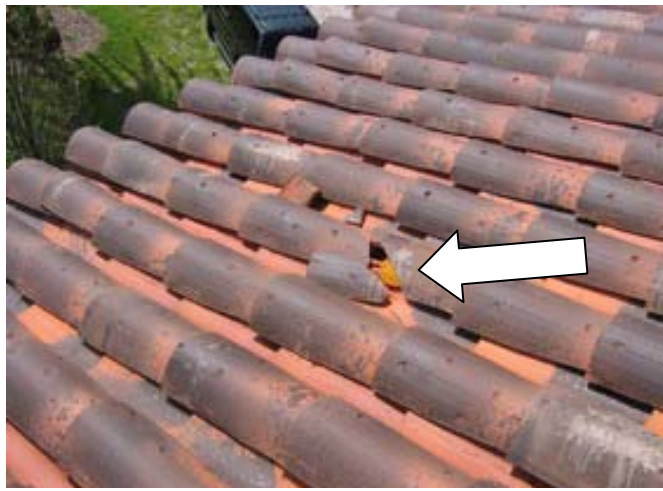
Photo # 2

- There are 50 + tiles that are chipped, cracked or broken from foot traffic. These tiles should be repaired or replaced.
- There are several pieces of construction materials left on the roof that should be cleared. There is broken masonry and a 5 gallon can of roofing mastic on the roof near the east balcony overlooking the pool
- There are several small plants that have taken root in cavities between the roofing tiles. These need to be removed before their roots cause damage.

There are a number of cracked tiles throughout the roofs needing repair. Lightening or foot traffic is usually the cause of cracked tiles.

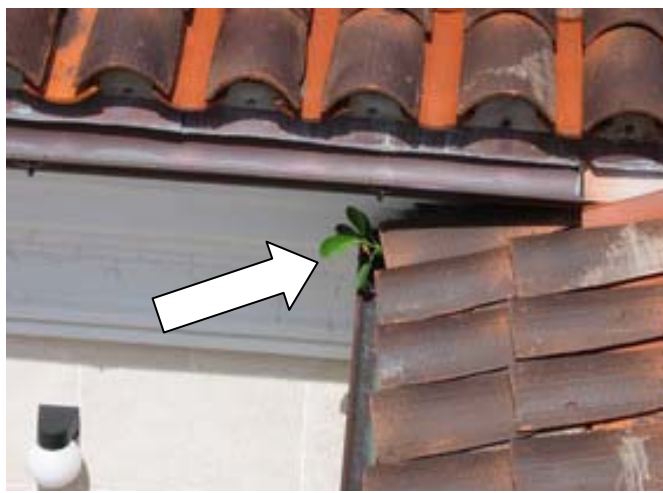
Photo # 3

One of several small plants that have taken root in the roofing tiles.

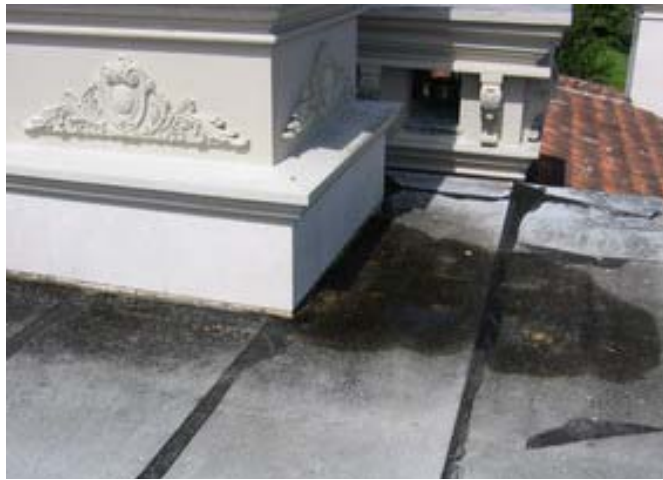
Photo # 4

- There is a small section of the flat roof over the main house that has standing water due to inadequate slope. This section is at the NW corner of the flat roof near a chimney. This area should be reworked to improve drainage. Standing water can accelerate the deterioration of the roofing materials in this area.
- Several stains were noted on the exterior walls of the main house. These stains are caused by rain run-off that is not being sufficiently managed by the gutter system. Flashing and tile placement needs to be adjusted in a few areas to avoid perpetual stains on the walls.
- One section of a roof leader (east of the main entrance) is missing. This needs to be replaced.

Small water pond on NW corner of the flat section of the roof over the main house.

This is a critical area because of the penetration for the fireplace chimney. This could be a potential problem if not reworked to get adequate slope away from the chimney.

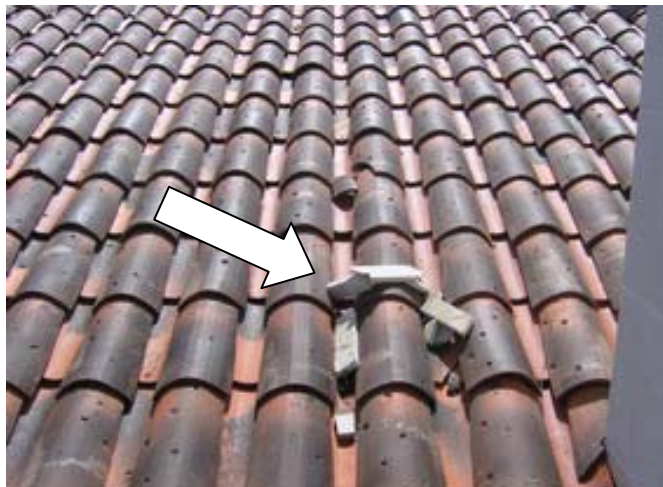
Photo # 5

Construction debris left on the roof need to be cleared.

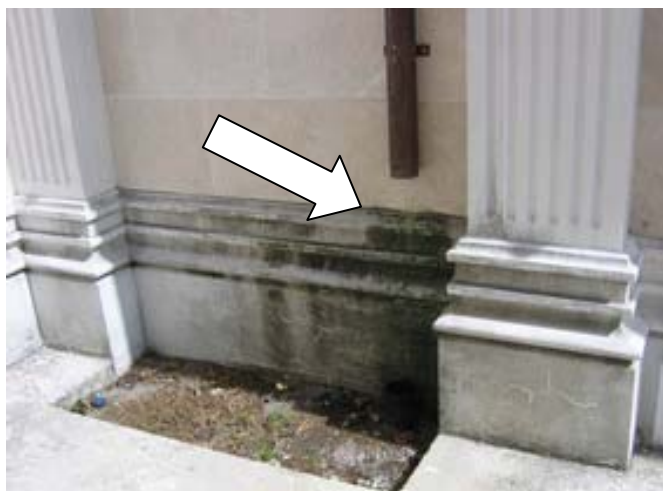
Photo # 6

Missing section of roof leader needs to be replaced.

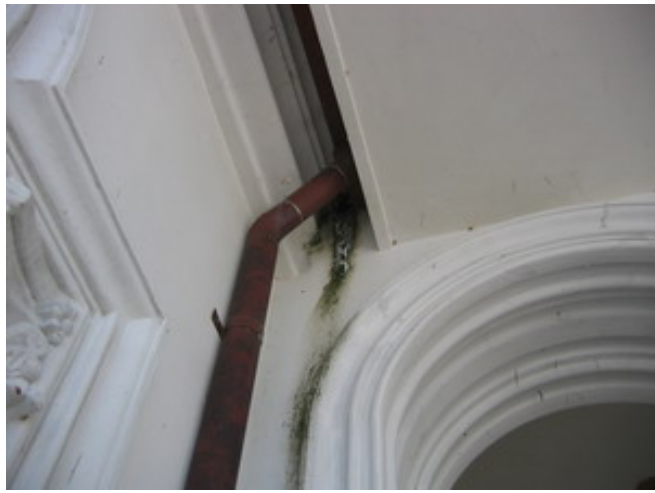
Photo # 7

- There are many stains on the exterior of the building from roof run-off and other weather conditions. Dirt has collected under all exterior doors and windows. All of this should be pressure cleaned prior to any painting.

Staining on walls from roof run-off not being managed by the gutter system. This staining will be a chronic problem if not corrected.

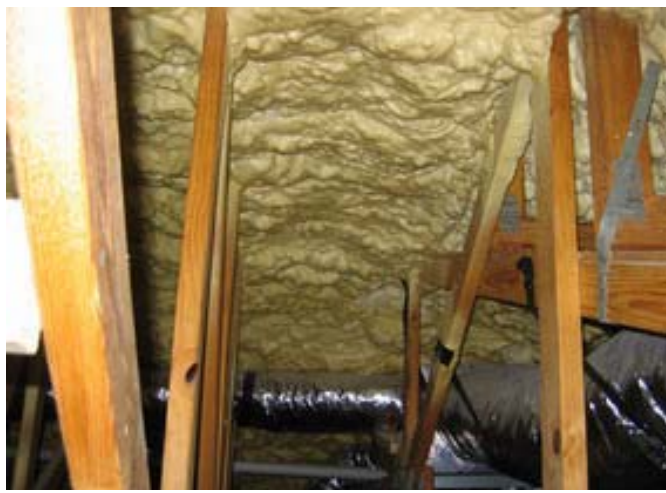
Photo # 8

The attic areas are insulated with a foam application to the interior side of the roof sheathing.

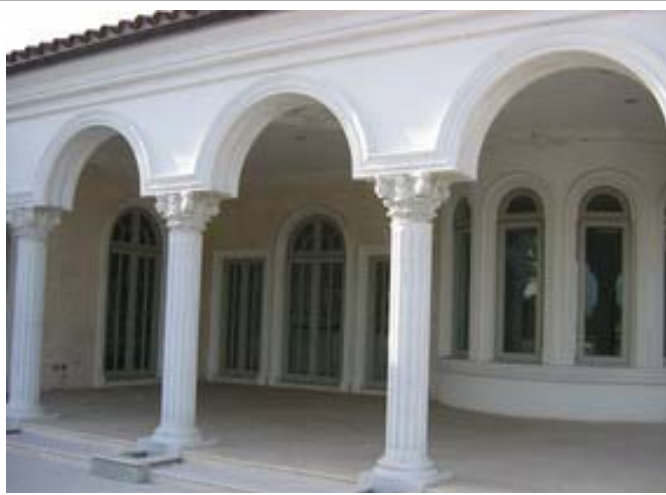
Photo # 9

- There are several exterior doors that have not yet been installed. This unfinished work needs to be quantified and scheduled by the builder.

A few exterior doors have not yet been installed but most are complete. All openings were found to have been water tight for the last 2 ½ years.

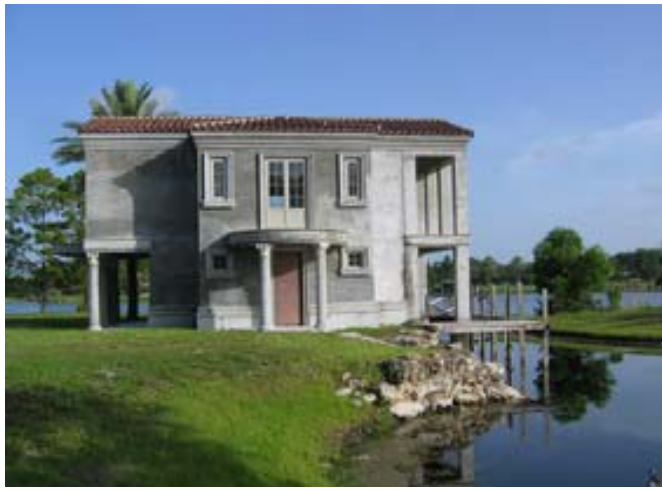
Photo # 10

The stone facing has not yet been installed on the guest/boat house.

The dock is only temporary construction and will need to be removed. It is not safe to walk on it.

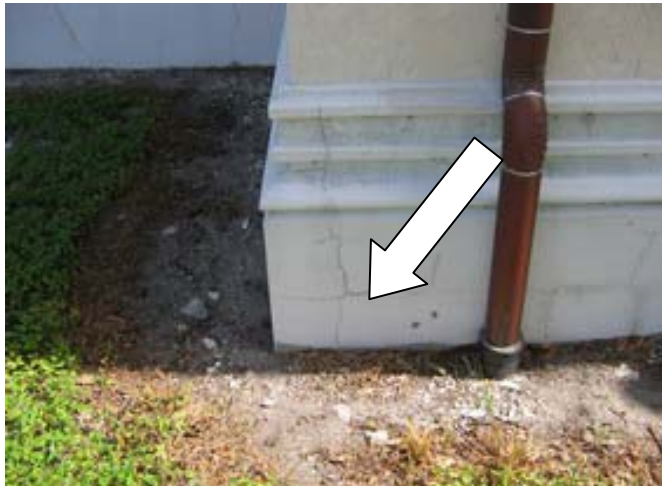
Photo # 11

- Minor cracks were noted in several architectural reliefs around the buildings. These minor cracks are from normal settling, curing of the stucco and thermal stress and are not due to structural or material defects. Many of the architectural reliefs are made from stucco. The cracked stucco surfaces will need to be cleaned and sealed with a good primer prior to painting to hide some of the larger cracks.

Many architectural reliefs have cracks in them. There appears to be a paint primer over these materials. It may take some caulking and additional primer to hide these cracks.

This copper roof leader is connected to a drain pipe that carries water away from the structure.

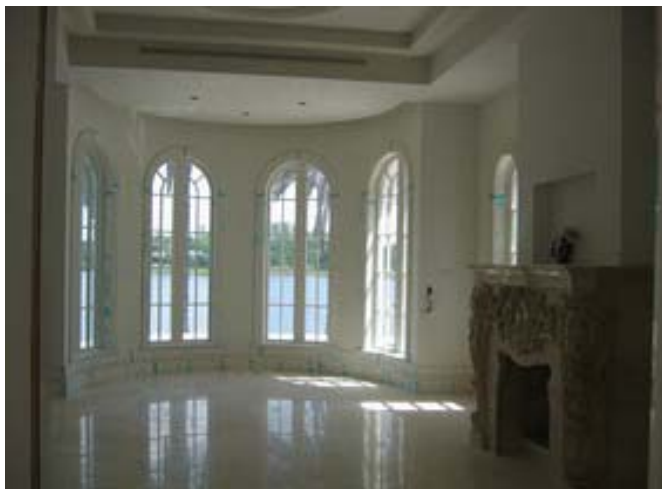
Photo # 12

Most of the interior walls, floors, ceilings and millwork have been substantially completed.

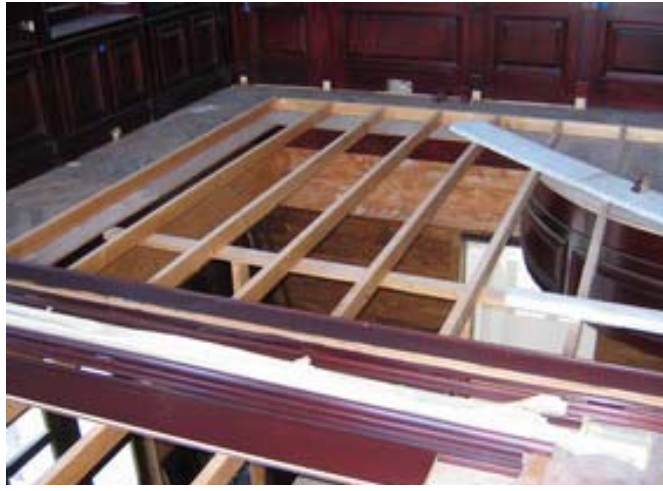
Photo # 13

Millwork and a railing for the 2nd floor of the library need to be completed.

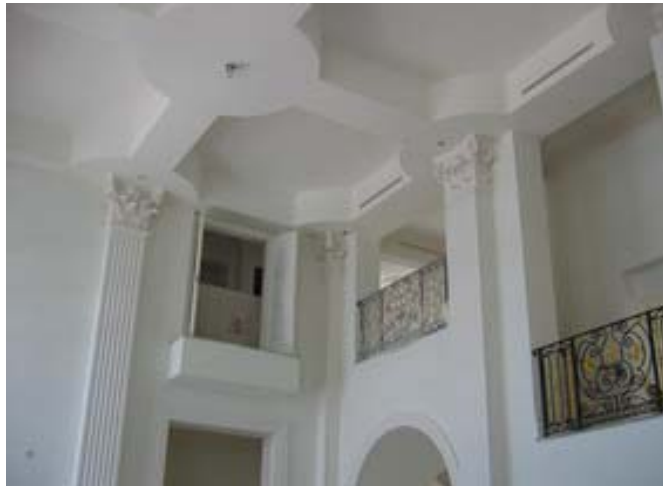
Photo # 14

There were no indications of settling cracks, displacement or water stains in any of the ceilings, walls or floors. Everything appears to be structurally sound.

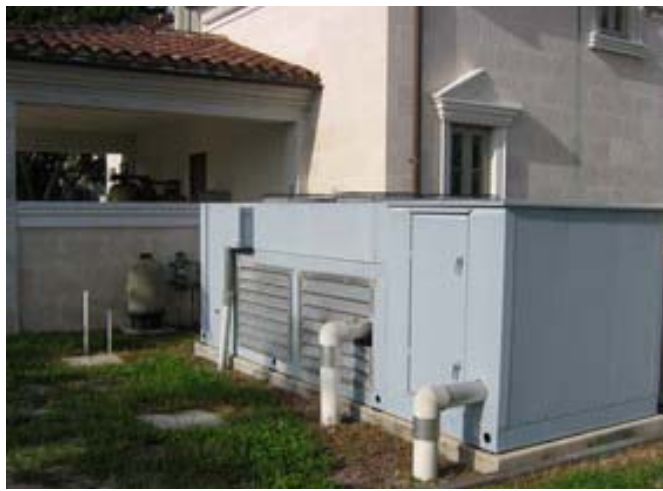
Photo # 15

Air Conditioning Systems – The three buildings on this property have fan coil units supported by a central water chiller behind the carriage house. The system was completed and functioning at one time; however, the chiller has been idle for 2 ½ years and can not be started again until it is serviced.

All three structures are cooled by chilled water from this chiller behind the carriage house.

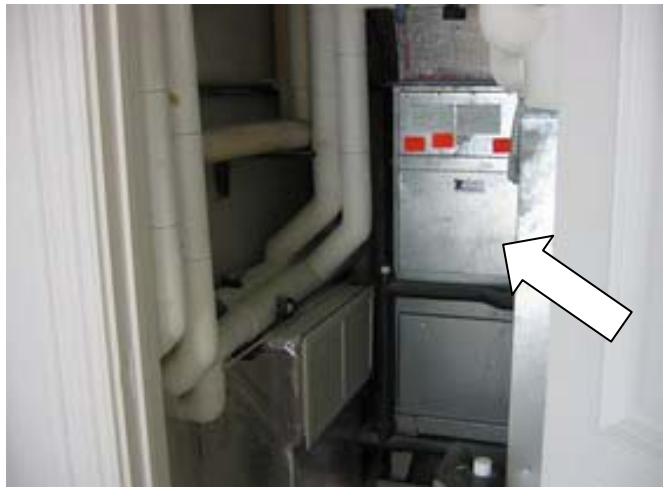
Photo # 16

Fan coil units utilize the chilled water to cool the air.

All of the units appear to be in new condition and clear of mold and dirt. They were only briefly operated during the past 2 ½ years.

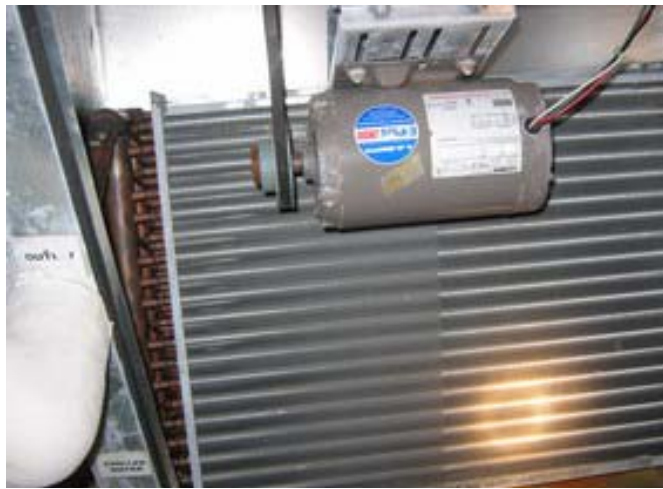
Photo # 17

This is the typical “new like condition” of the coils inside the fan coil units throughout the three structures.

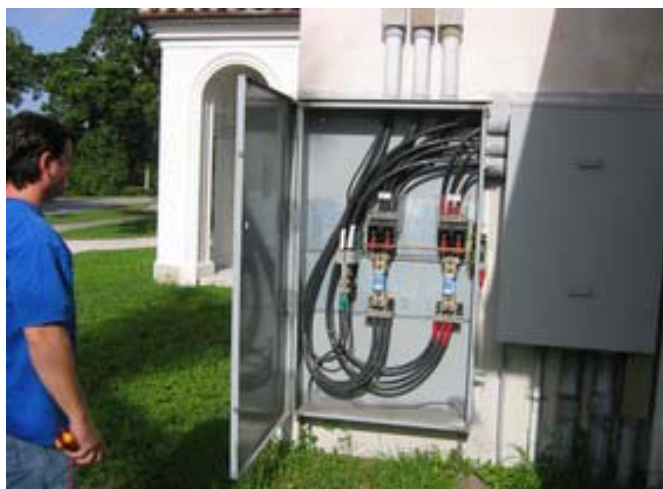
Photo # 18

The electrical system appears to be professionally installed and in good condition.

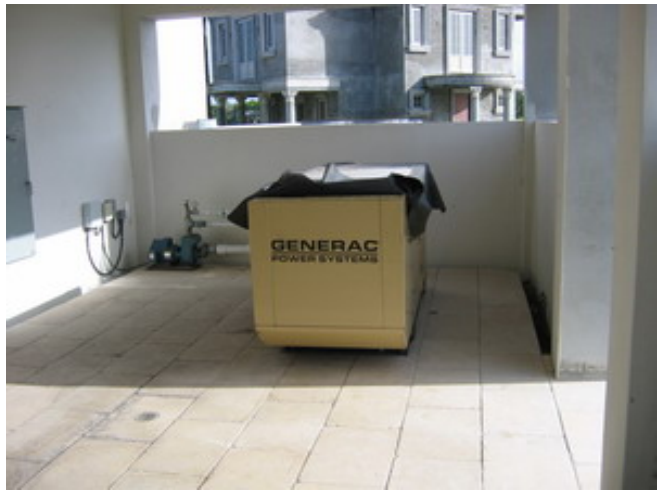
Photo # 19

There is an emergency generator and transfer switch behind the carriage house. This device was not run (it has been idle for a long period and should not be started until it is serviced).

The home has an emergency generator. This may not be sized to handle all loads.

Check with the builder on which systems will be supported during loss of power.

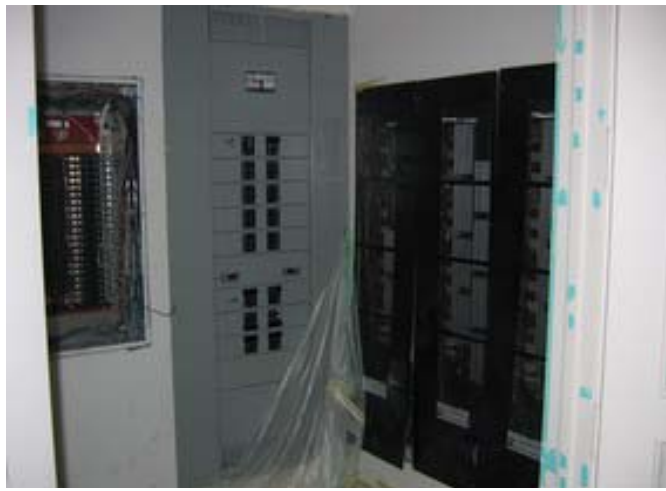
Photo # 20

It will be difficult for an electrician (unfamiliar with the work to date) to estimate the scope and cost of the remaining work needed. A Time & Material type of contract should be considered to complete the work.

The electrical work stopped during the final stages. It is uncertain what remaining scope of work needs to be done.

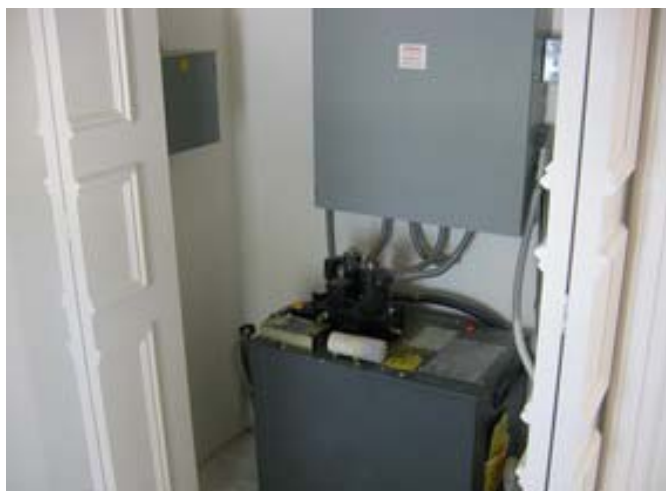
Photo # 21

The elevator and equipment appears to have been nearly completed.

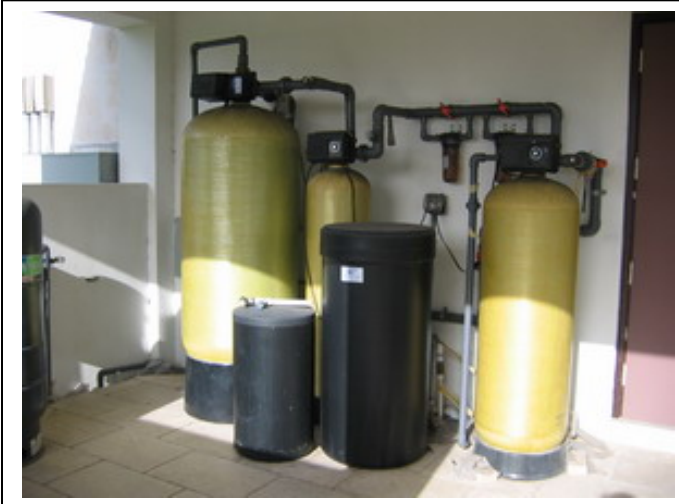
Photo # 22

There is a well on site for potable water. This filtration system is behind the carriage house. It will need regular professional maintenance.

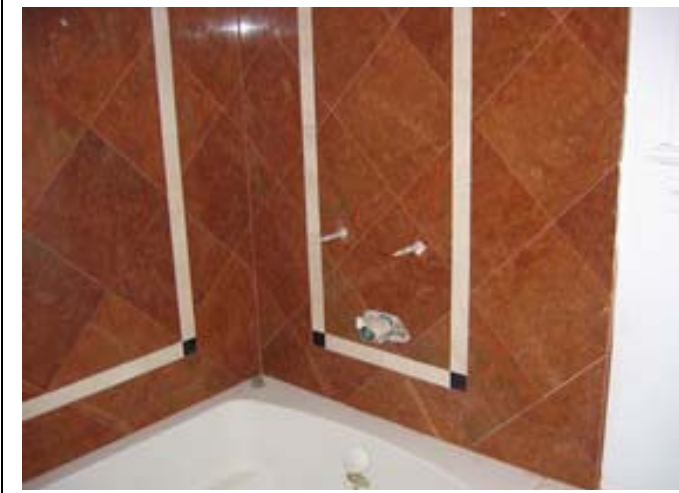
Photo # 23

The plumbing fixtures have not yet been completed.

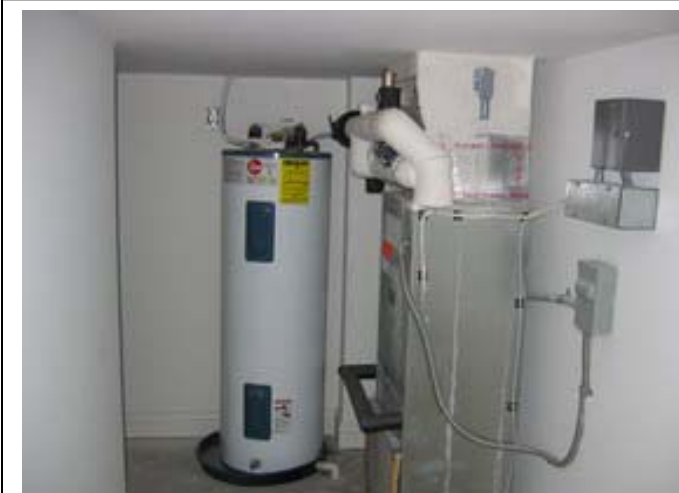
Photo # 24

Hot water heaters are installed in all three buildings.
