Standard Home Inspection Report

File Number: 05-15-006

Type of Property: Single Family Home

Date of Inspection: 10/12/2005

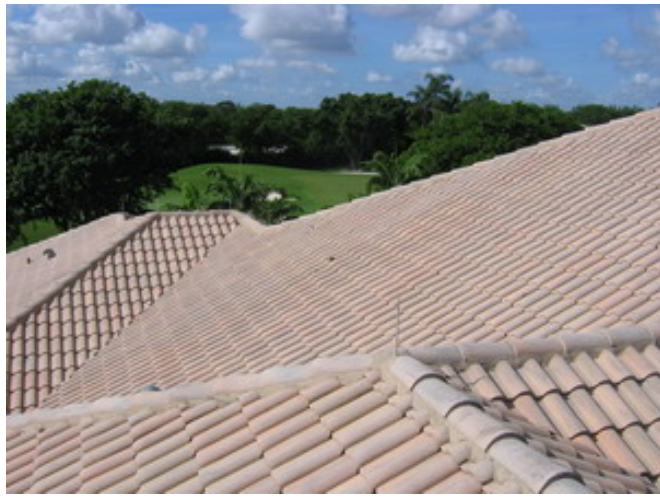
Photo # 1

This is a complex roof design with many valleys. The workmanship appears to be professional.

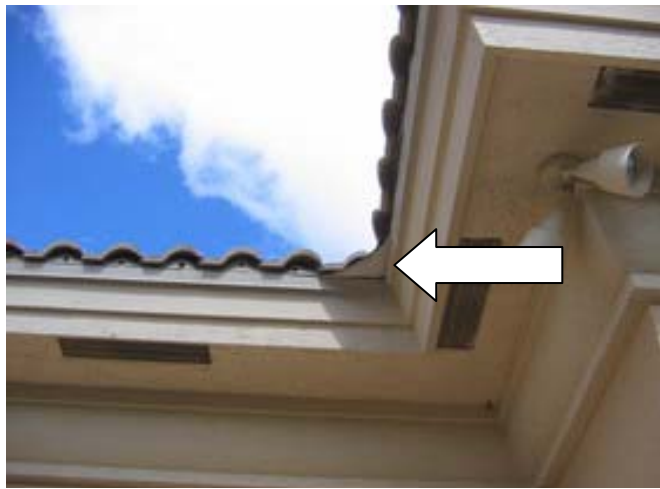
Photo # 2

Flashing is properly placed in critical areas.

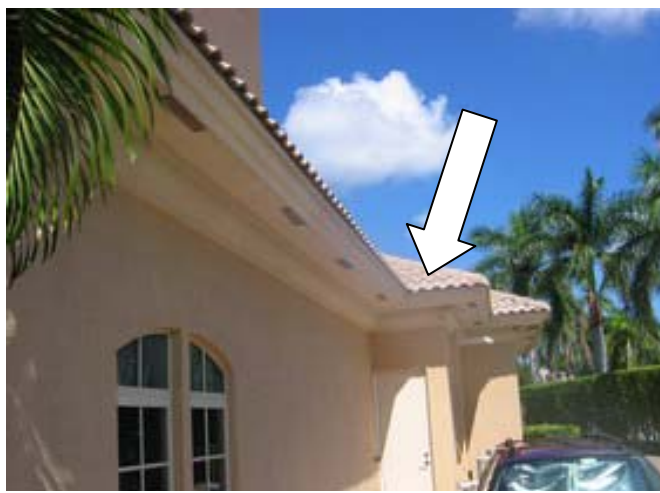
Photo # 3

Gutters are not installed near the basketball court side of the home. A gutter over this garage door entrance is recommended to keep roof run-off away from the door threshold.

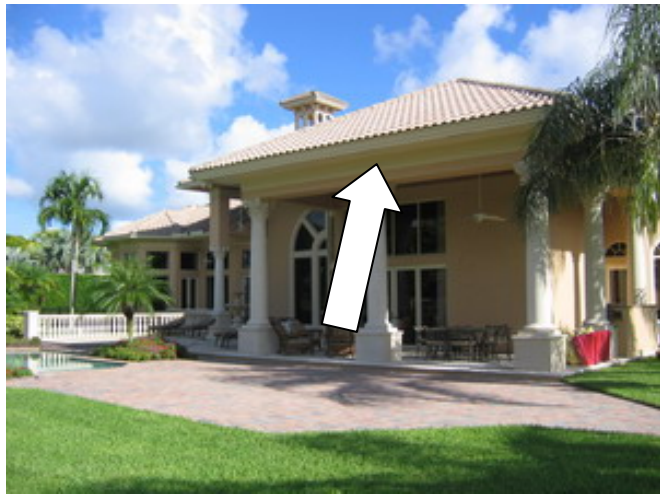
Photo # 4

Gutters are not installed over the rear patio. The roof run-off will hit the pavers below. The pavers should not be damaged by this run-off. Adding gutters here is a personal preference. They are not required by building code.

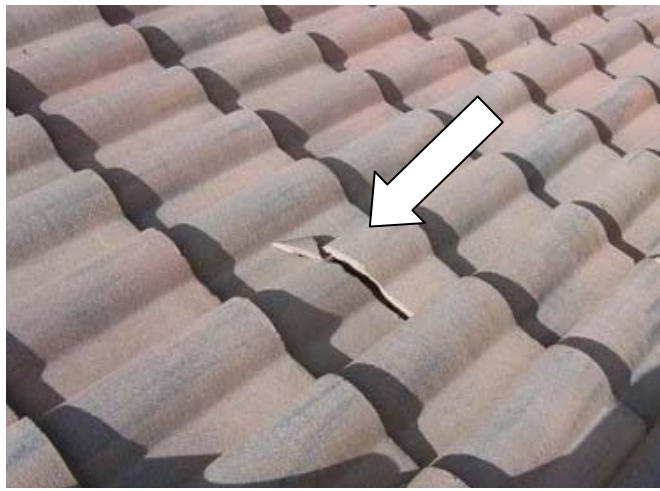
Photo # 5

There are a number of cracked tiles needing mending on the roof.

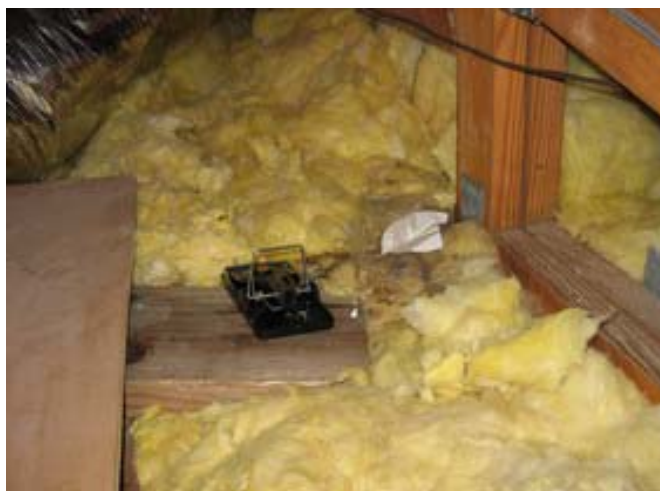
Photo # 6

The attic areas are well insulated.

This vermin trap indicates that there have been intrusions. The open pipe chase near the SW A/C condensing units is a likely entry point.

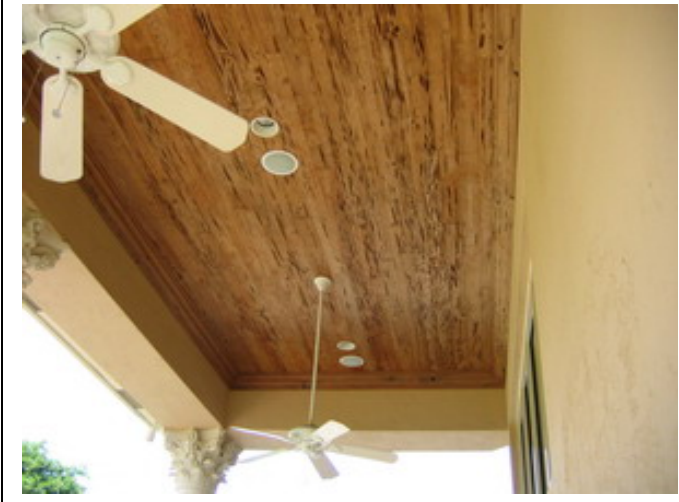
Photo # 7

The wood trim in the soffits is well protected from weather.

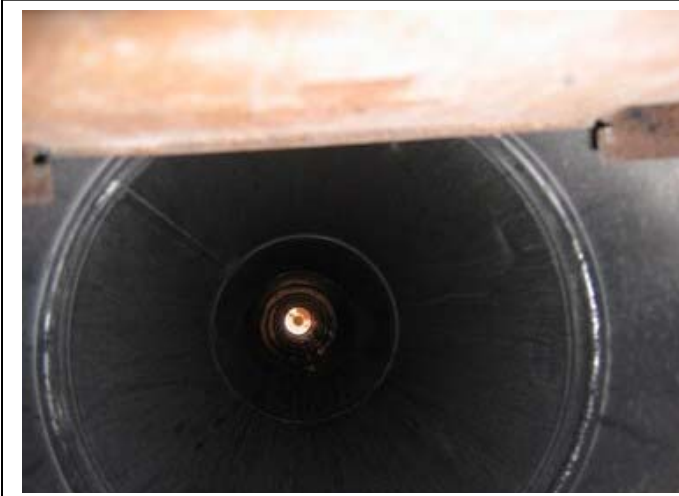
Photo # 8

The fireplace flue is clear. It appears that it was never used.

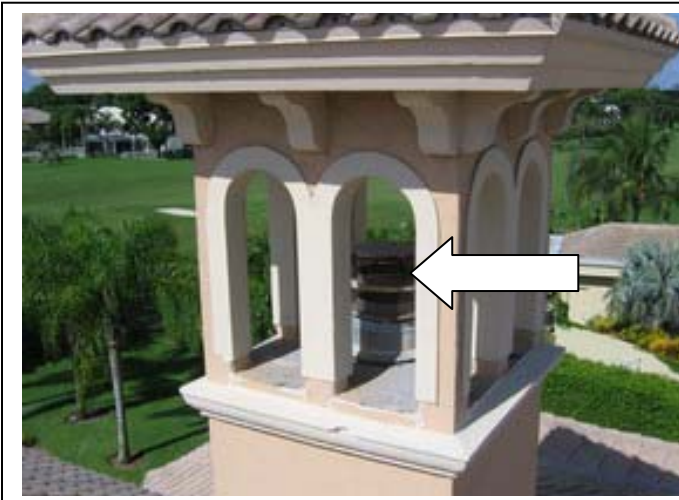
Photo # 9

The fireplace chimney cap is secure and well protected from weather.

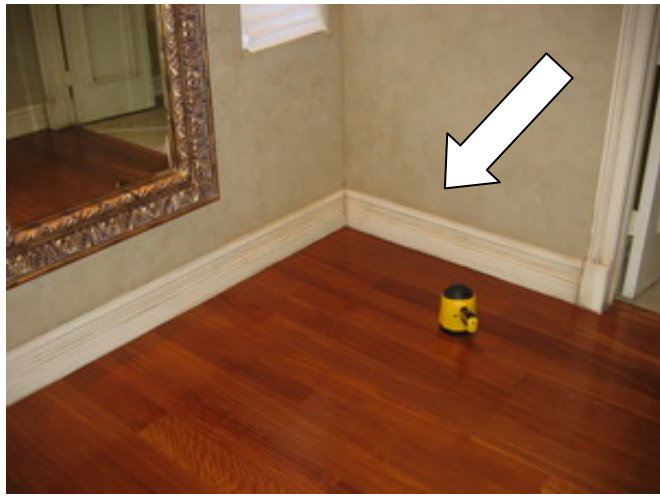
Photo # 10

The wood flooring in the master bedroom suite is secure. The gap under the wall baseboard is a cosmetic issue due to the concrete floor that is not perfectly level.

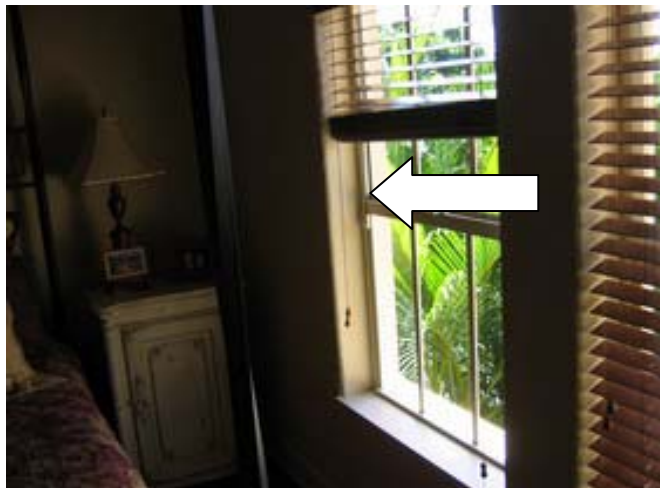
Photo # 11

Balance rod in 2nd floor bedroom window needs repair.

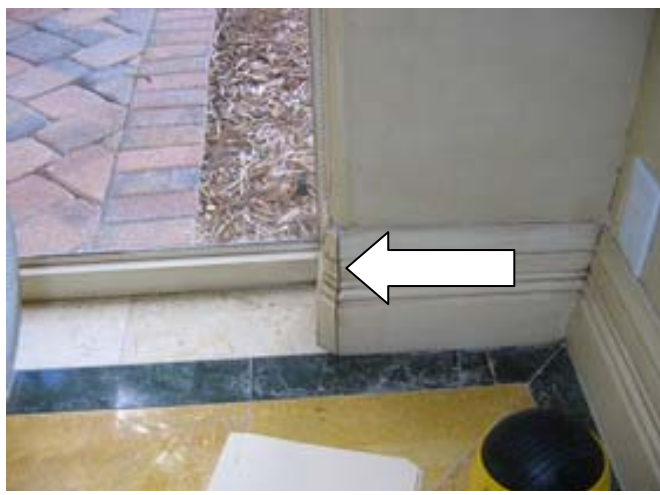
Photo # 12

Base board molding is loose near sliding door in dining room. This is a cosmetic issue.

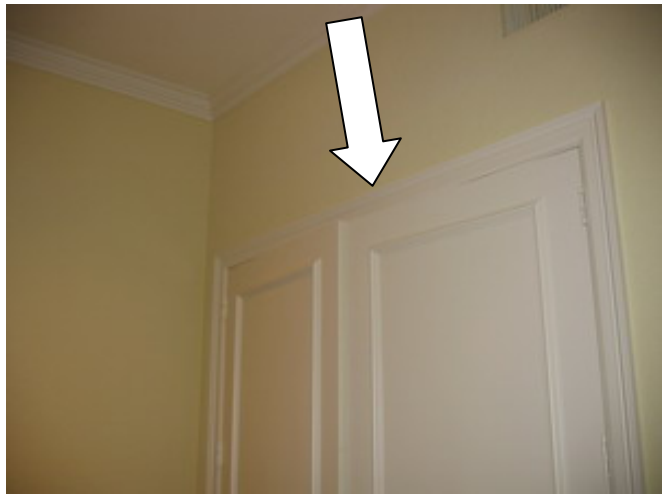
Photo # 13

Latching buttons on top of closet doors in 1st floor guest bedroom # 2 need adjustment.

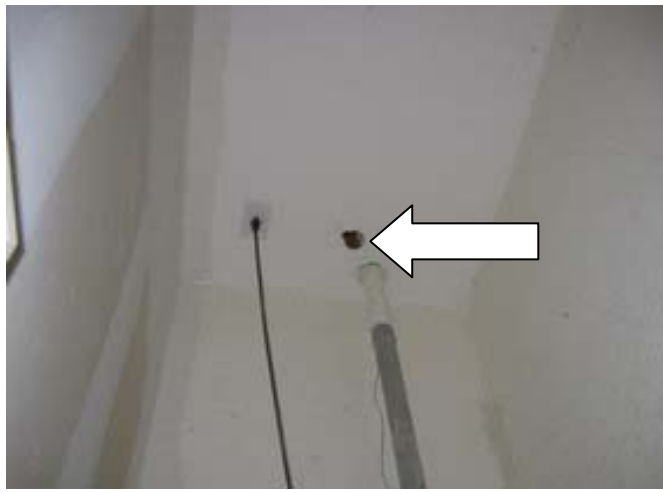
Photo # 14

Hole in ceiling of garage closet housing the central vacuum systems should be patched.

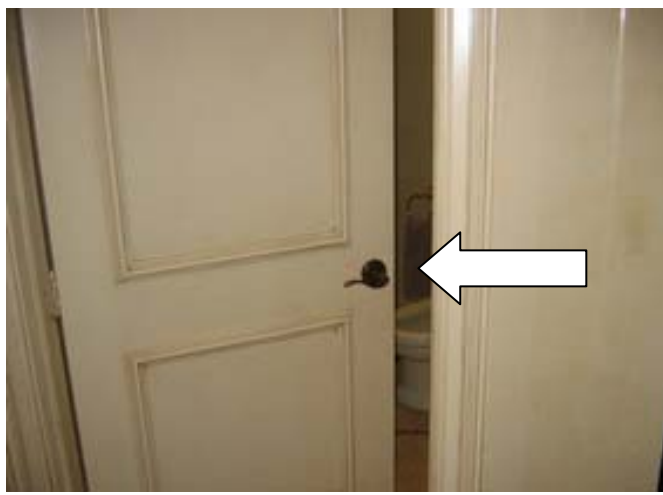
Photo # 15

Door to "His" master bathroom did not latch properly and needs minor adjustment to door strike.

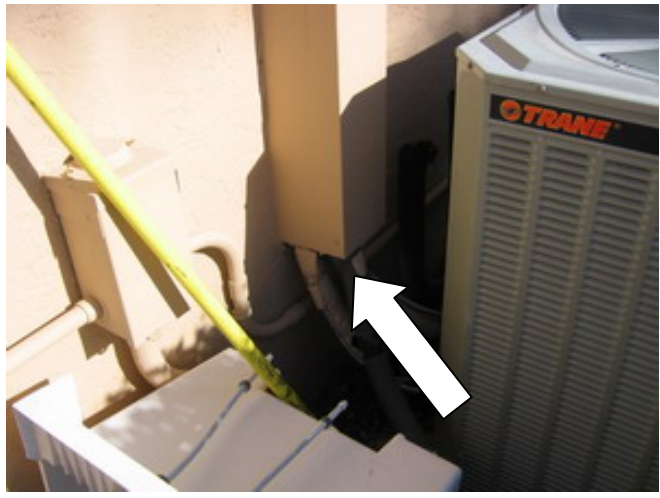
Photo # 16

The pipe chase for refrigerant lines next to the A/C condensing units on the SW side of the home should be plugged with foam insulation to eliminate an access for vermin.

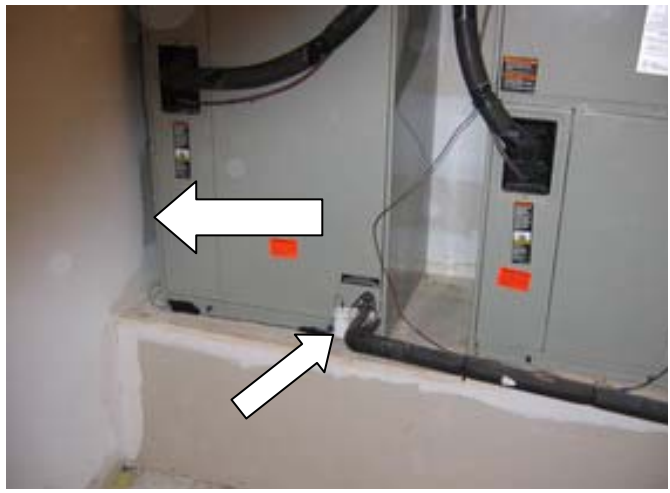
Photo # 17

Cold supply air is leaking from behind this air handler over the "Hers" master bedroom closet.

Leak detection shut-off switches are installed on these air handlers. This is a good design practice.

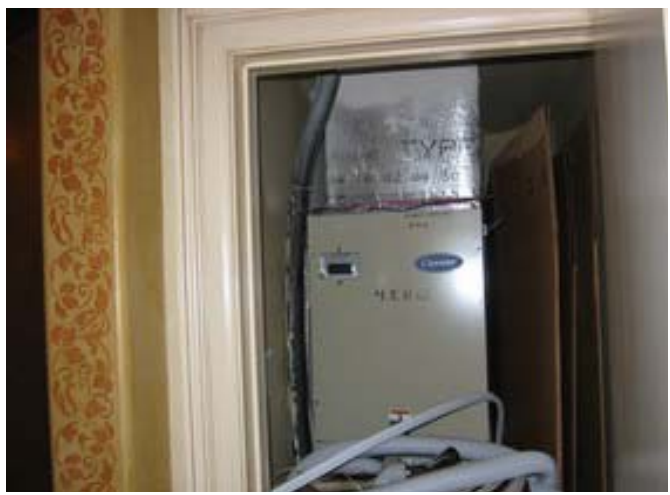
Photo # 18

The new air handler in the closet near the theater does not have a leak detection shut-off switch. One should be installed.

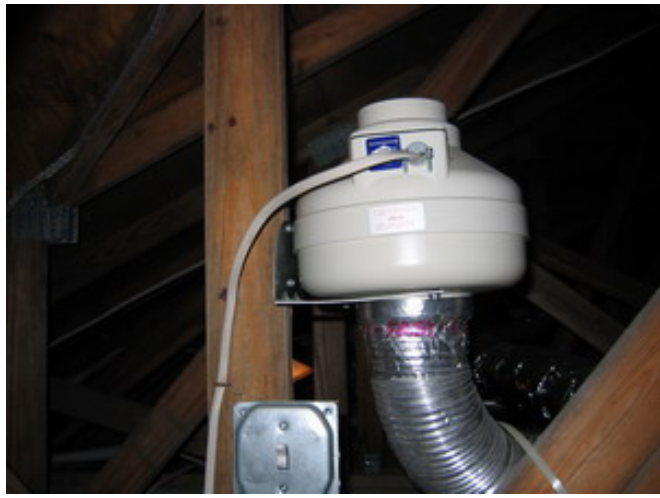
Photo # 19

The A/C systems in this home were modified because of design problems. The owner stated that he had a significant amount of work done to correct temperature and humidity problems. The temperature and humidity appears to be well managed now; however, it is uncertain what corrective actions were taken. The owner stated that ductwork to several supply and return registers were modified. Much of this ductwork is not easily accessible to verify what may have been done. It is suggested that the company that made these modifications be interviewed. Any documentation of this work should be collected and reviewed.

This appears to be a modification to the A/C ductwork over the garage. This fan is discharging conditioned air into the attic. This is not a normal practice and why it was done needs further investigation.

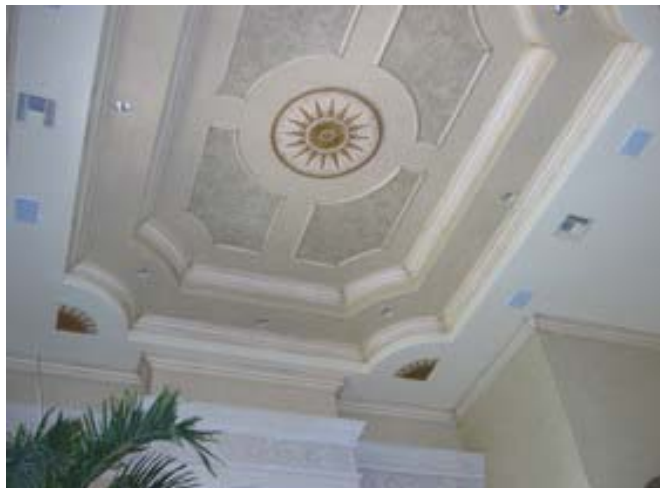
Photo # 20

Changes to the ductwork above the high ceilings are not accessible to view.

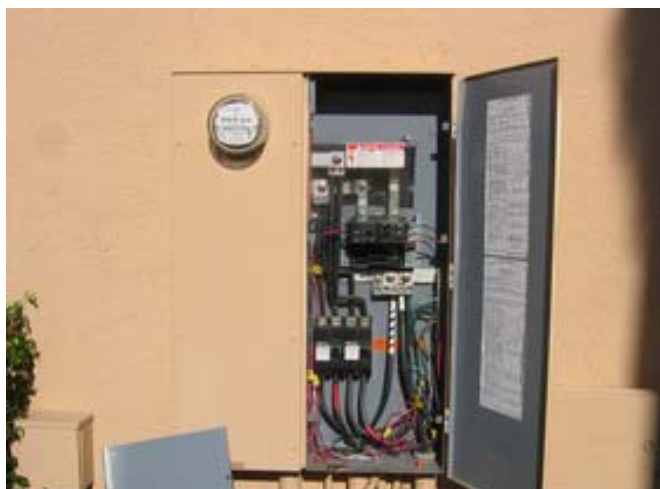
Photo # 21

The electrical system appears to have been professionally installed.

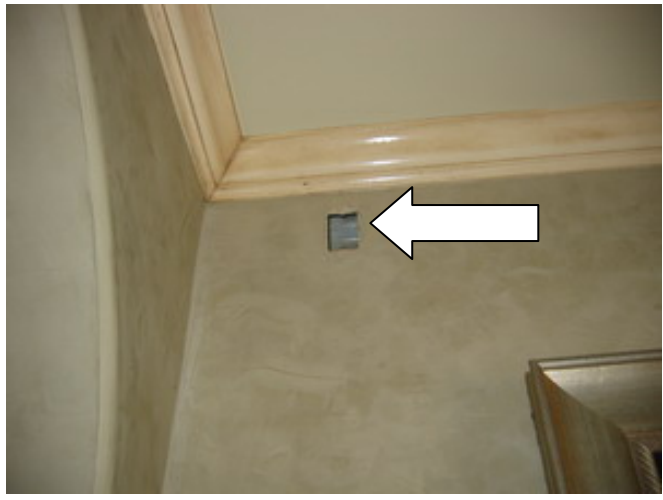
Photo # 22

Cover trim plate missing in 2nd floor hallway.

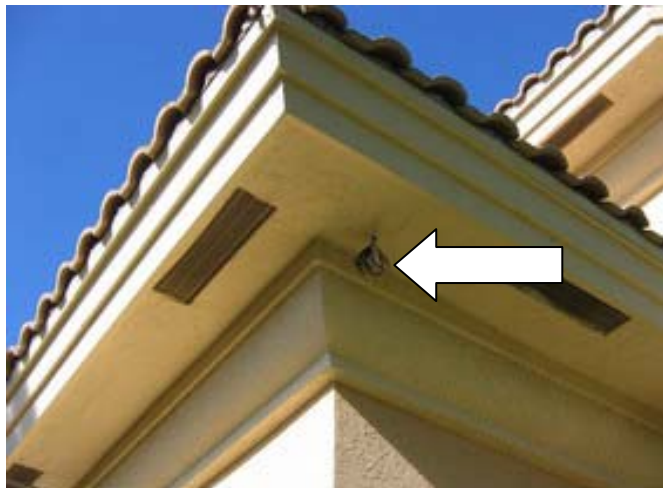
Photo # 23

Wire bundles surrounding the exterior and inside the home are for future security camera installations.

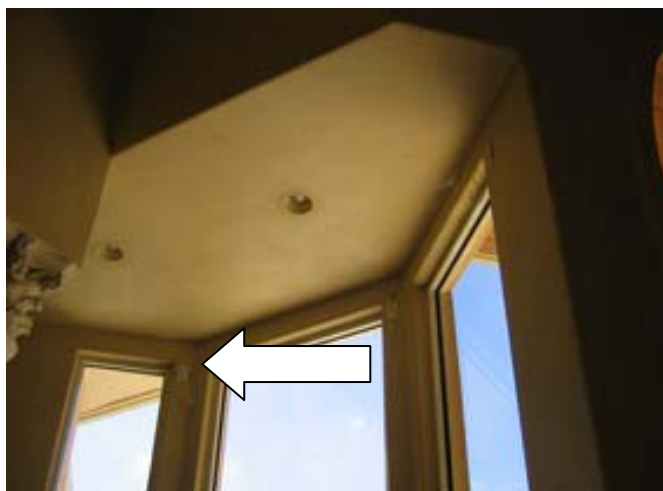
Photo # 24

Outlets are provided for additional powered drapes if desired.

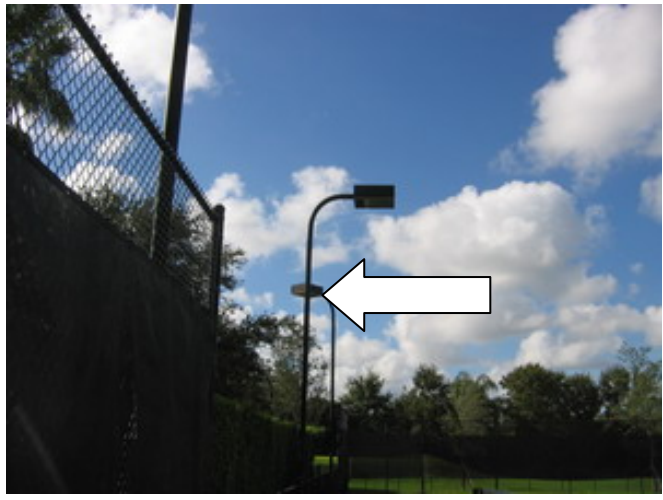
Photo # 25

Two tennis court light fixtures need to be realigned and the wiring checked.

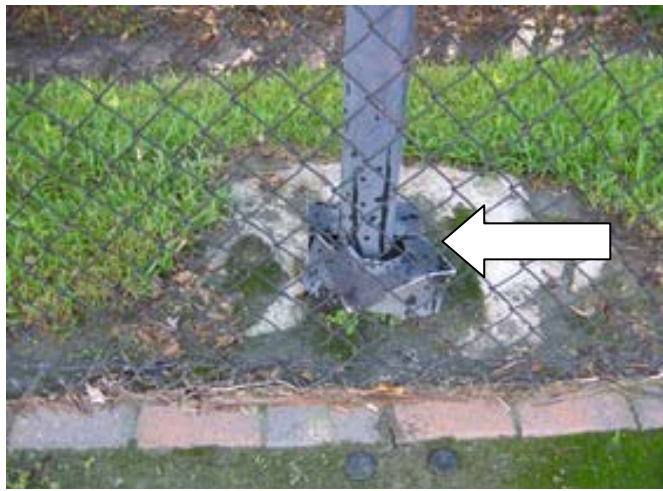
Photo # 26

Lawn equipment has damaged the base of two tennis court light fixtures. They should be examined for any wiring damage.

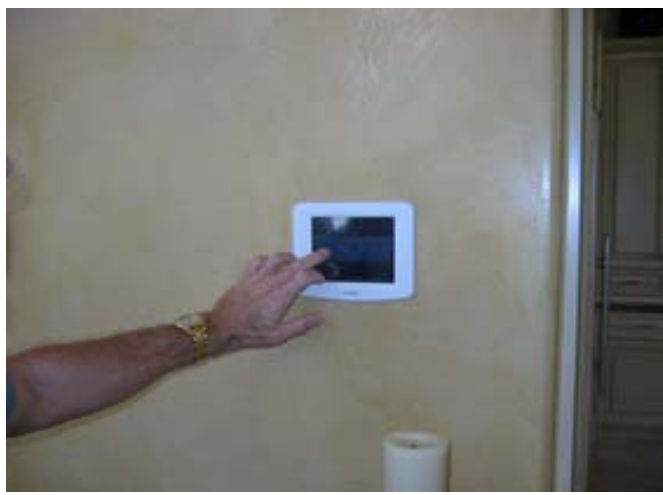
Photo # 27

The low voltage lighting and drape controls appear to function properly

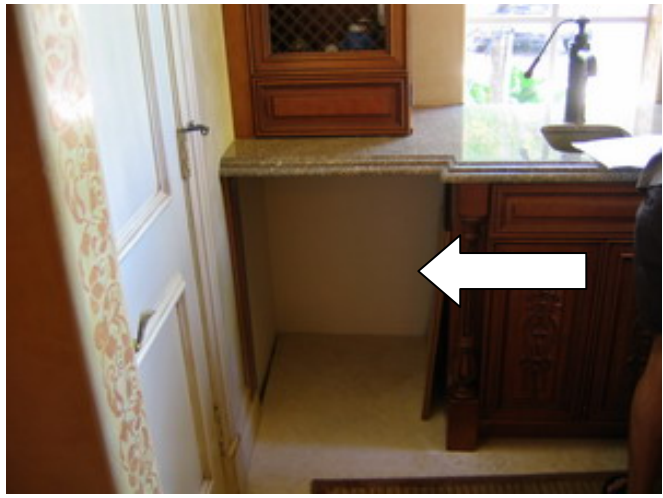
Photo # 28

Power is not provided for a mini refrigerator near the theater.

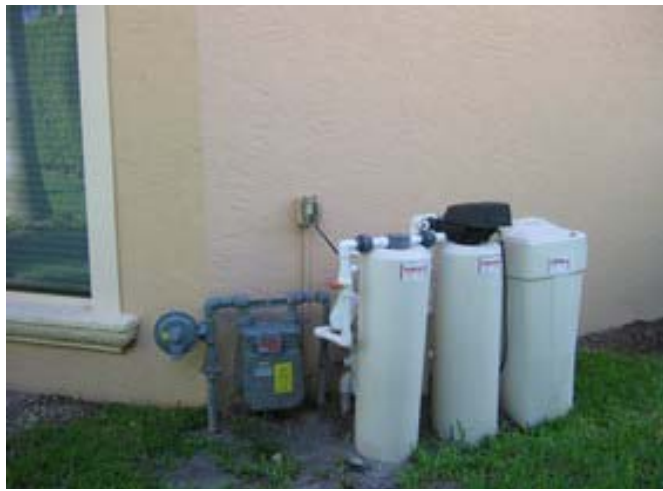
Photo # 29

Natural gas odor was noted along the north side of the home. The gas company should be called to investigate.

This home has natural gas service. Natural gas odor was noted along the north side of the home. The leak may be associated with the pool heater.

The water treatment equipment appears functional but should be serviced by a water treatment company to recommend any desired improvements.

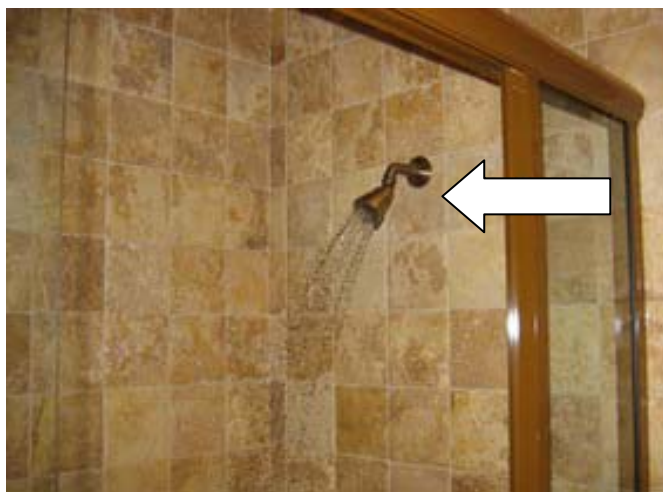
Photo # 30

Water pressure is low in the shower of the housekeeper's bathroom. This needs further investigation and repair.

Pressure was adequate at the sink and toilet in this bathroom and good throughout the entire home. This is an isolated problem.

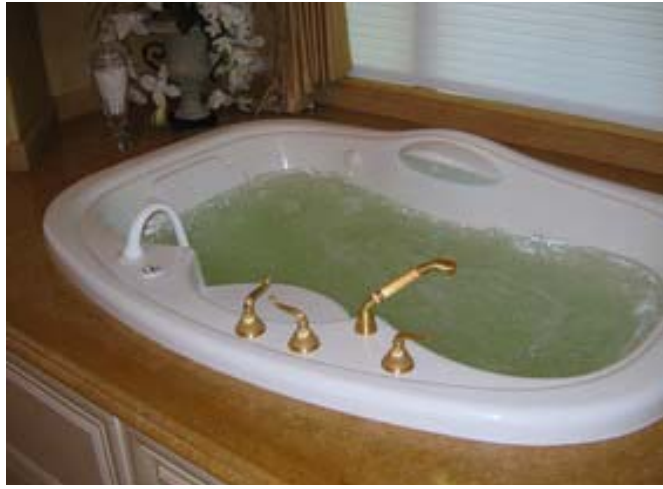
Photo # 31

The "Hers" SPA functions.

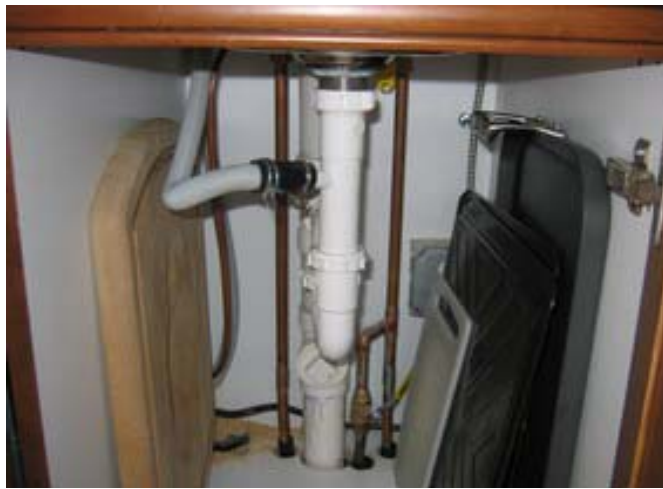
Photo # 32

Plumbing throughout the home appears to have been professionally installed. No leaks were noted.

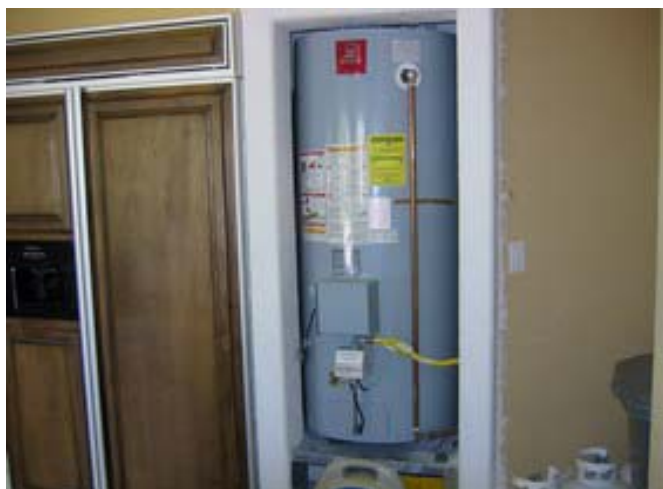
Photo # 33

The hot water heater in the garage is gas fired and professionally installed.

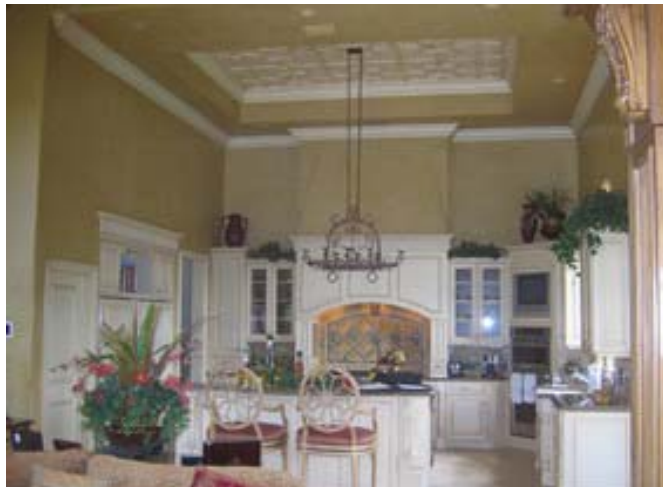
Photo # 34

All kitchen appliances appear to be professionally installed.

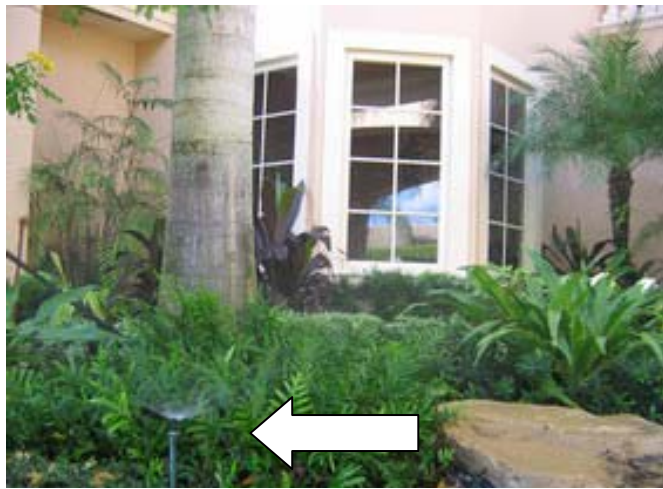
Photo # 35

Irrigation water is pointed toward the home near the front entrance. There is only a minor amount reaching the windows. No water intrusion was noted.

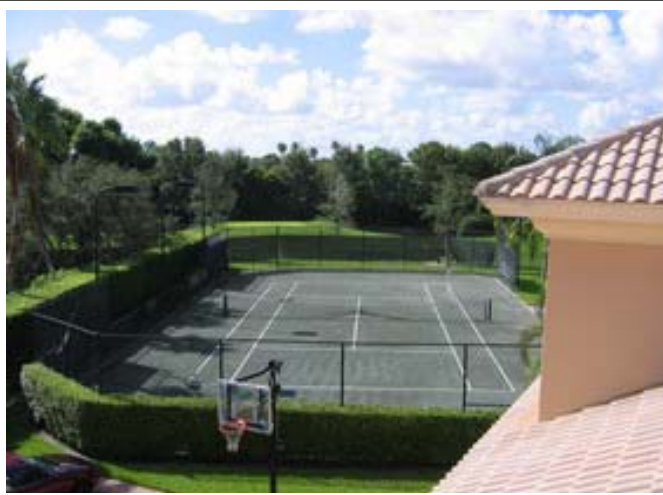
Photo # 36

Screening surrounding the tennis court is torn in many places and may need to be replaced.

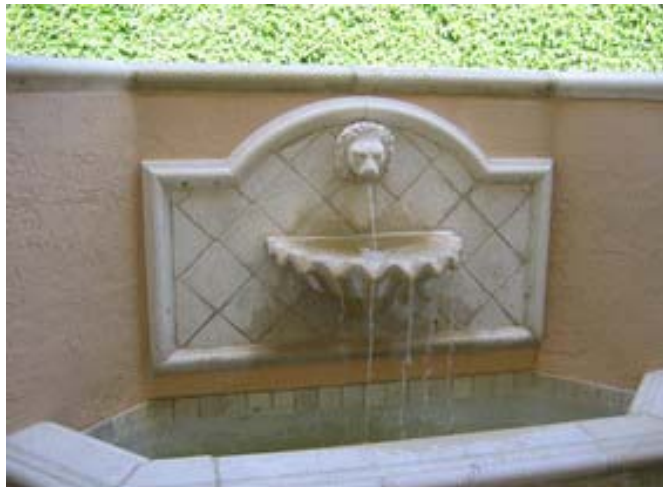
Photo # 37

The fountain on the north side functions properly.

The fountain on the south side is being repaired.

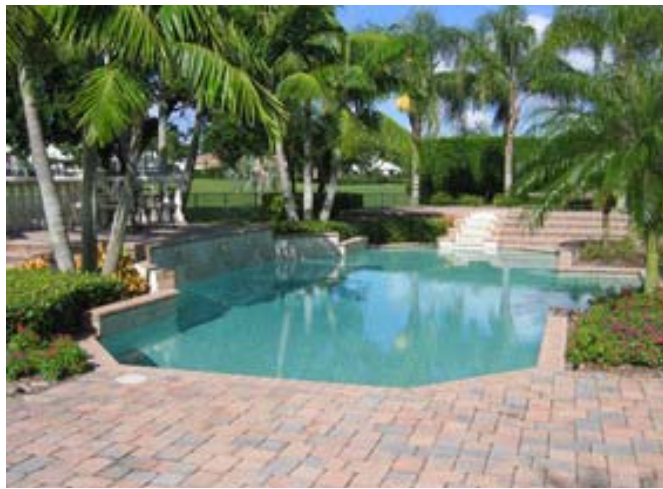
Photo # 38

The pool and spa are in good condition.

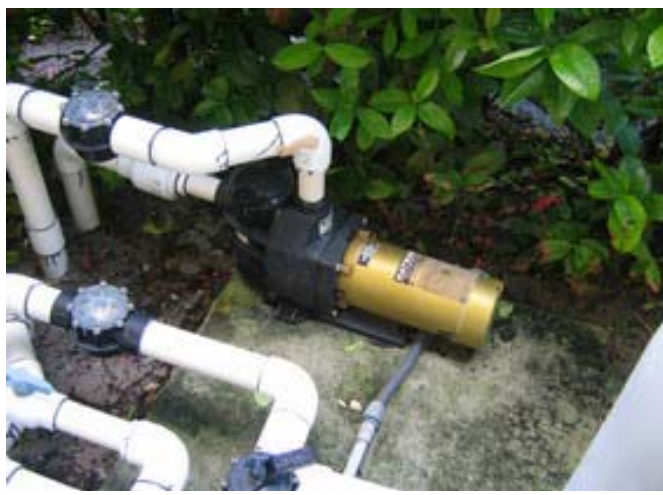
Photo # 39

This pump is not working. The pool service company said that it was never running. It was installed for a high intensity waterfall.

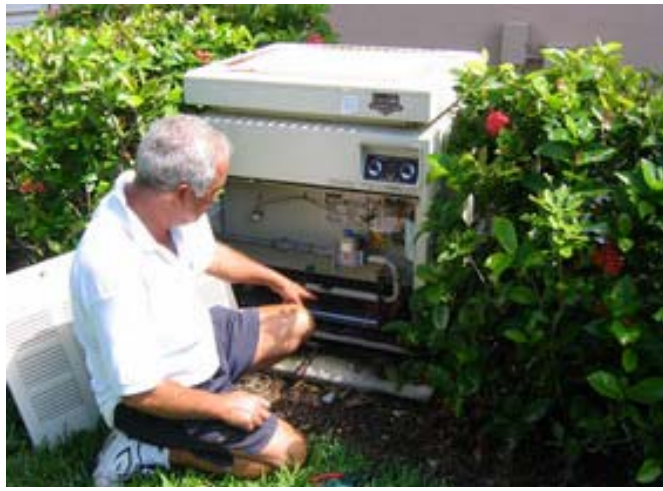
Photo # 40

The pool and SPA heater was under repair by the pool service contractor.

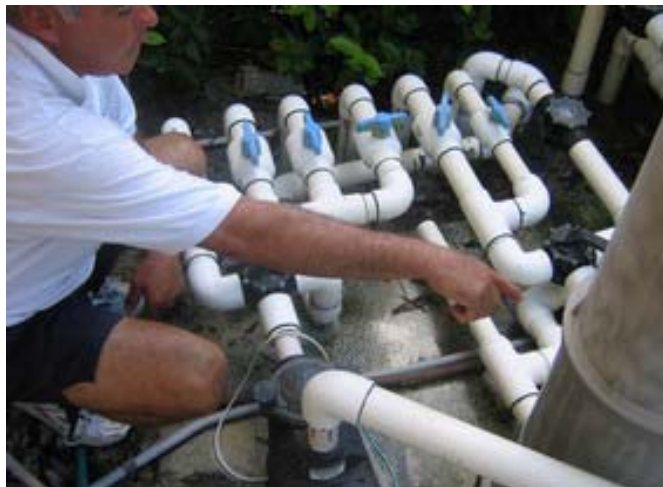
Photo # 41

The pool heater can be used for either the SPA or the pool by manually turning valves. The service company technician stated that all of this could be set-up to be controlled automatically from inside the home if desired (for additional cost).

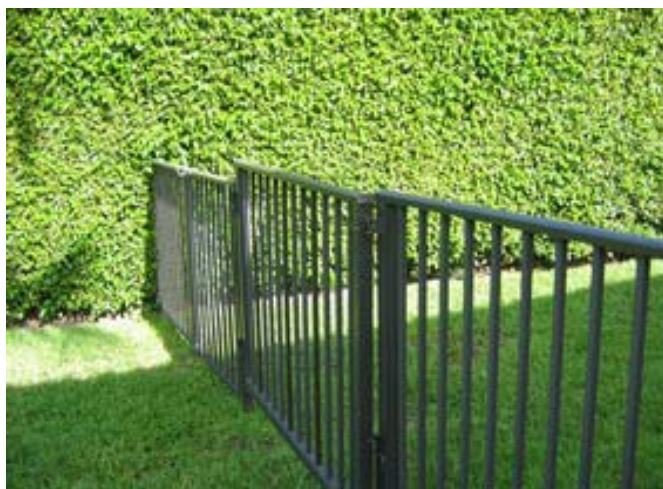
Photo # 42

The latch on the north pool security gate did not close properly and needs adjustment.
