Standard Home Inspection Report

File Number: 05-15-008
Status of Property: unoccupied
Type of Property: Single Family Home
Square Footage: 17,401± SF (not verified)
Age of Home: 2001± (not verified) Permitted prior to 2001 Unified Building Code
Date of Inspection: 04/22/2005
Time of Inspection: **Start:** 9:15 AM **Finish:** 2:45 PM
Weather conditions today: 80° F, Partly Cloudy
Recent weather conditions: no recent rain

Inspector: Craig P. Milliken, PE
Phone: (561) 866 9956

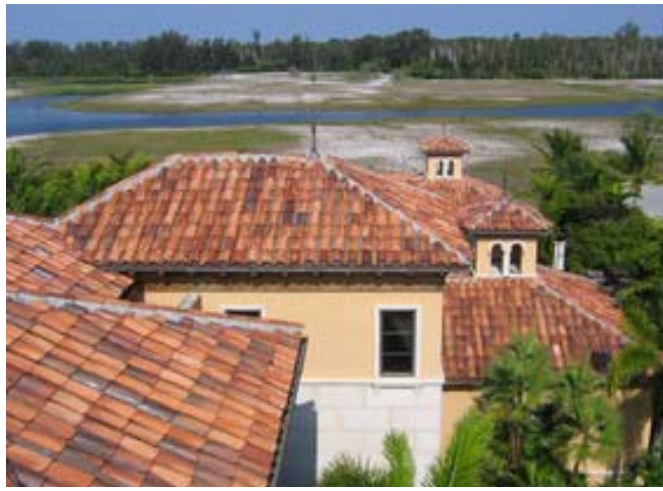
Photo # 1

Overall the workmanship in the roof sections appears to have been professionally performed; however there are a number of items needing attention shown in the following photos.

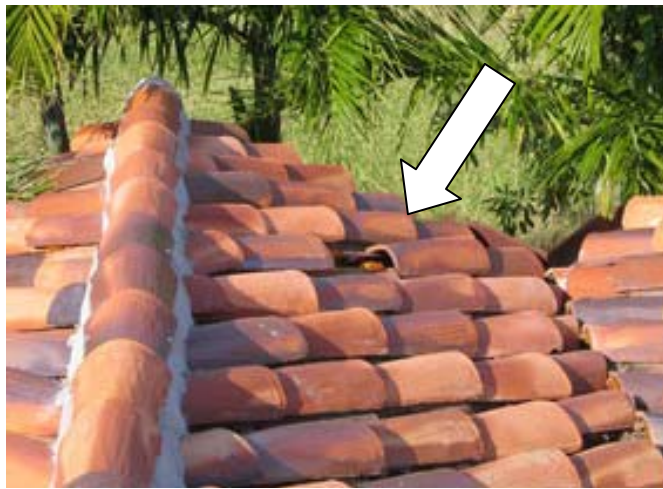
Photo # 2

Displaced tile at SW corner of roof

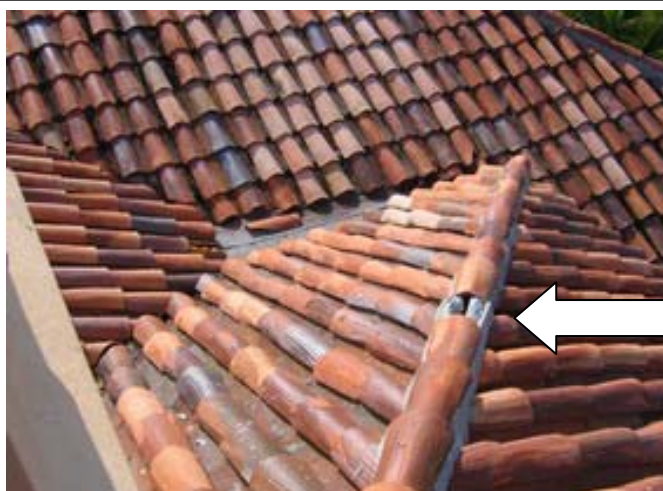
Photo # 3

Missing tile on SE section of roof.

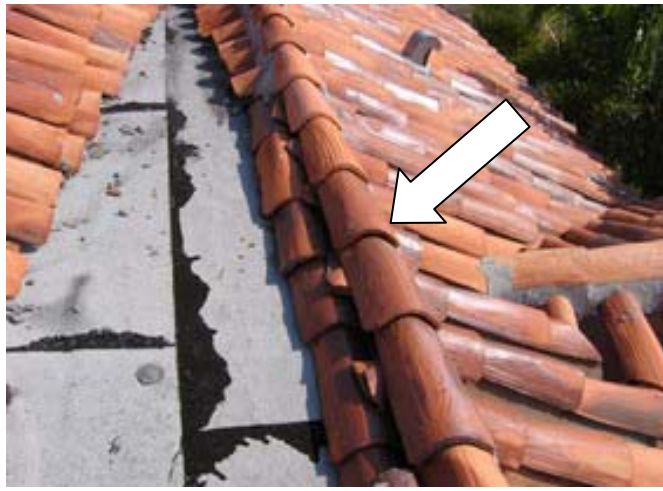
Photo # 4

Numerous loose tiles along this ridge over the master bedroom suite.

It is estimated that there are at least 100 tiles that are loose throughout the roof. A roofing crew needs to examine the entire roof and secure all loose tiles with mastic.

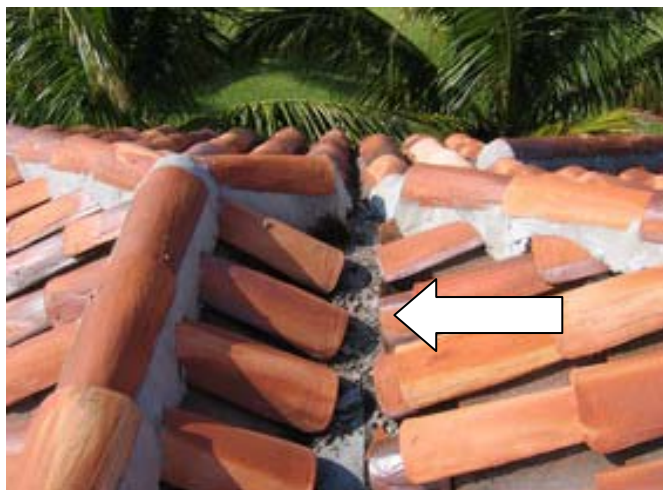
Photo # 5

Debris is blocking the valley over the master bedroom suite.

Debris (excess mortar and tile chips) was noted over many sections of the roof. If not removed it may cause similar blockage problems which can contribute to roof failures at critical points.

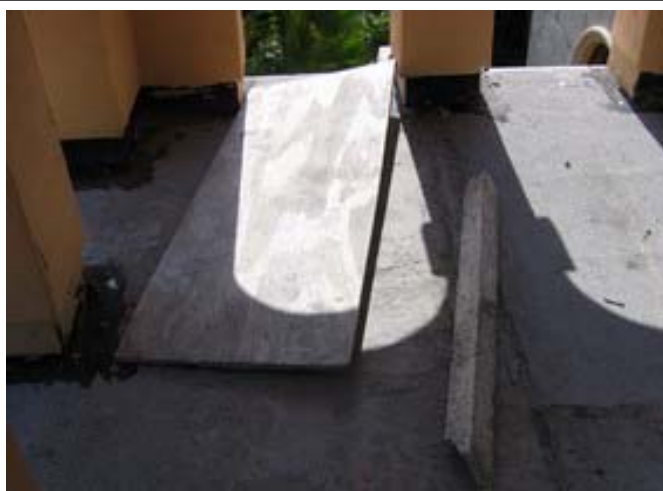
Photo # 6

Construction debris inside pinnacle over east garage.

This is a piece of plywood and a piece of trim.

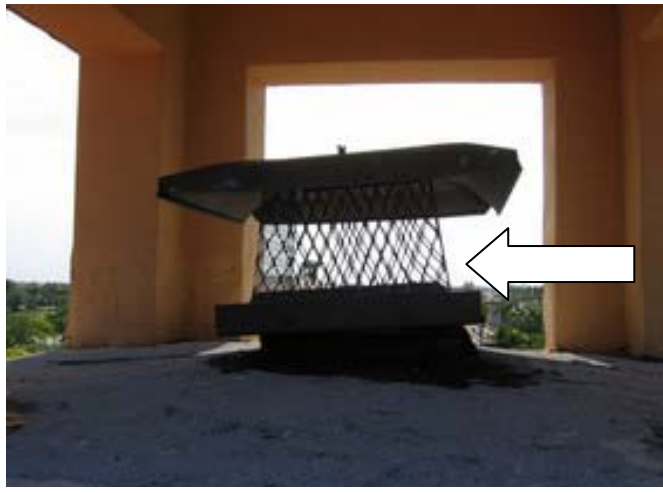
Photo # 7

Loose chimney cap over living room area. Screws need to be tightened.

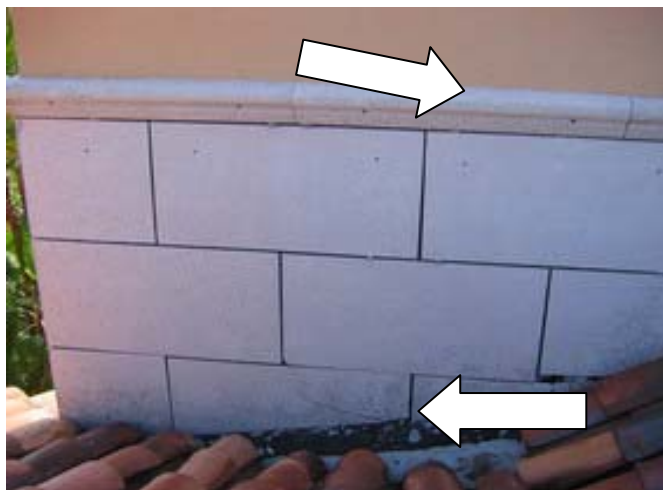
Photo # 8

Stone fascia trim panels over the east garage are not grouted.

Bottom panel is cracked.

Cracks in cap need caulking.

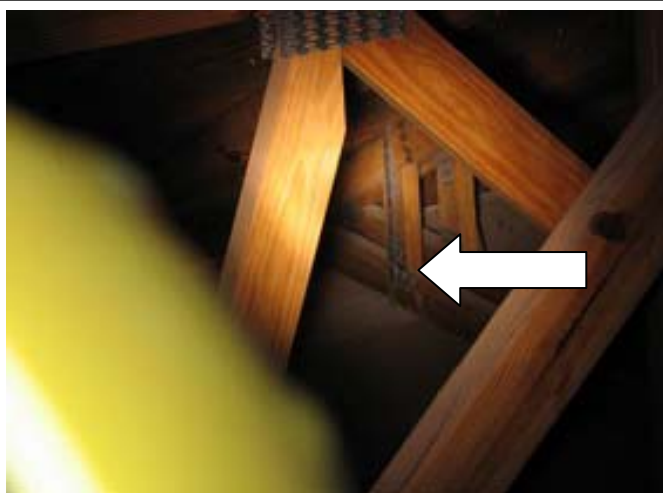
Photo # 9

Hurricane straps appear to be properly installed.

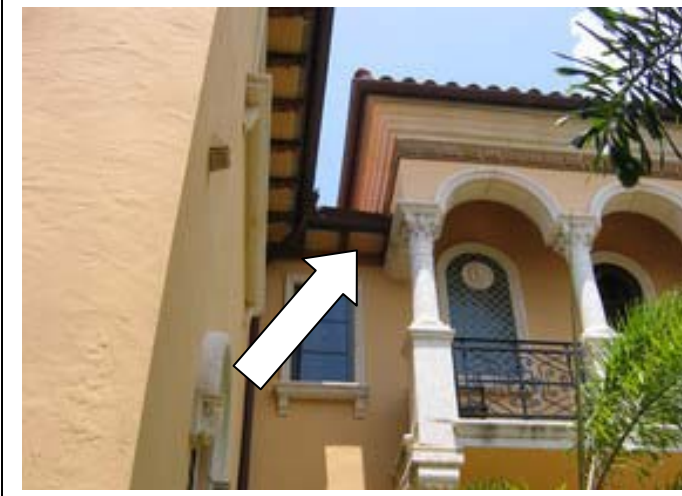
Photo # 10

Gutter over front entrance is reverse pitched and causing mildew on the walls below it.

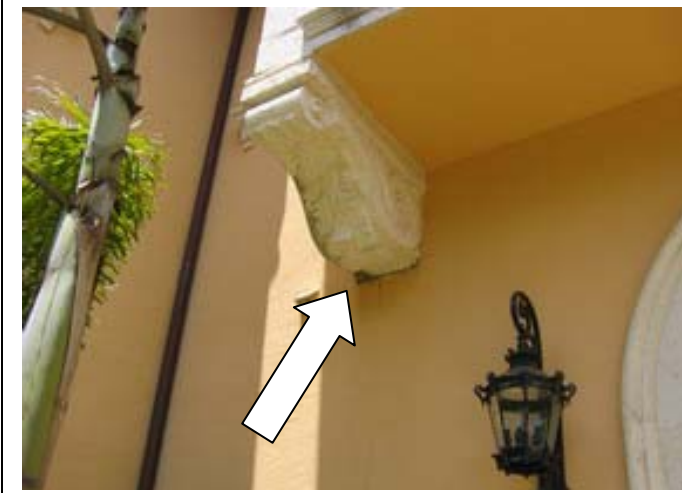
Photo # 11

Mildew on walls under the balcony due to gutter problem shown in photo # 10.

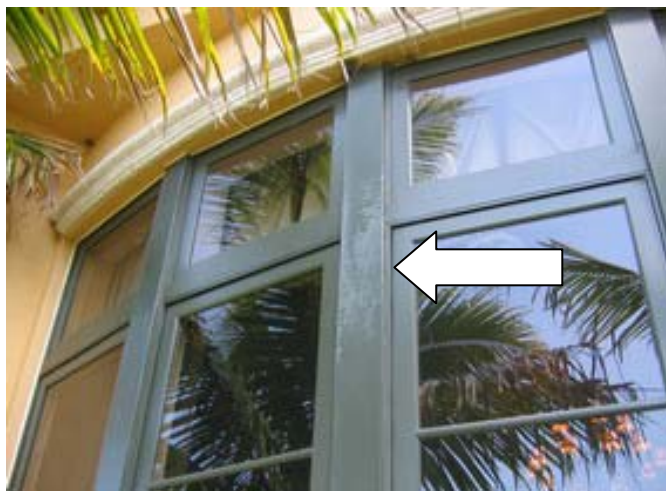
Photo # 13

Damaged paint on exterior side of living room bay window due to palm tree limbs and wind.

All tree limbs need to be kept trimmed away from the walls and roof.

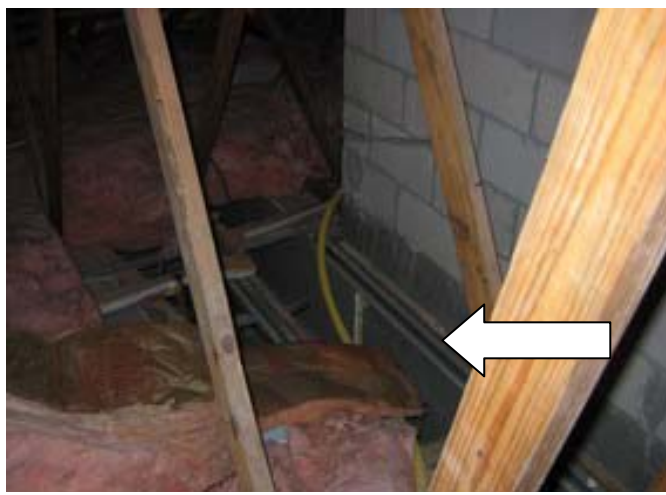
Photo # 14

Displaced insulation in the attic. This area is over the family room.

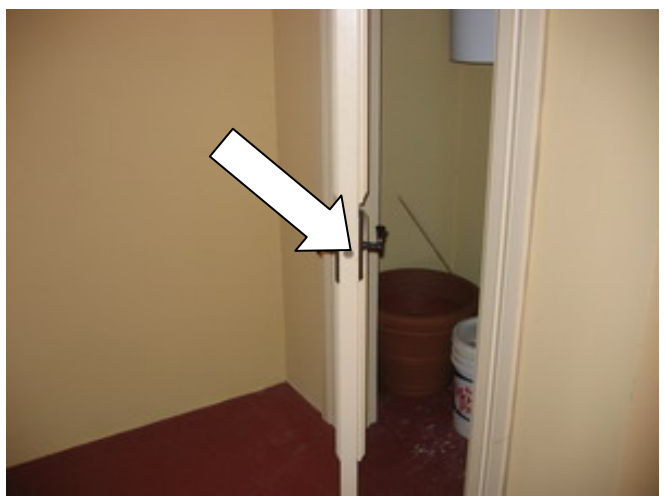
Photo # 15

Hardware missing in door latch assembly. This is in the east garage.

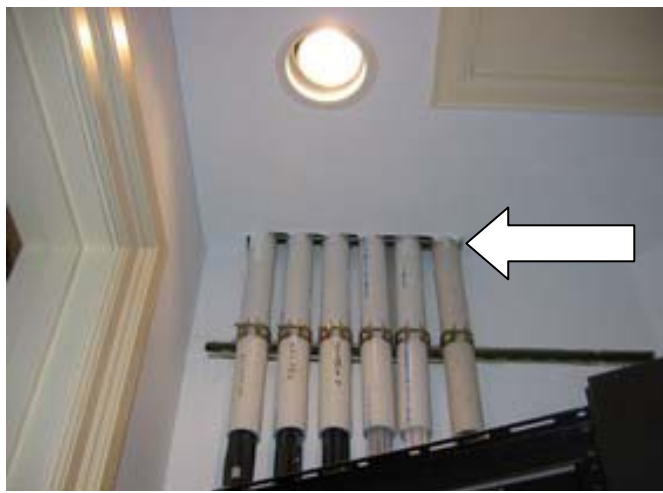
Photo # 16

Gaps around conduit penetrations through the drywall ceiling in a closet near the kitchen area.

This compromises the fire rating of the ceiling assembly.

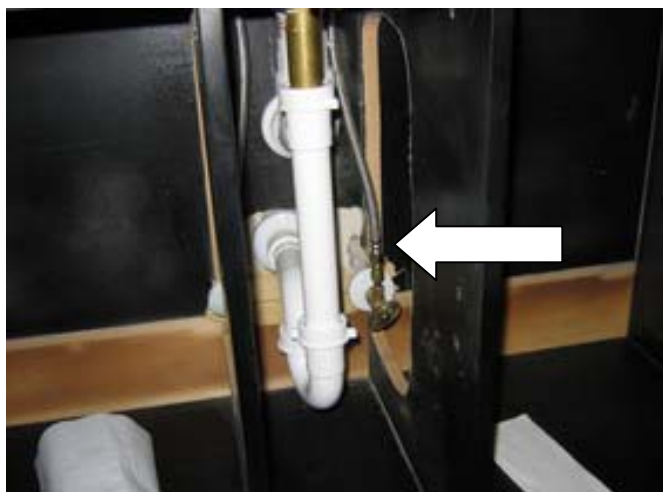
Photo # 17

Gaps in drywall under the powder room sink.

This is poor workmanship.

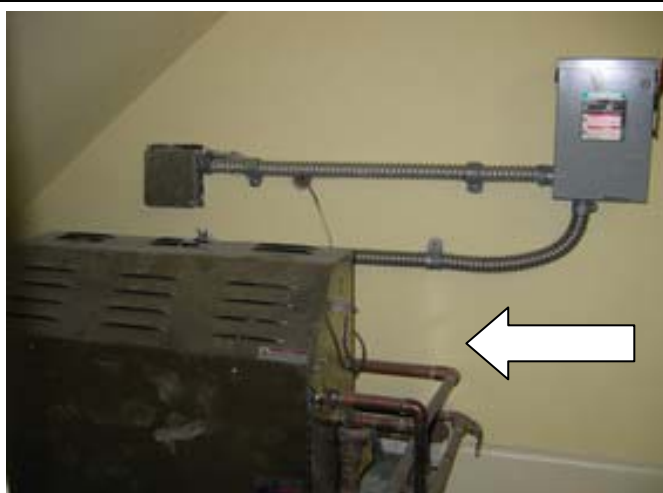
Photo # 18

There are gaps in the drywall behind steam generator in guest house.

The steam generator did not function.

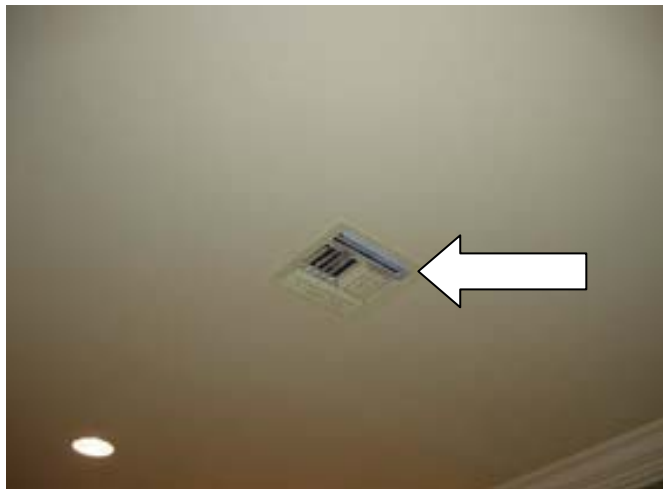
Photo # 19

2. Surface mildew on two supply air diffusers on the 2nd floor of the main house. This problem is being corrected by Automated Air Conditioning personnel

Mildew stained diffuser in 2nd floor of main house.

The duct inside is not contaminated. This is a condensation problem being addressed by Automated Air Conditioning. Keep windows and doors closed during summer months.

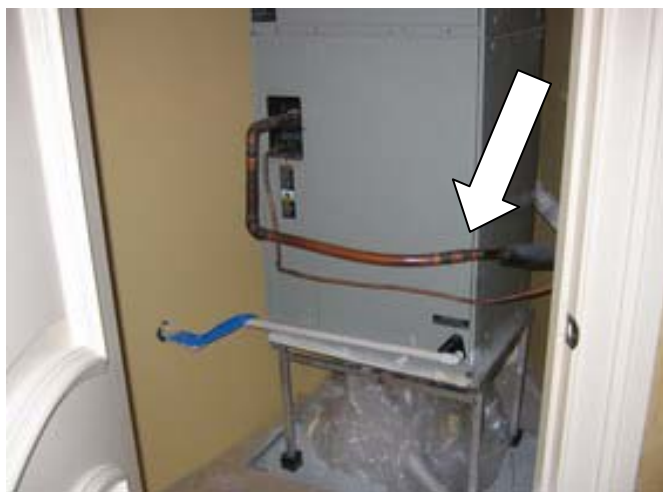
Photo # 20

Refrigerant line insulation missing on air handler near kitchen.

All air handlers and condensing units should be labeled # 1 – 6 for ease of maintenance.

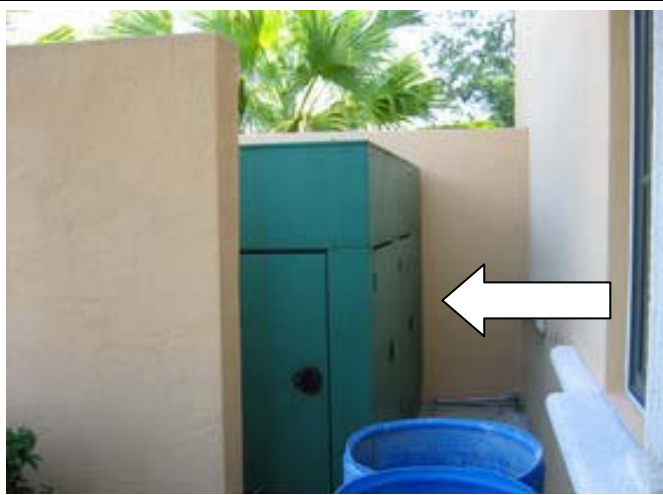
Photo # 23

The generator was not tested. These need to be run on a monthly basis and regular maintenance to ensure that they stay in a ready condition.

Ask the builder for copies of the maintenance log. OK Generators is currently providing the service. Phone – 800.385.3187

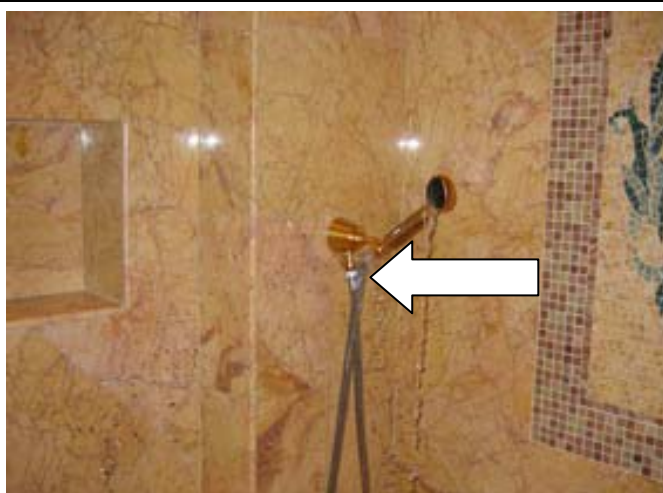
Photo # 24

Leaking fitting in "hers" master bath.

All fittings should be checked after the hot water is turned on.

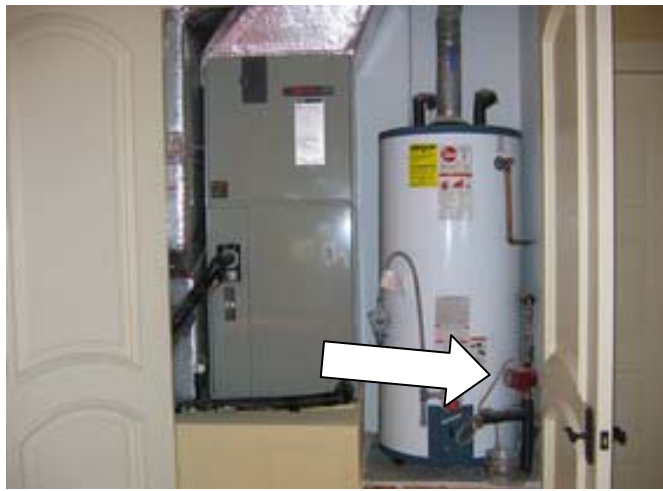
Photo # 25

None of the hot water heaters were functioning. All are gas fired.

Circulating pumps are installed but are not electrically connected.

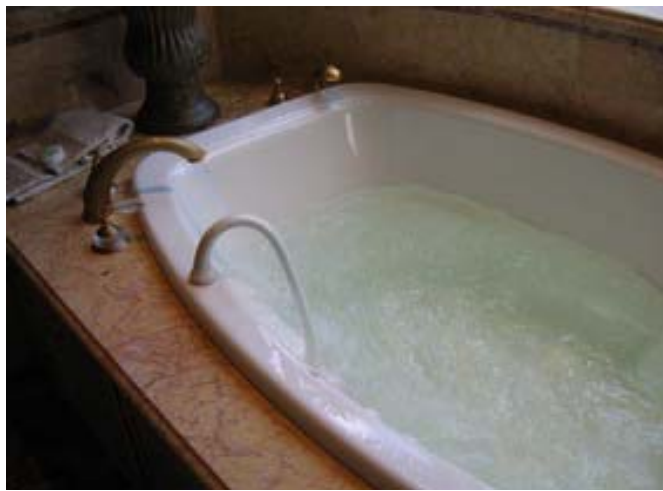
Photo # 26

The "hers" SPA functions properly.

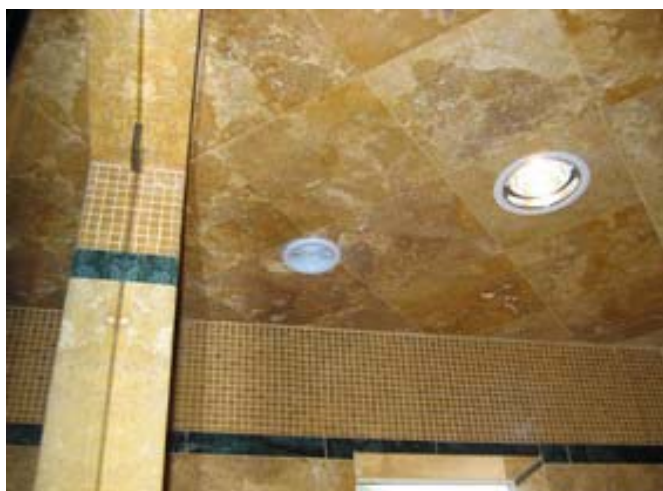
Photo # 27

Exhaust fan in "his" master bath is noisy.

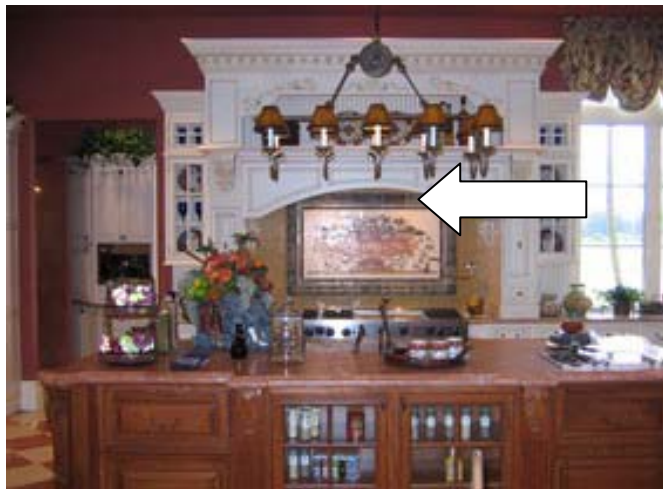
Photo # 28

Kitchen exhaust did not function.

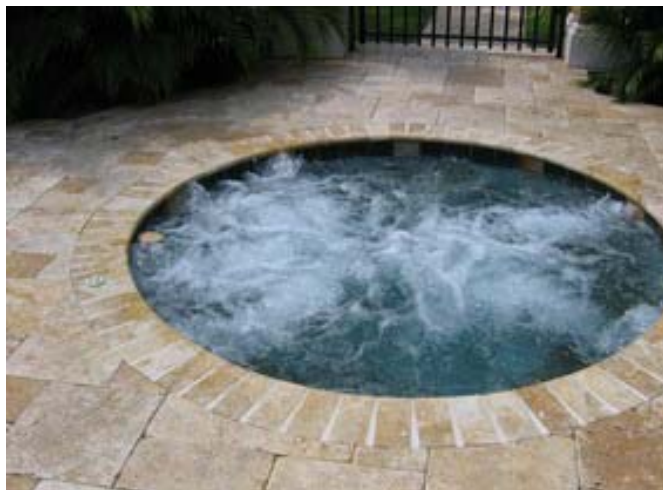
Photo # 29

The pool and SPA pumps work correctly.

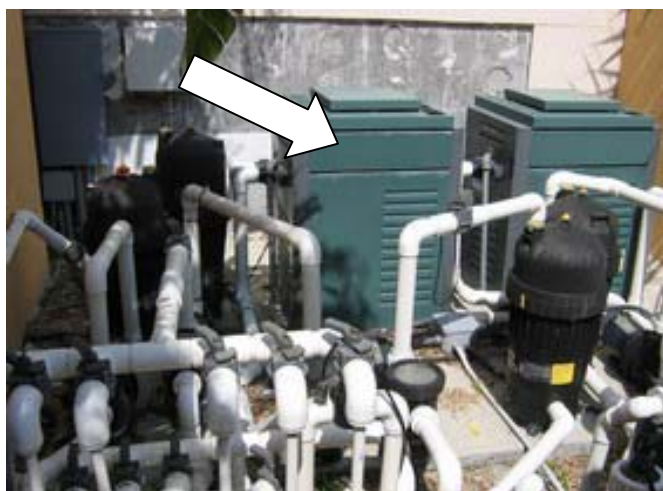
Photo # 30

The pool and SPA heaters were not functioning. These are gas fired.

The kitchen stove did function. It may have a different supply.

Check with the builder on the status of gas service. There may be an underground tank that needs to be filled. All of the gas devices need to be checked for leaks and tested by service companies.

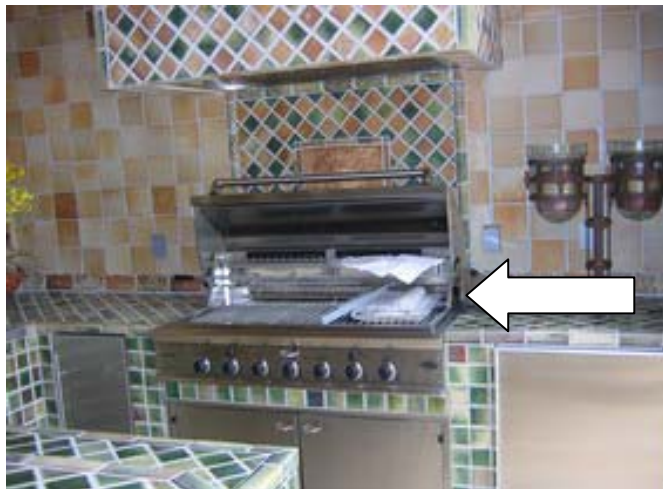
Photo # 31

Some of the appliances like this patio area grill were not tested due to packing materials left inside them.

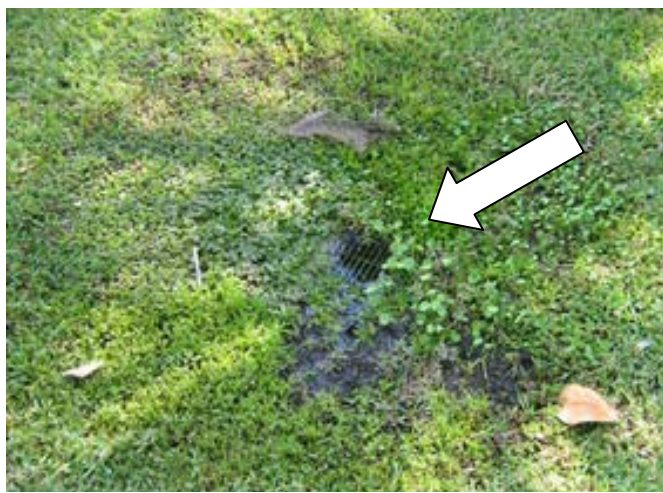
Photo # 32

Drain in front of the main entrance appears to be clogged or in need of some elevation change. This soggy area will always be full of weeds.

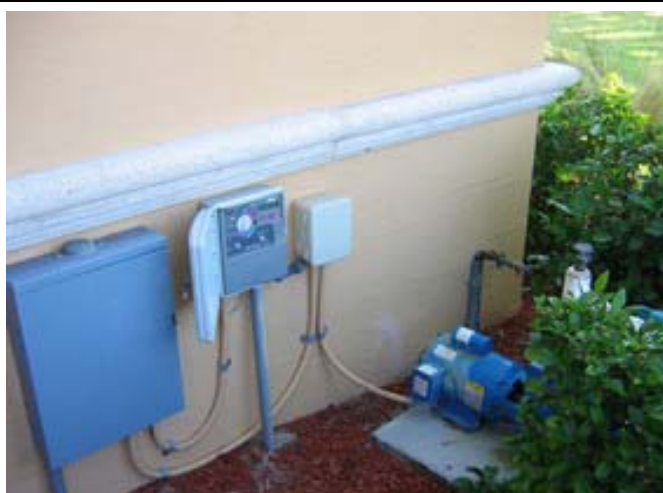
Photo # 33

The irrigation system is behind the west garage. The builder was not certain if there was a city water connection as well as this pump as a water source. The pump was functioning properly.

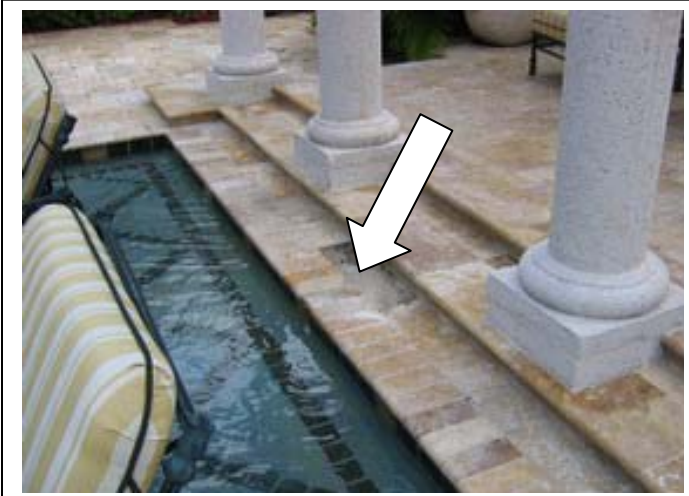
Photo # 35

A paving stone is missing on the east side of the pool.

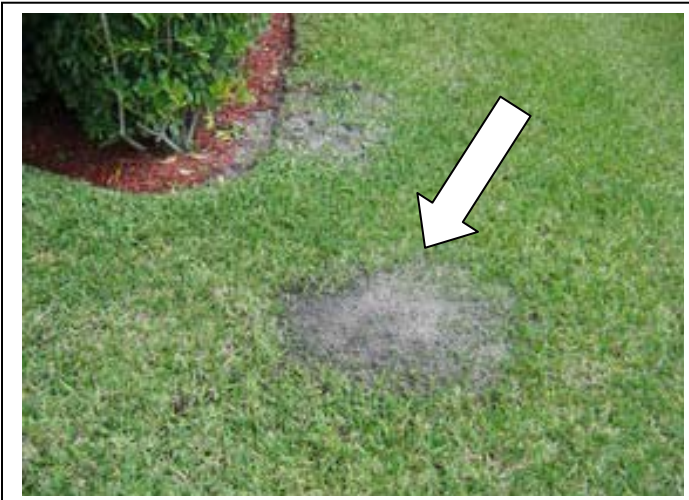
Photo # 36

The turf is full of fire ants.

This is a maintenance issue for a landscape or pest control company.
