Standard Home Inspection Report

File Number: 05-15-011

Type of Property: Single Family Home

Date of Inspection: 05/05/2006

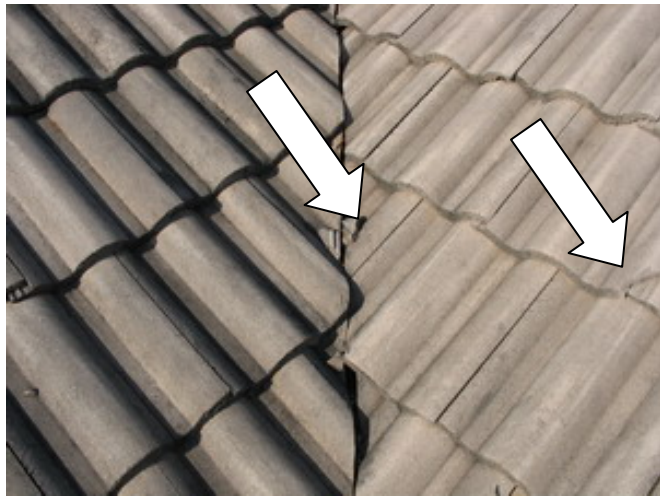
Photo # 1

RAINWATER RUNOFF FROM ROOF NOT CHanneled AWAY FROM ENTRANCES		NO
Comments:		
<ol style="list-style-type: none"> 1. This roof appears to be professionally installed and in a water tight condition. 2. Approximately 20 tiles have small chips that should be mended. 3. Three tiles are cracked and need to be mended. Cost of roof repairs - \$ 50 - \$ 250 (all roof repairs can easily be performed by a good handyman. A roofer is not required)

Approximately 20 tiles have small chips that need to be replaced.

The loose chips need to be sorted to the location where they came from and mended with roofing caulking.

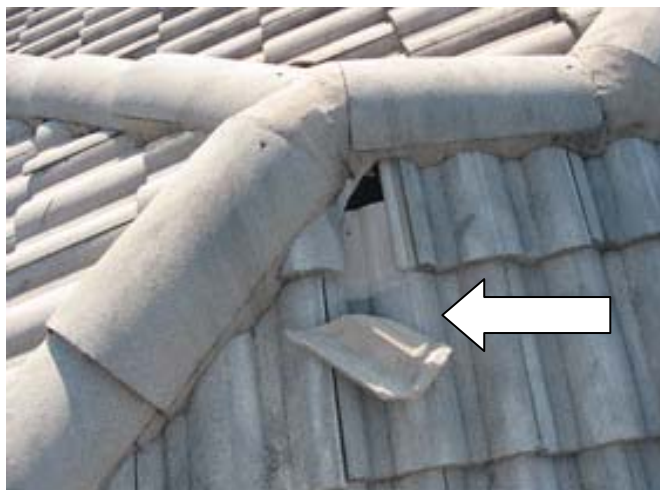
Photo # 2

Three tiles similar to this one have fractured and need to be mended with roofing caulking.

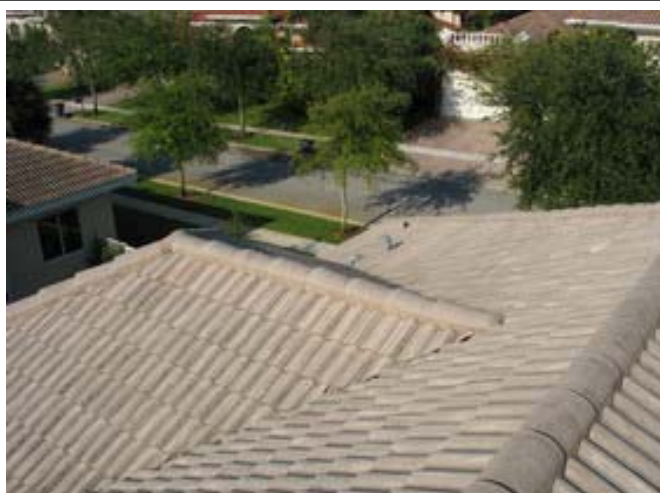
Photo # 3

Overall the roof is in a water tight condition. All tiles are secure and in the proper place. This was a very good roofing job.

Other similarly shaped roofs in the neighborhood did not fare as well after hurricane Wilma.

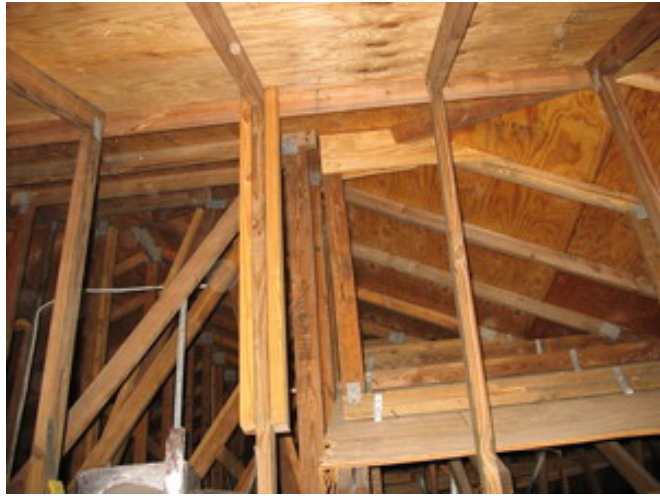
Photo # 4

No signs of leaks found in the attic.

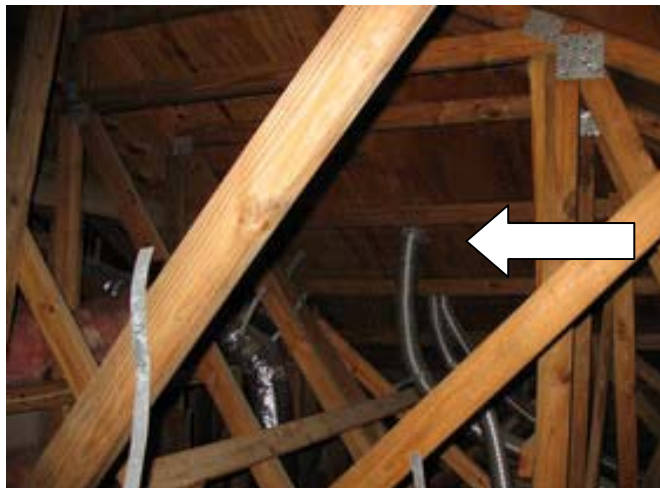
Photo # 5

All roof penetrations are water tight.

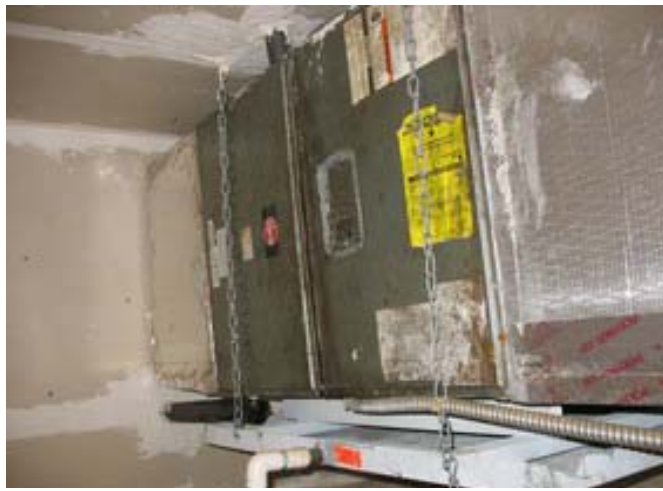
Photo # 8

The air conditioning systems are well designed.

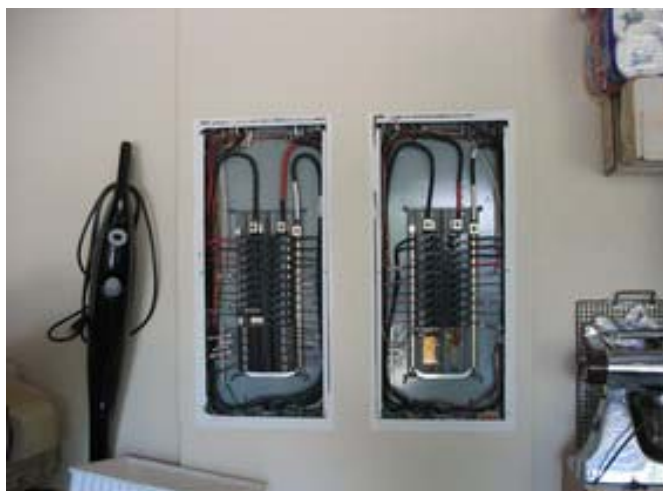
Photo # 9

The electrical system is professionally installed.

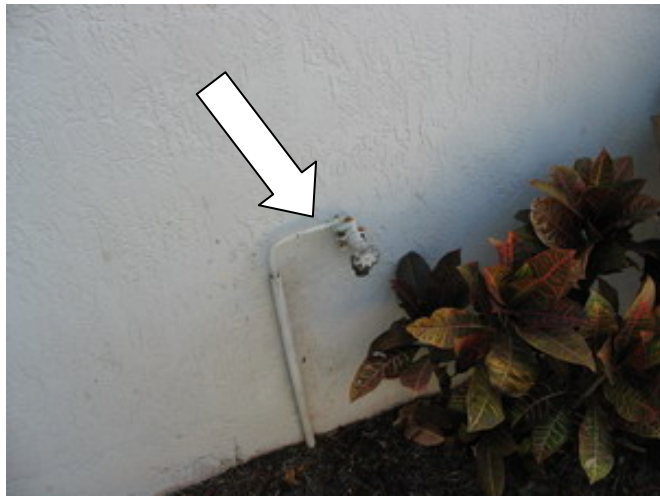
Photo # 10

EVIDENCE OF UNPROFESSIONAL WIRING MODIFICATIONS TO ORIGINAL WIRING		NO
EXHAUST OR CEILING FANS NOT FUNCTIONING		NO
Comments:		
<p>1. Ground strap on water line on the west side of the home needs to be secured. Cost - \$ 0 - \$ 25</p>

Loose ground connection at water pipe on west side of home.

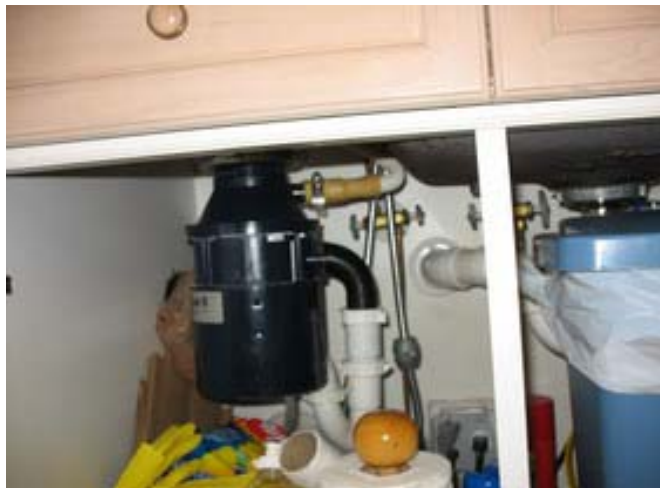
Photo # 11

All plumbing connections are water tight and professionally installed.

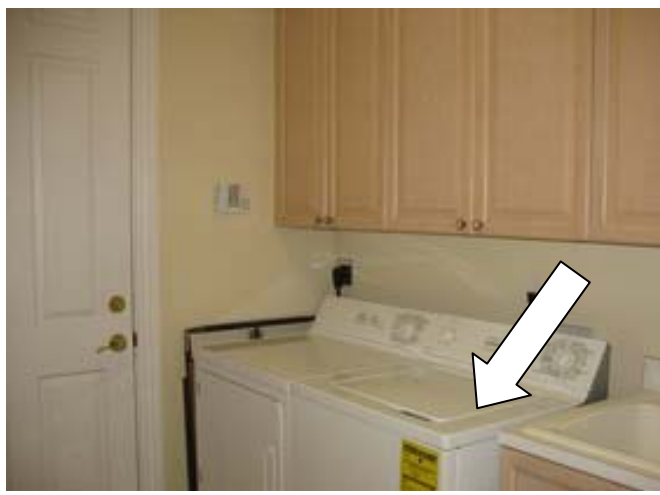
Photo # 12

INSTANT HOT WATER DISPENSER		
DEVICE NOT FUNCTIONING PROPERLY		NO
TRASH COMPACTOR		
DEVICE NOT FUNCTIONING PROPERLY		none installed
Comments:		
<ol style="list-style-type: none"> 1. Clothes washing machine was noisy and may need servicing. Cost – unknown 2. Hot and cold water supply hoses on the clothes washing machine should be changed as a precaution. Cost - \$ 25 - \$ 50

Clothes washing machine was noisy when running. It likely needs some repair.

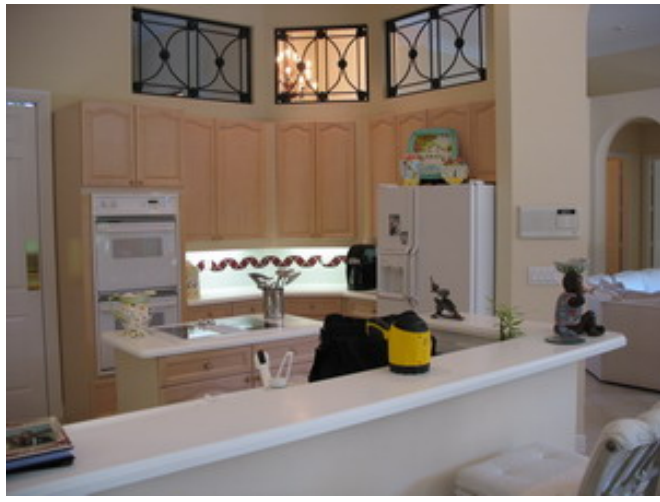
Photo # 13

All kitchen appliances are functioning and are in good condition.

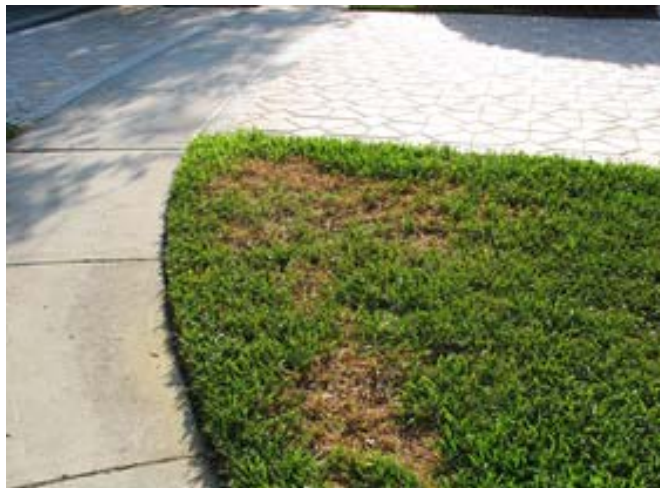
Photo # 14

Misaligned irrigation sprinkler heads (or fertilizer burns) have caused some minor brown spots in the lawn.

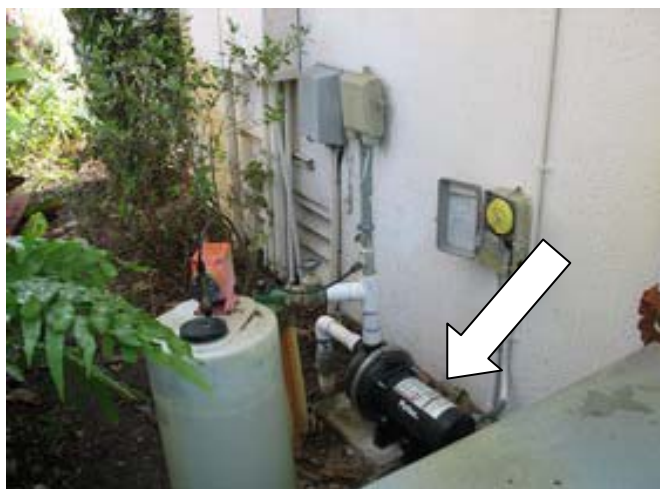
Photo # 15

The irrigation system is supplied by a pump and well. All irrigation equipment is in good operating condition.

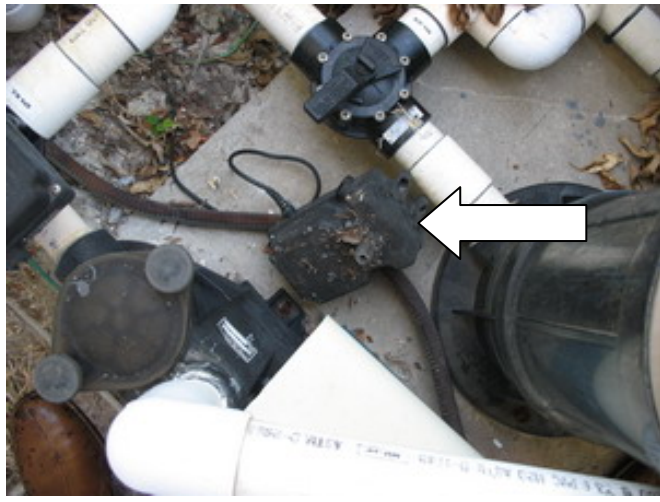
Photo # 16

Actuator has been disconnected on the pool piping. It is not necessary to have this device to operate either the pool or SPA.

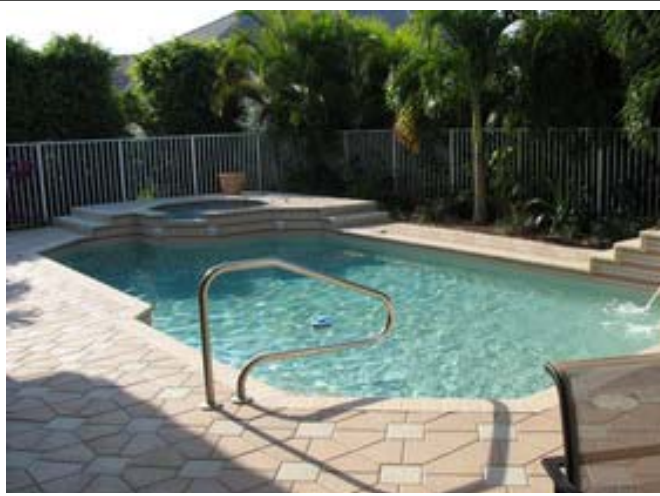
Photo # 17

The pool, SPA and deck are in good condition.

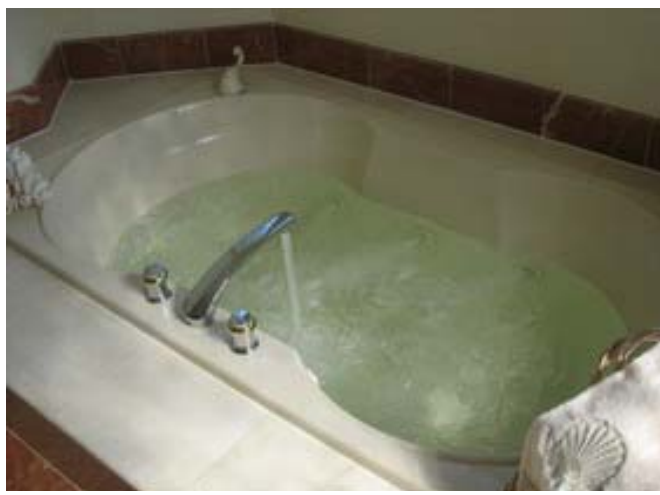
Photo # 18

The home has a SPA in the master bathroom and the NW bathroom. Both are functioning properly.

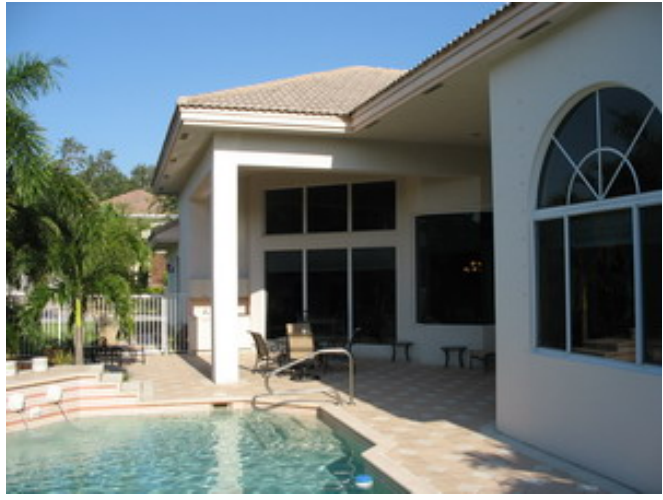
Photo # 19

The home is attractive, clean and well constructed.
