Standard Commercial Building Inspection

Summary Report

Subject Property: Shopping Center, Ft. Lauderdale, Florida

Date of Inspection: 03/05/04

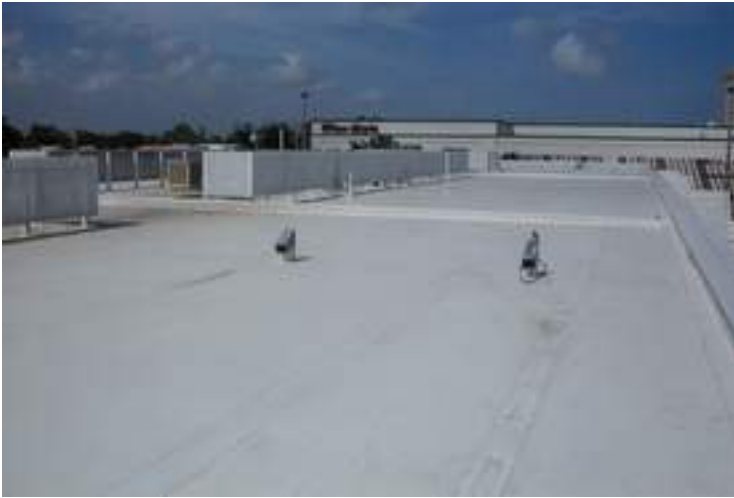
The flat section of the roof was stated to be approximately one year old by the representative of the property management company. The flat section appears to be professionally installed and water tight. This roof should be under a warranty that is transferable to the new owners.

Overall the roof appears to be in good condition and professionally installed.

There may be a warranty that can be transferred to the new owners

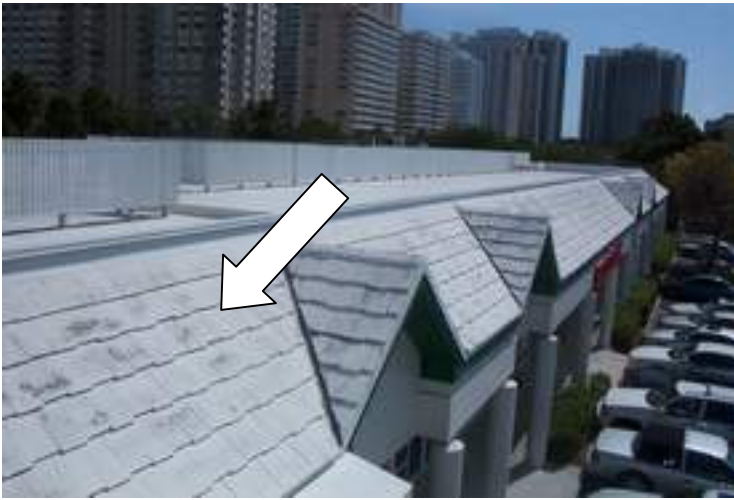
The mansard sections of the roof appear to be original roofing materials. These sections cover the walkway surrounding the building and do not cover occupied space except over the patio seating in front of the restaurant. No leaks were noted under this walkway but it is likely that some will occur in the near future because of the age of the roofing materials. Leaks in these sections will need to be repaired as they appear to prevent moisture from collecting in the plenum above the walkway.

The mansard sections of the roof appear to be original materials and may need more maintenance than the flat sections

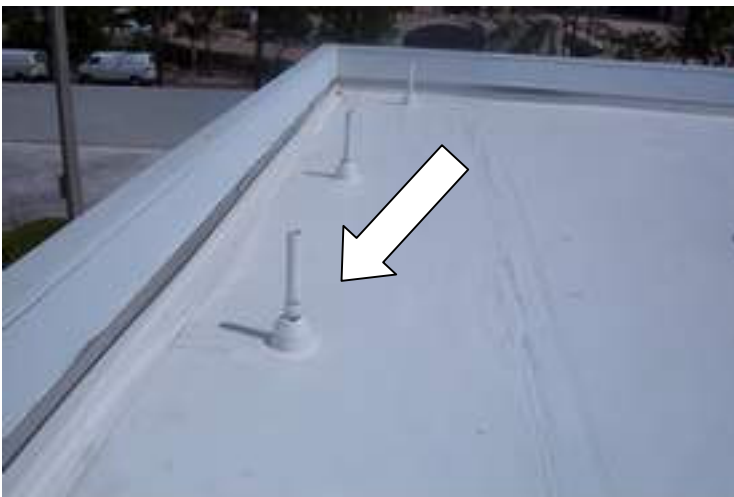
All flashings and roof penetrations appear to be professionally installed and water tight

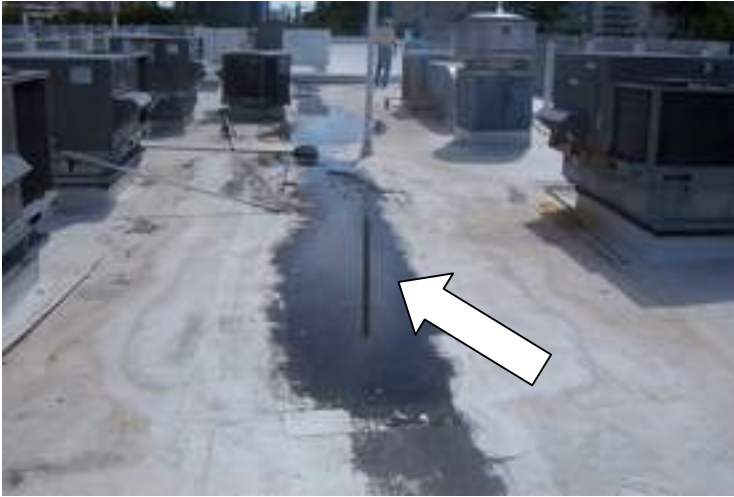
The ponding of water on the center section of the roof is probably due to inadequate tapering of the insulation board under the membrane.

These wet areas are from condensate from the A/C units on the roof

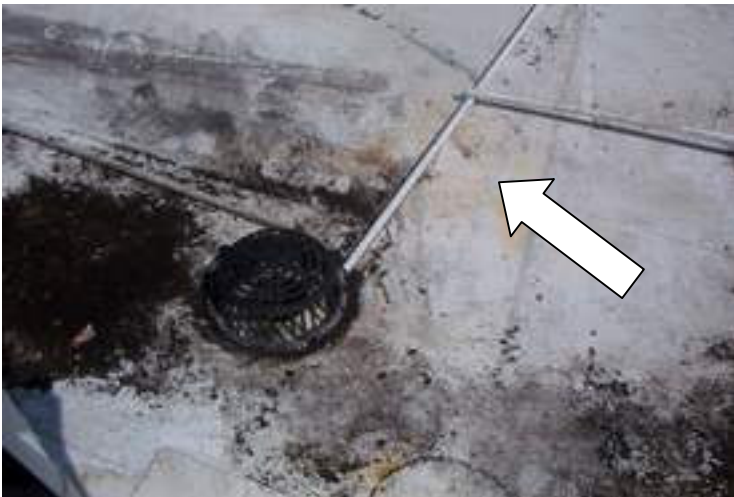
These PVC pipes carry the condensate towards the roof drains but they stop short of penetrating the screen over the opening.

It is suggested that they be redirected directly into the roof drain to keep the condensate from ponding and accelerating the deterioration of the roof membrane.

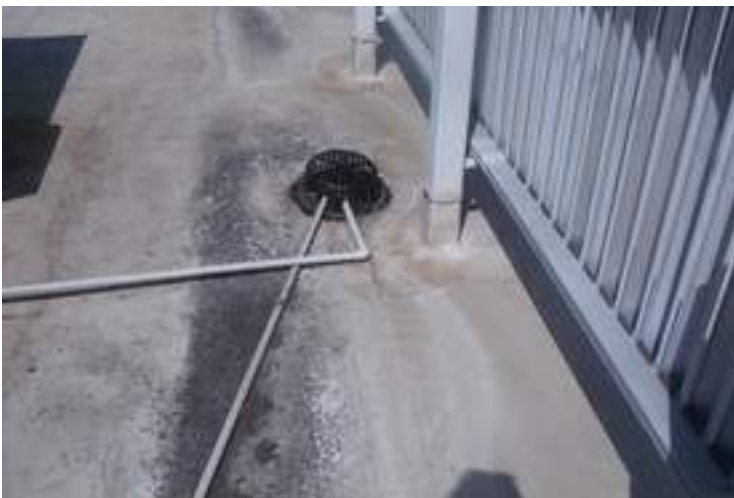
These two condensate drain pipes are correctly aligned inside this drain opening.

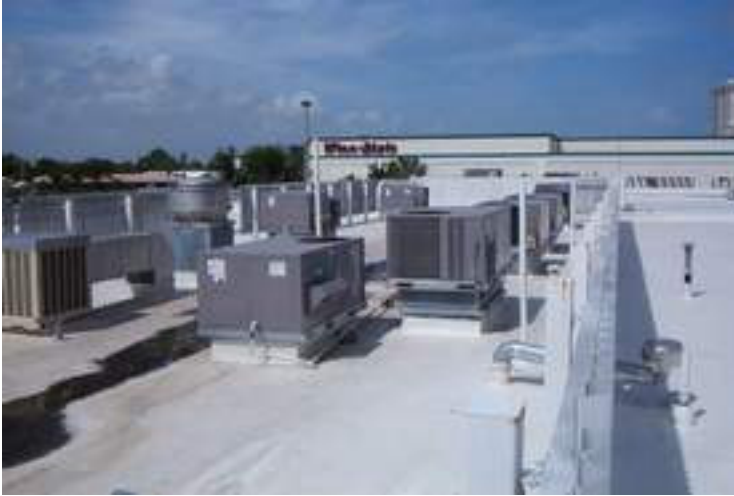
All of the units appear to be functioning properly. The property management representative stated that all of the tenants are responsible to maintain their own system(s). The service life expectancy for these units is 10 – 15 years.

There are 13 package type air conditioning systems on the roof and most are relatively new

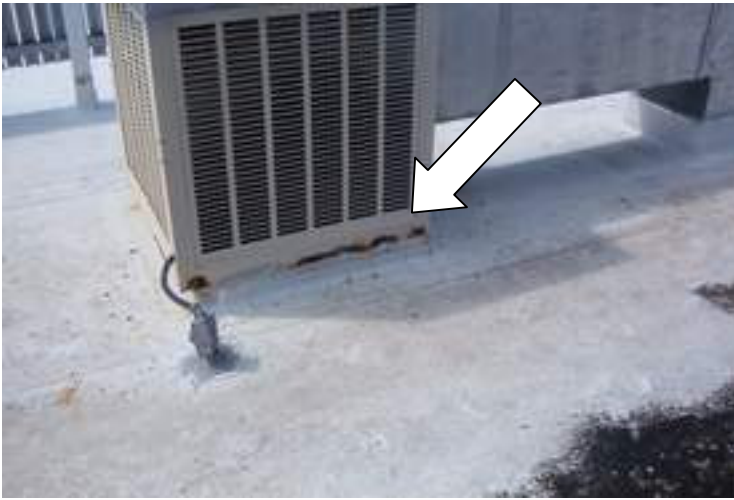
Some of the past leaks may have been because some of the previous units may have rusted and leaked through the roof openings. There is a rusted section along the bottom of the frame for a ventilation fan for the restaurant. This may be a problem soon for the restaurant.

The rust along the bottom of the frame to this exhaust system over the restaurant may soon leak rain water into the duct below

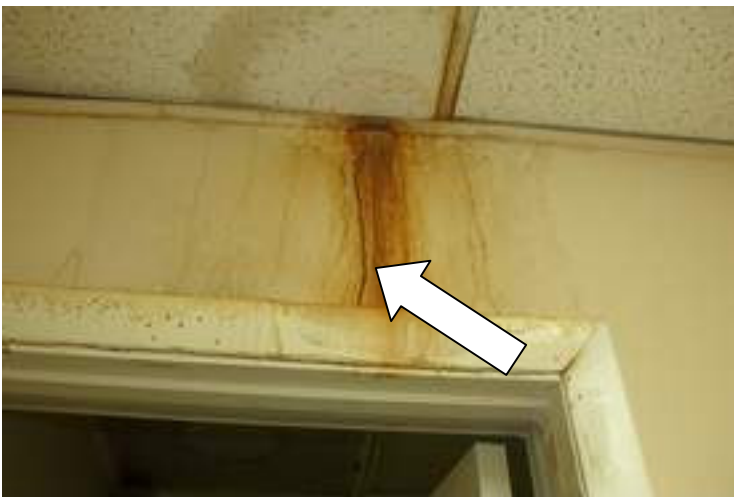
This stain is in the doctor's office. He stated that it stopped leaking when the roof was replaced approximately one year ago.

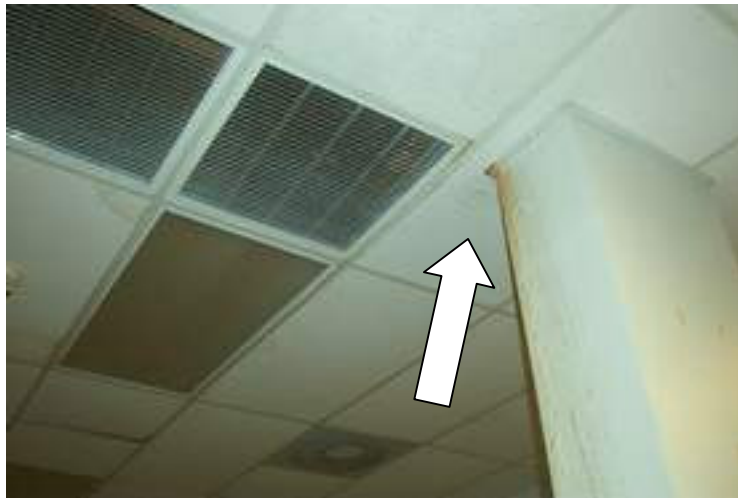
Additional stains were noted on the ceilings of the vacant space. These also appear to be from previous and now inactive leaks.

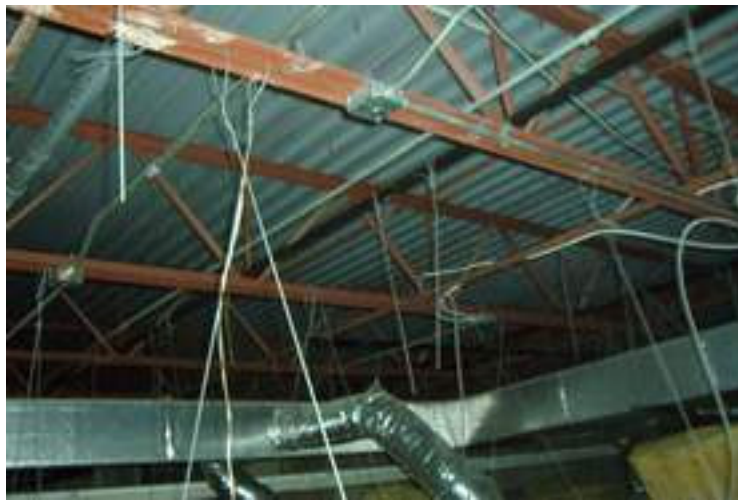
The visible structural elements of the building appear to be professionally installed and in good condition

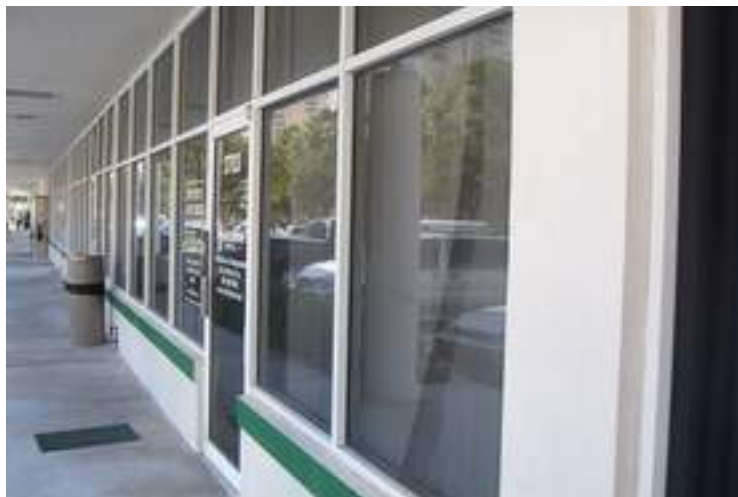
The building's exterior glazing and finishes all appear to be in good condition

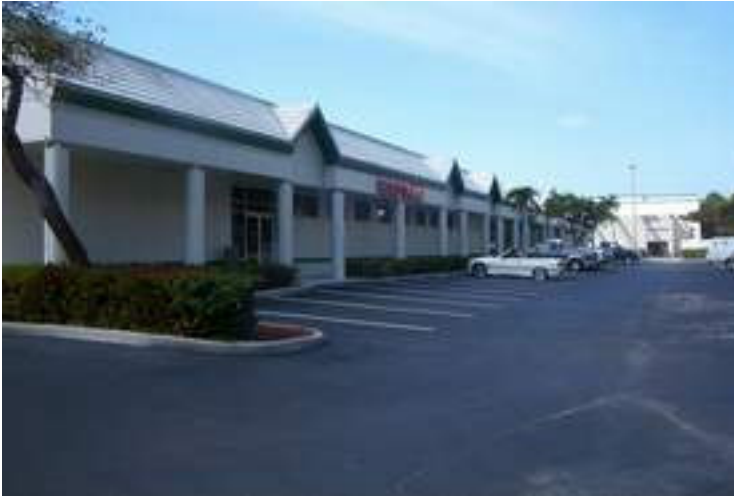
There seems to be ample underutilized parking in the rear of the building but the current ordinance for parking requirements may dictate what types of future tenants can be placed on the site.

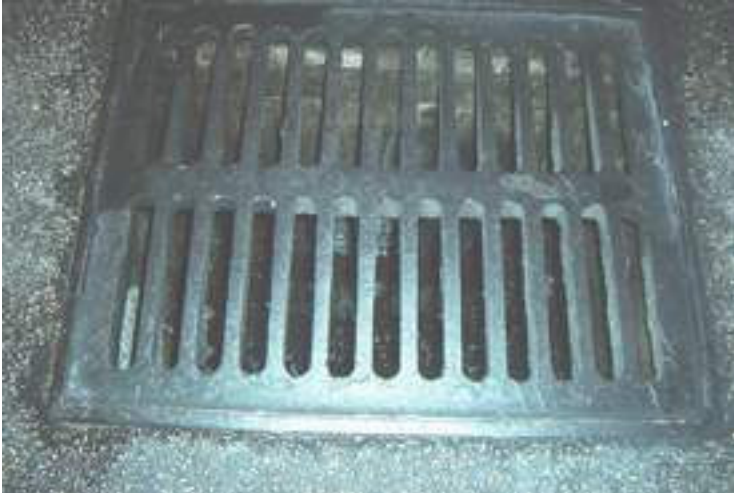
The drains in the parking areas appear to be clear and there was no evidence of previous flooding in any areas.

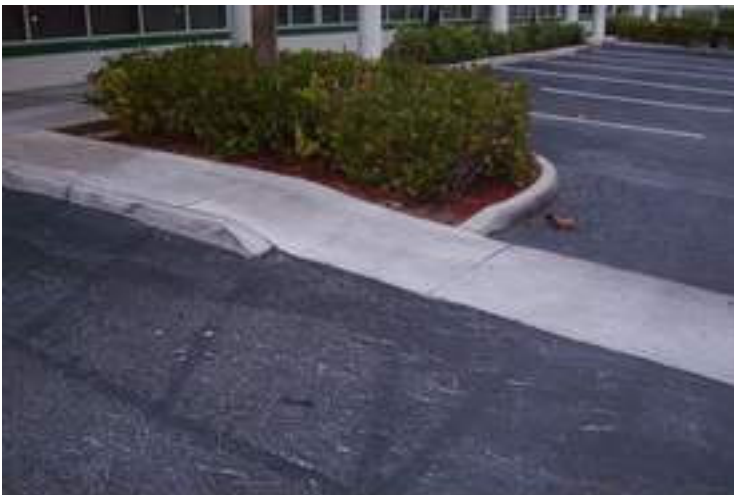
It was noted that a ramp up to the Medical Center occupancy does not appear to be compliant with current ADA specifications and exceeds a 1/12 ratio in the slope. It appears that it could be easily fixed if it becomes an issue.

This access ramp in the rear of the building does not appear to conform to ADA requirements of a 1/12 slope ratio.

The estimated cost to make the ramp in the rear compliant is \$ 500 - \$ 1000.
The cost for Re-stripping and marking the spaces in the front of the building \$ 500

It may be prudent to modify this ramp to meet the ADA code.
