Standard Building Inspection

Summary Report

Subject Property: 750 South Federal Highway, Pompano Beach, FL

Date of Inspection: Tuesday, March 15, 2005

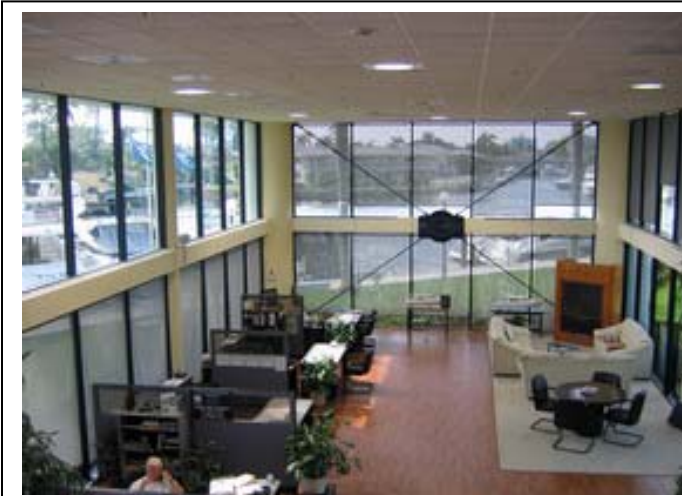
Photo # 12

The building's interior appears to be in excellent condition.

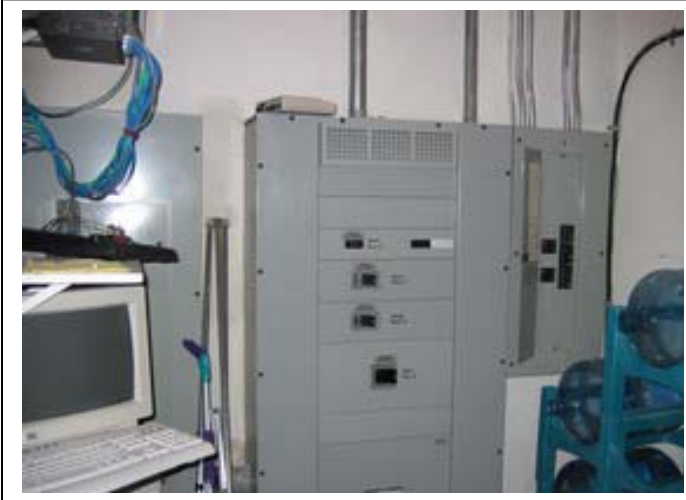
Photo # 13

The electrical system appears to have been professionally installed and in good condition.

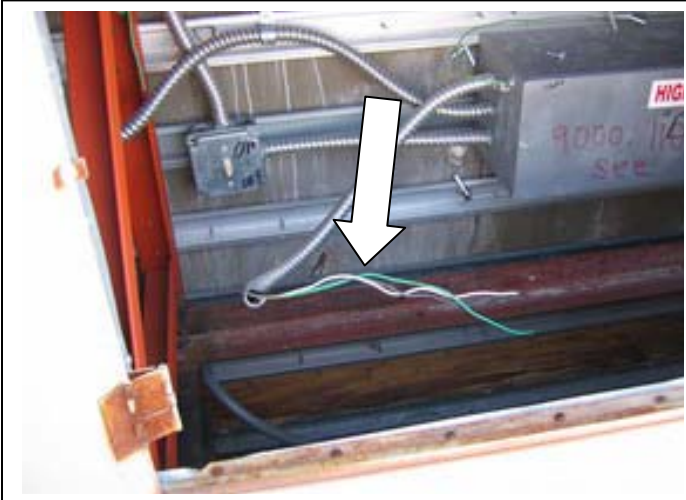
Photo # 14

Electrical Systems – All panels and wiring appear to have been professionally installed and in good condition. Some wiring inside the parapet walls needs the attention of an electrician. Exterior illuminated signs have been installed and the electrical work is untidy. Some abandoned circuits should be removed and secured.

Loose ends of wiring (inside the parapet) need to be cleaned up.

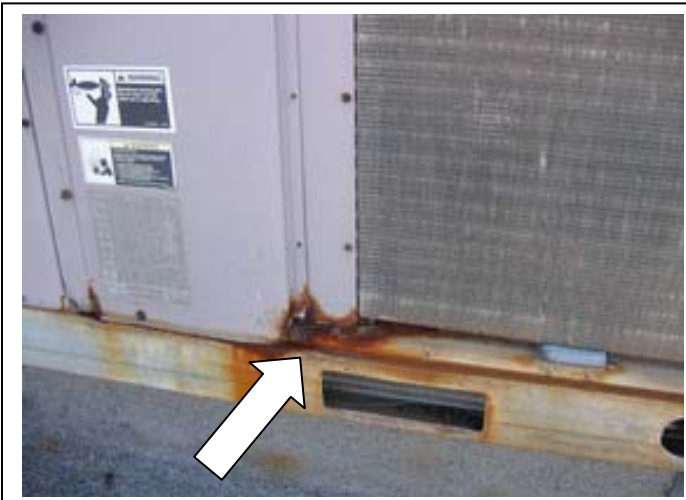
Photo # 15

- The condensing coils in the RTU's have a significant amount of corrosion but still appear to have adequate clear surface area to perform reasonably well. Commercial units typically last 10 years before repair cost and corrosion forces replacement. These units are nearing the condition to consider replacement within the next few years.

The RTU's have significant corrosion at some points.

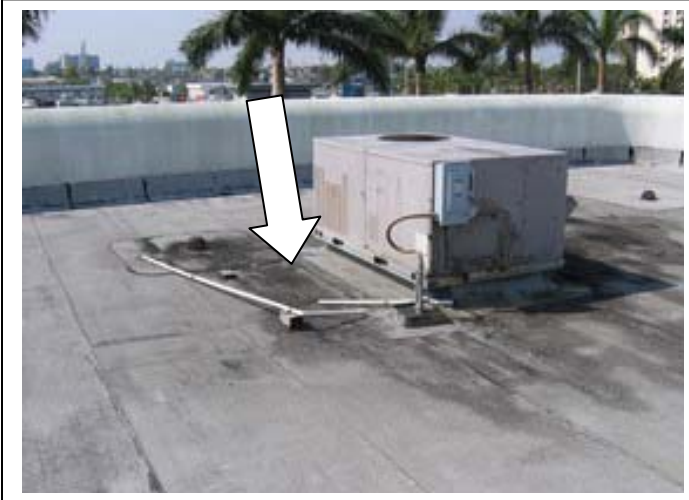
Photo # 16

- The condensate lines from the RTU's were at one time well managed on the roof to terminate into the roof drains near these units. This is a good design feature to keep the condensate off the roof surface. The condensate piping from the south unit is broken and needs to be repaired. The condensate is ponding around the curb opening and will contribute to an accelerated deterioration of the roofing materials in this area.

Broken condensate drain line on south RTU needs repair.

The discoloration surrounding this RTU is caused by ponding water. This can lead to accelerated deterioration of the roofing materials.

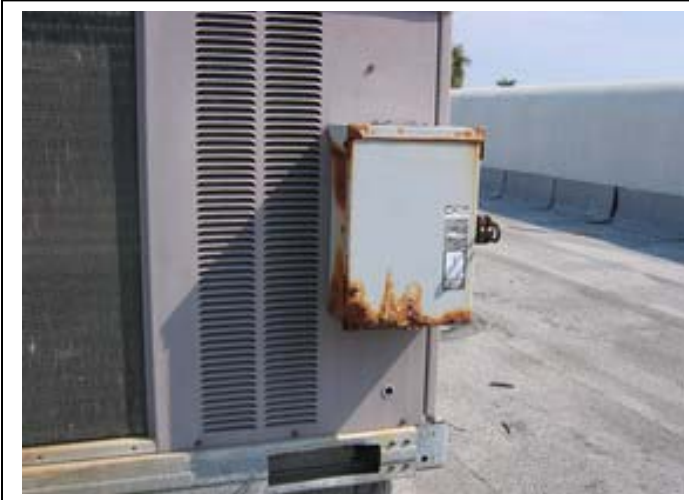
Photo # 17

- The electrical disconnect panels mounted on the RTU's are significantly corroded and are no longer water tight. Problems may occur if they are not replaced or repaired. They will need to be replaced if new units are installed.

Electrical panels on the RTU's are badly corroded.

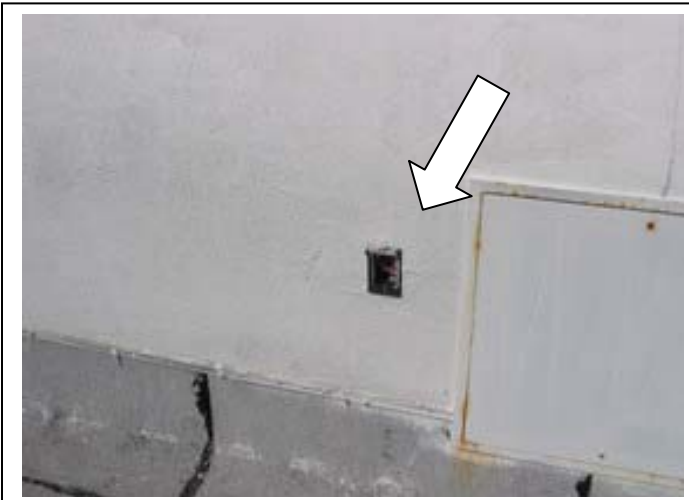
Photo # 18

Electrical junction box on parapet wall needs a cover.

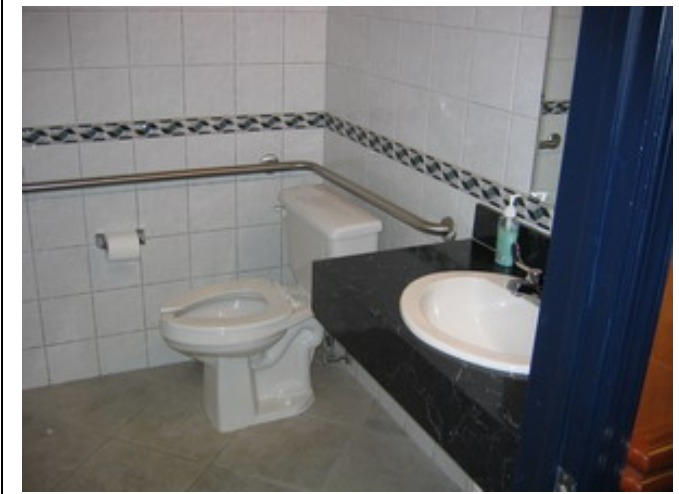
Photo # 19

The 1st floor restrooms appear to be ADA compliant.

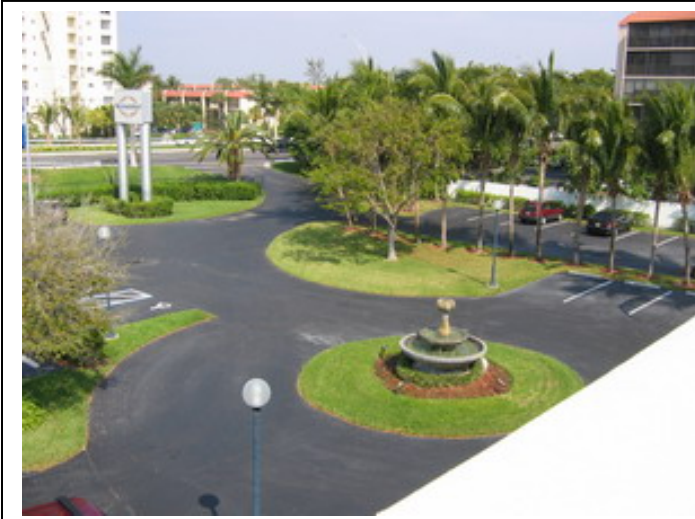
Photo # 22

The parking spaces, drives and landscape appear to be in good condition.

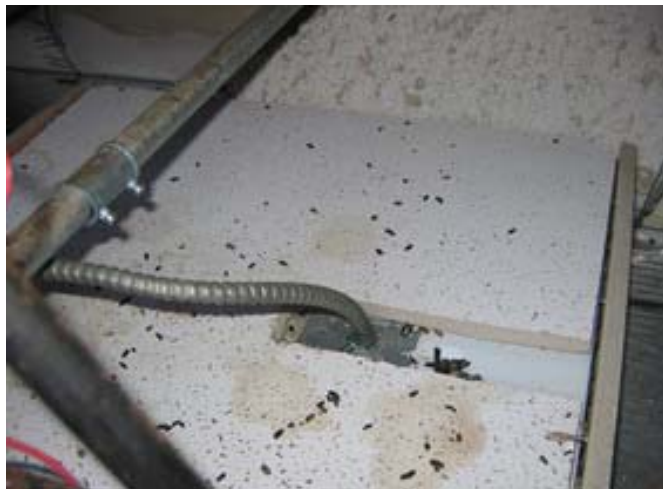
Photo # 23

Wood Destroying Organisms – There is no evidence of termite infestation or wood rot problems in the building. Small lizards have found access to the area above the 2nd floor ceiling. Their excrement was noted on the top of the suspended ceilings. Finding the access points and closing them off is the only remedy. No obvious entry points were noted. The lizards are not known to cause any damage.

Lizard excrement noted above the suspended ceiling on the 2nd floor.

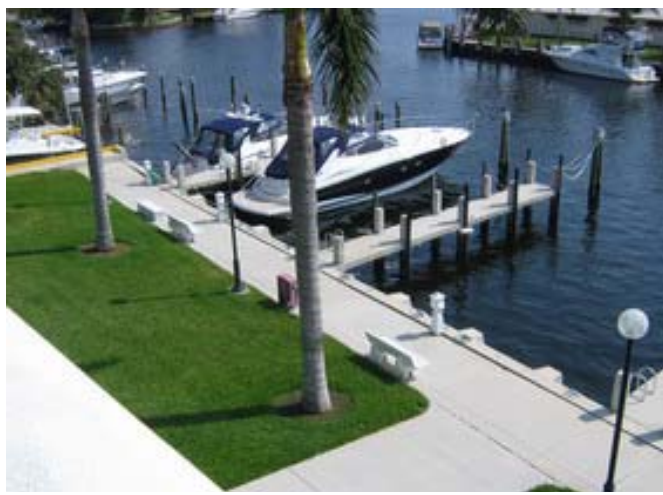
Photo # 24

The seawall was not inspected under this report.
