Limited Commercial Building Inspection

Summary Report

Subject Property: Bealls Department Store # 70, Boca Raton, Florida

Date of Inspection: 02/26/04

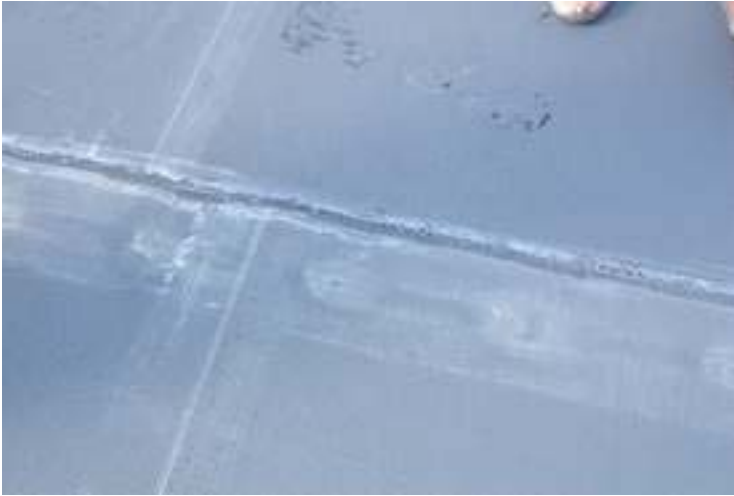
Overall the roof appears to be in good condition and professionally installed.

Large sheets of the EPDM membrane are welded together at the seams. All of the seams appear to be well bonded and it is unlikely that any current leaks are attributed to holes in the membrane.

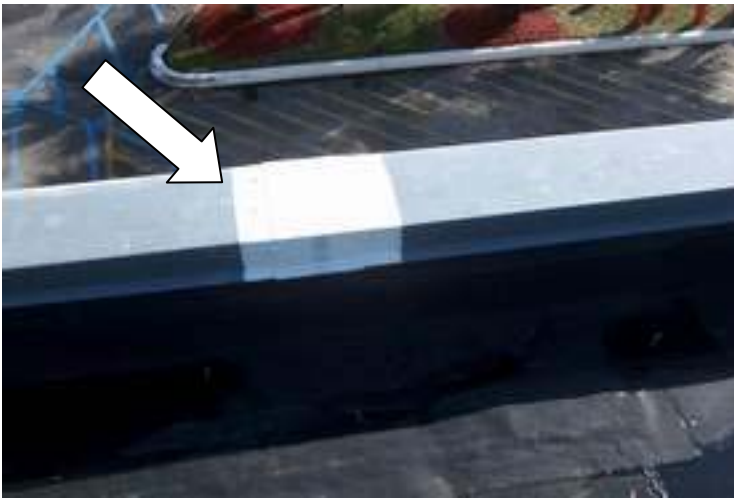
Patches by the roofing company have been placed over joints in the parapet cap. These joints need this type of maintenance to keep them water tight.

This is a typical repair that was professionally performed by Crowther Roofing personnel.

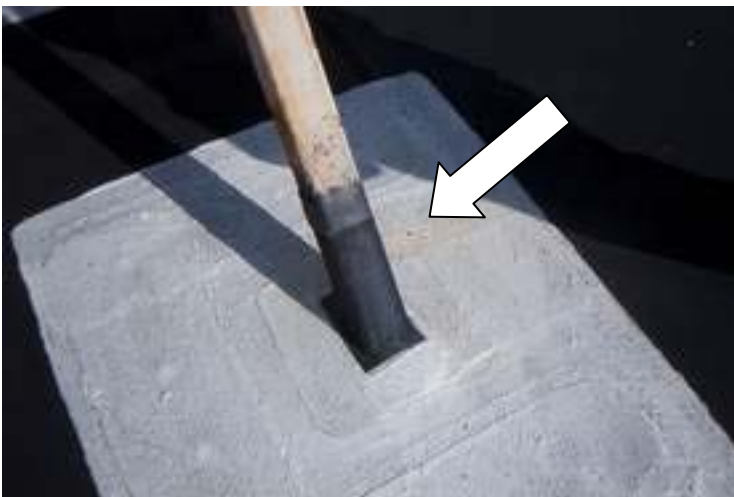
These are also typical repairs made by the roofing company.

This area around this support brace could have had leaks but is now water tight

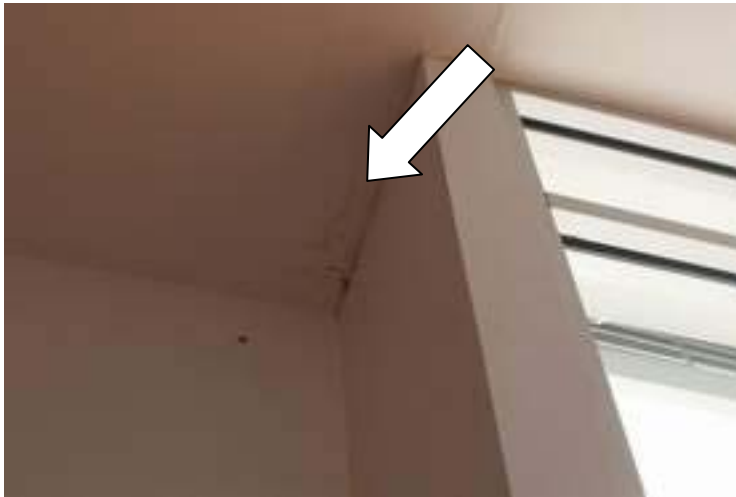
Water stains such as this one near the front entrance are probably attributed to roof leaks from the kinds of problems noted above

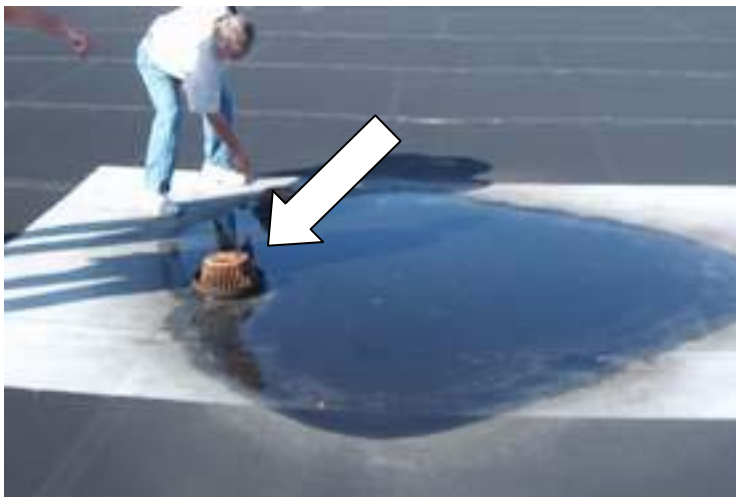
The ponds are a result of improper sloping of roofing materials, during the original installation of the roof, around the drains. These areas unfortunately cannot be reworked without removing a significant portion of the roof around each drain with this problem. The most cost effective solution to address this issue to monitor each area and to reseal any de-lamination or cracking of the roof membrane as they may appear.

The area around this roof drain is not sloped properly to allow for proper draining. This standing water can cause an acceleration of the deterioration of the roof membrane.

The white square is a patch that has been applied by Crowther roofing personnel to prevent this deterioration.

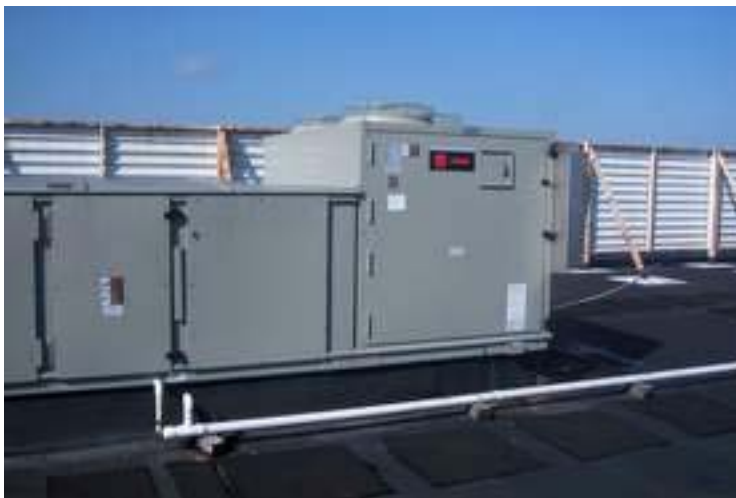
This is one of six air conditioning units mounted near the center of the roof.

Four of them are only a year old but two are original equipment from 1991. All of the units on the roof were professionally installed.

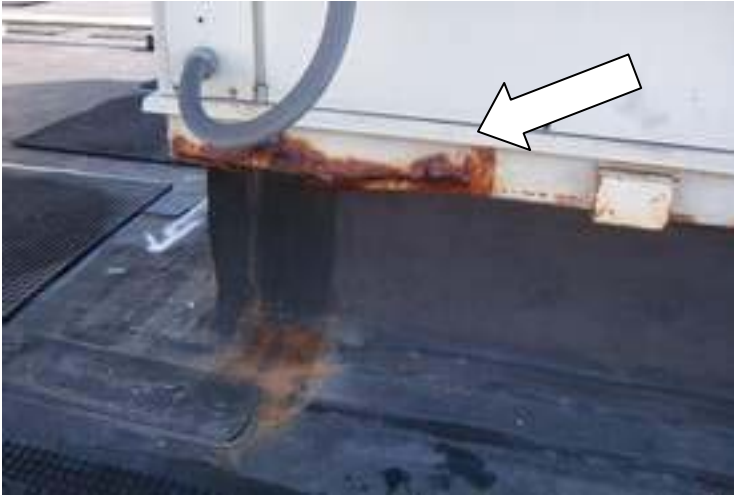
Several leaks were noted in the ceiling areas around the two older package units. During this inspection these older units were opened and inspected. A significant amount of corrosion was noted in the bottom of these two units and in the sheet metal frames and interior panels of these units.

This is the corner of one of the older units. The frame is rusted and could be a source of the current leaks. Water can get through this rusted area and fall down inside the curbing on which this unit rests.

If the two remaining 1991 package units are replaced, the potential of water leaking through these units will be eliminated. When they are removed, the curbing under these units can be inspected and any problems addressed. Attempting to repair or seal any leaks in these two older units will probably not be effective or provide a lasting remedy.

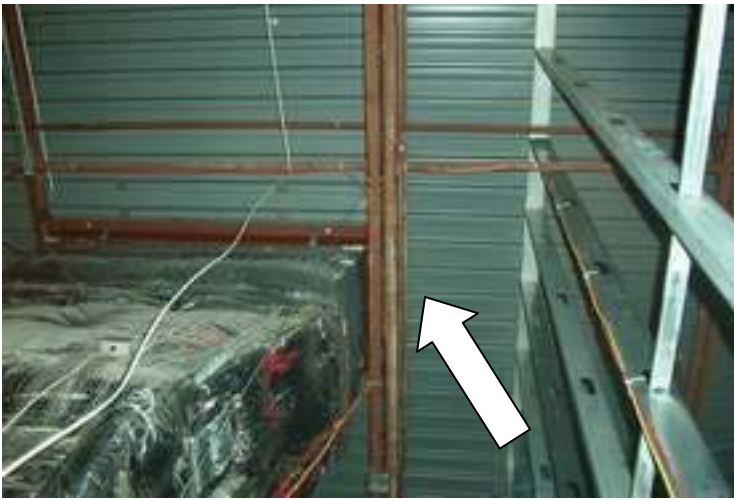
These units could not be safely accessed from the sales floor below to positively identify the exact points where the water was originating from; however, it is likely that the current active moisture problems noted in the ceilings of this building are due to water from rain and condensate leaking through these two older units. It is recommended that these two original Package Type air conditioning units be replaced because of their age and because water was observed dripping from under areas where these units are located on the roof. These units are identified as unit # 3 and unit # 5, on the Crowther Roof Asset Management report.

This is the ductwork that runs under the older unit that is located above the Young Men's Clothing area in the store. Water was running down from this area in significant quantities.

The ceiling is too high to safely inspect closely without a lift and removing a significant portion of the ceiling

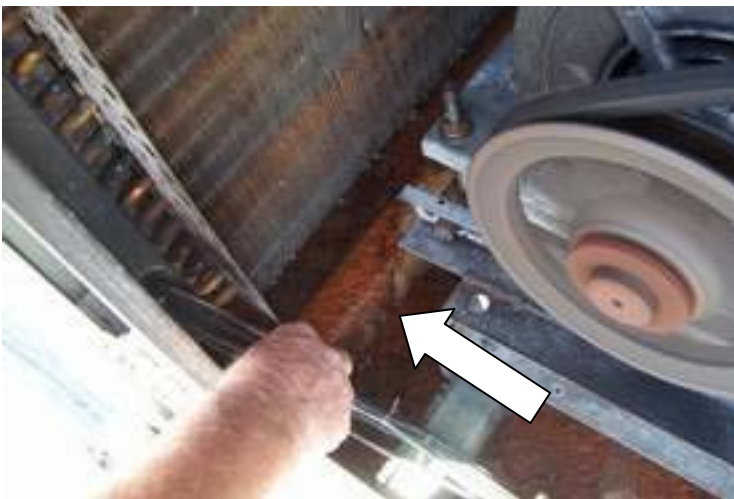
The interiors of the two older air conditioning units are heavily corroded.

It is likely that water is leaking from under them down into the building

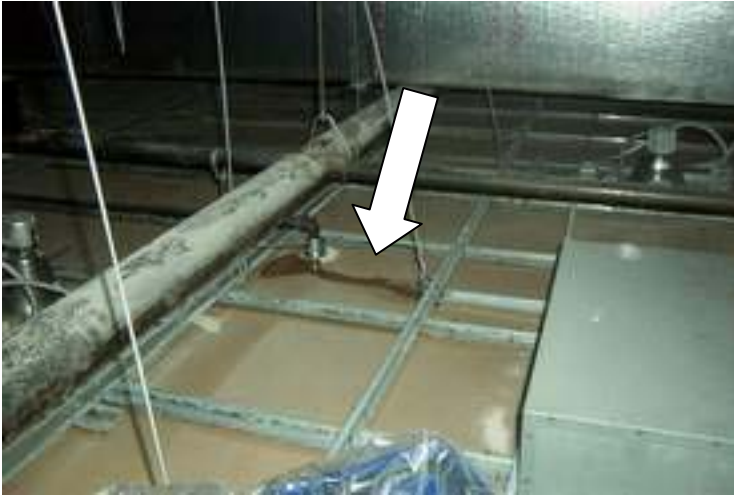
It was noted above the Jewelry area that the dripping water seemed to be coming from a section of the roof just north of unit # 3. There is suspicion that water may be trapped under the roof membrane in this area. It is suggested that this area be opened and examined. If water is found in this area it should be removed and the roof membrane resealed. Ron Ricketts is estimating the cost to perform this invasive examination.

This area just north of the jewelry department has an active leak.

This is the area where trapped water may be under the roof membrane.

Crowther roofing personnel need to cut open the roof and determine if this is what has happened.
