Standard Home Inspection Report

Subject Property: Royal Palm Beach, FL33411
Client: Ms. Brown
Status of Property: unoccupied
Type of Property: Single Family Home
Square Footage: 2196± Total SF (Property Appraiser's data)
Age of Home: 1997± (Property Appraiser's data)
Date of Inspection: 02/18/2019
Time of Inspection: 10:00 AM
Weather conditions today: 81° F, Partly Cloudy
Recent weather conditions: no precipitation over last 24 hours

Inspector: Craig P. Milliken, PE # 32779
Phone: (561) 866 9956

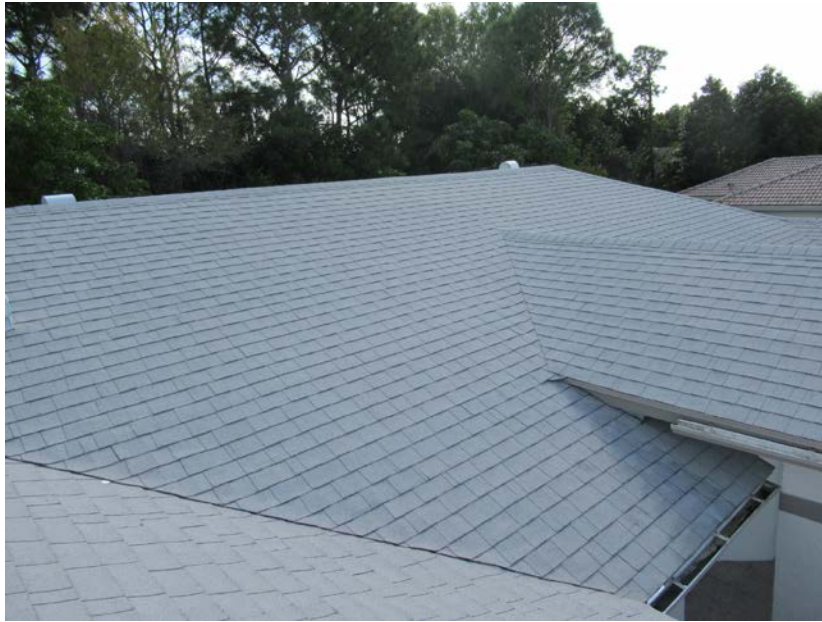
Photo # 1

The entire roof was recovered in 2018

It is in good condition

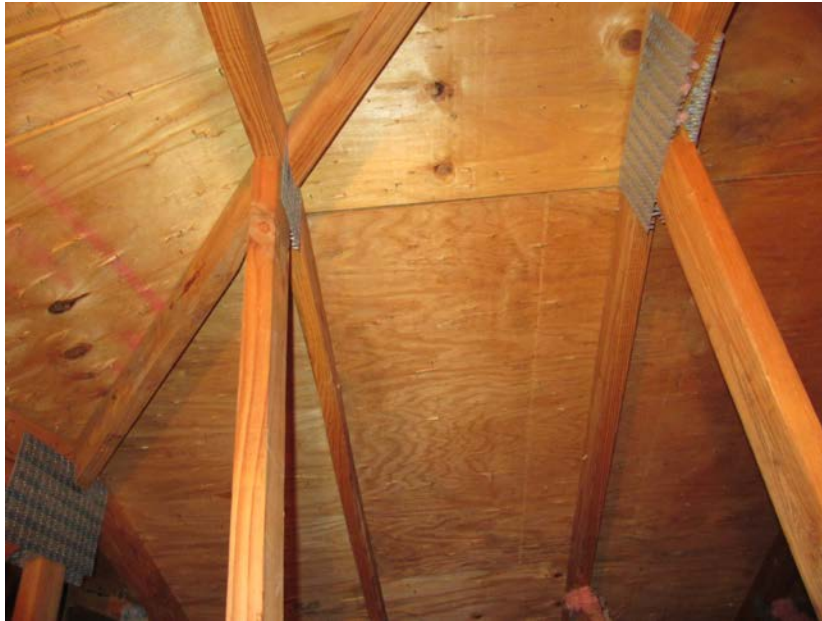
Photo # 2

No signs of leaks in the attic areas

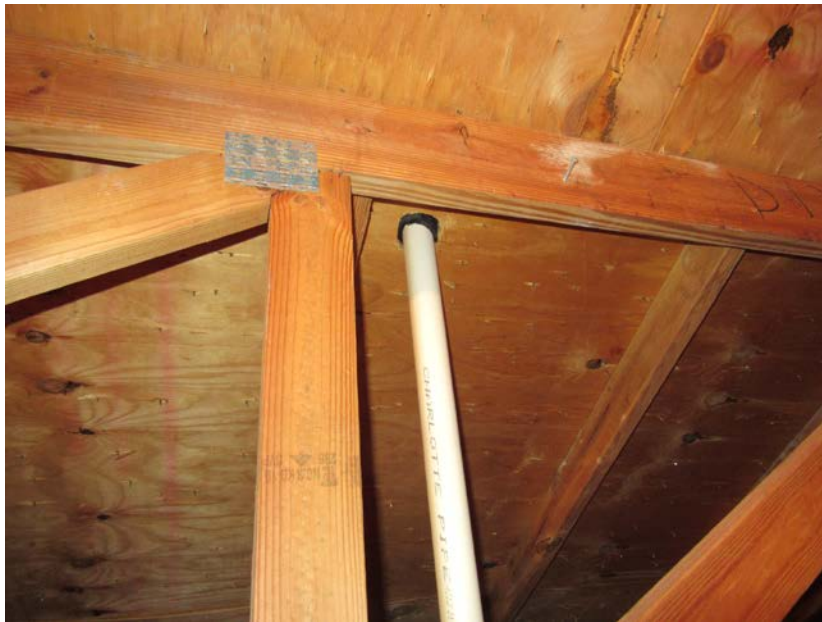
Photo # 3

Roof penetrations are water tight

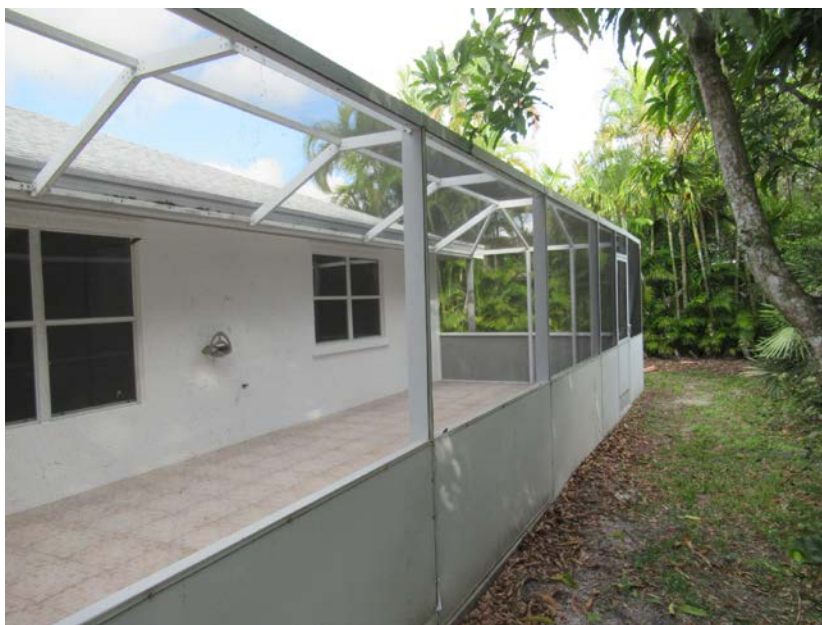
Photo # 4

Patio screening is in good condition

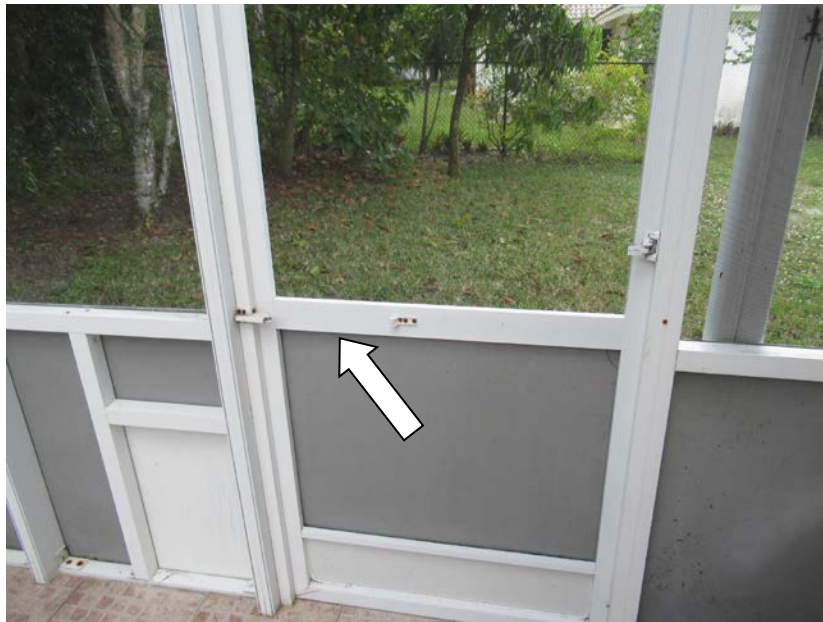
Photo # 5

The south patio door is missing a closure mechanism

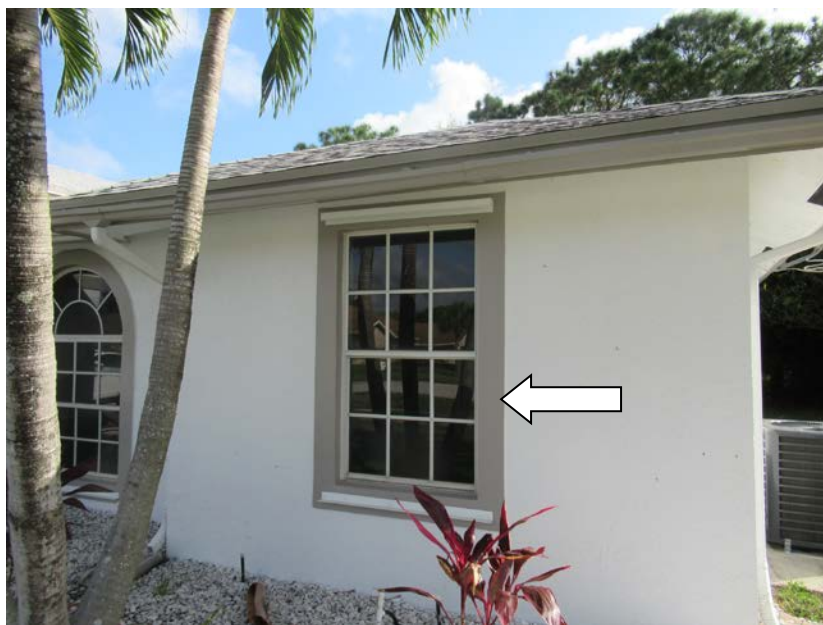
Photo # 6

Screens are missing on SW guest bedroom window and south window of the living room

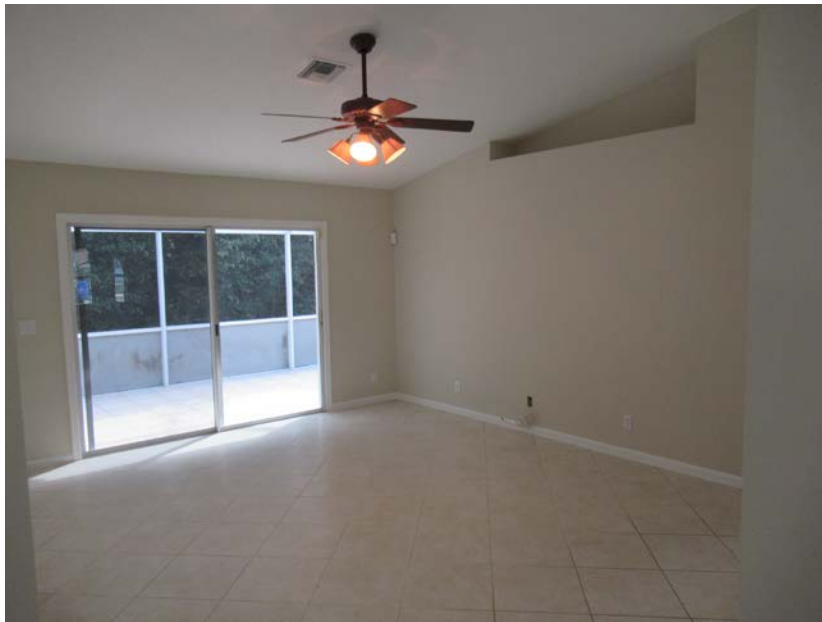
Photo # 7

Interior elements are in good condition

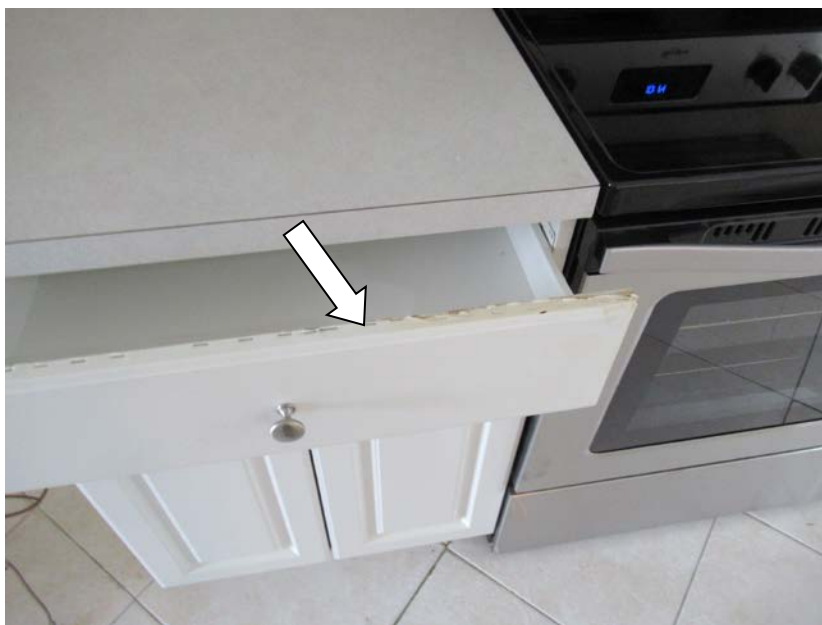
Photo # 8

INTERIOR CEILINGS, WALLS, STAIRWAYS, FLOORS, DOORS, TILE AND MILLWORK		SECTION 105
ITEMS INSPECTED	CONCERNS	
WATER DAMAGE OR STAINS ON CEILINGS, WALLS OR FLOORS		NO
LOOSE STAIRS, TREADS, RAILINGS OR BALUSTERS		NA
SUSPECTED PRESENCE OF ADDITIONS OR MODIFICATIONS TO HOME THAT MAY NOT HAVE BEEN PROPERLY PERMITTED OR INSPECTED		NO
BROKEN OR MISALIGNED DOORS, DRAWERS, HINGES OR LATCHING MECHANISMS	YES	
BROKEN OR LOOSE TILES ON FLOORS OR WALLS		NO
MISCELLANEOUS	YES	
Comments:		
<ol style="list-style-type: none"> There is no hardware on the pocket door to the master bathroom. Cost - \$ 50 - \$ 150 The top edge of the kitchen drawer (left of the stove) is delaminating and needs glue to be repaired. Cost - \$ 50 - \$ 100

The top of this kitchen drawer is de-laminating. this is a cosmetic issue.

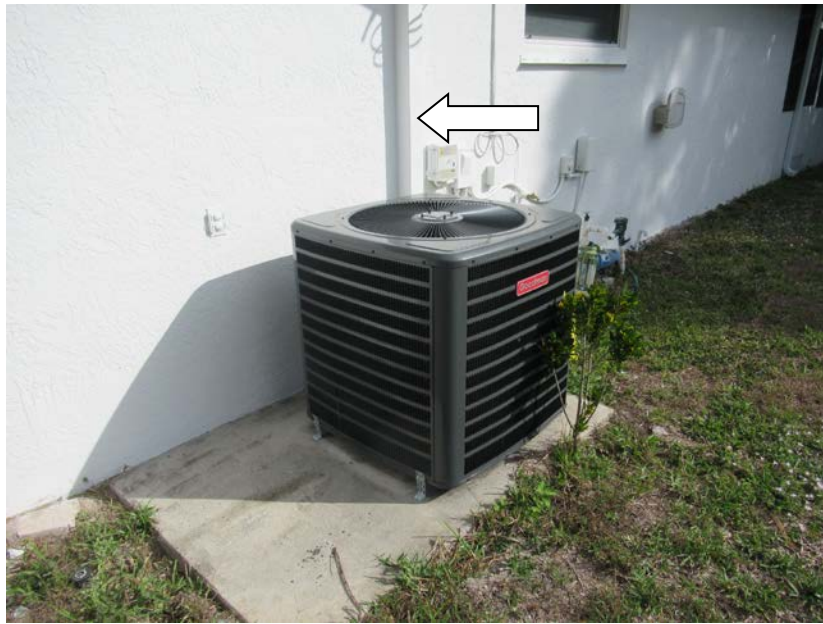
Photo # 9

The A/C system was replaced in 2018

The bottom of the pipe chase next to the condensing unit should be filled with expanding foam insulation to prevent vermin intrusion into the attic

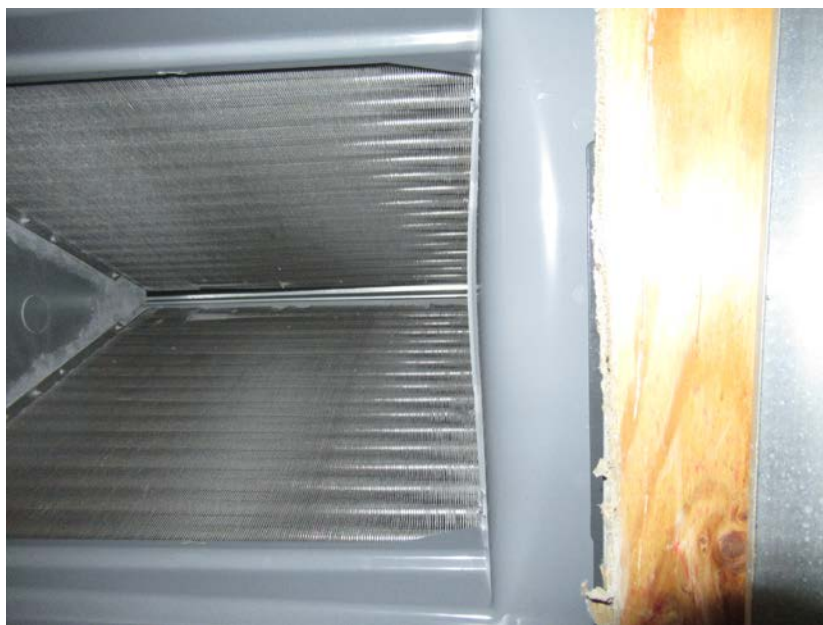
Photo # 10

The evaporator coil in the air handler is clean

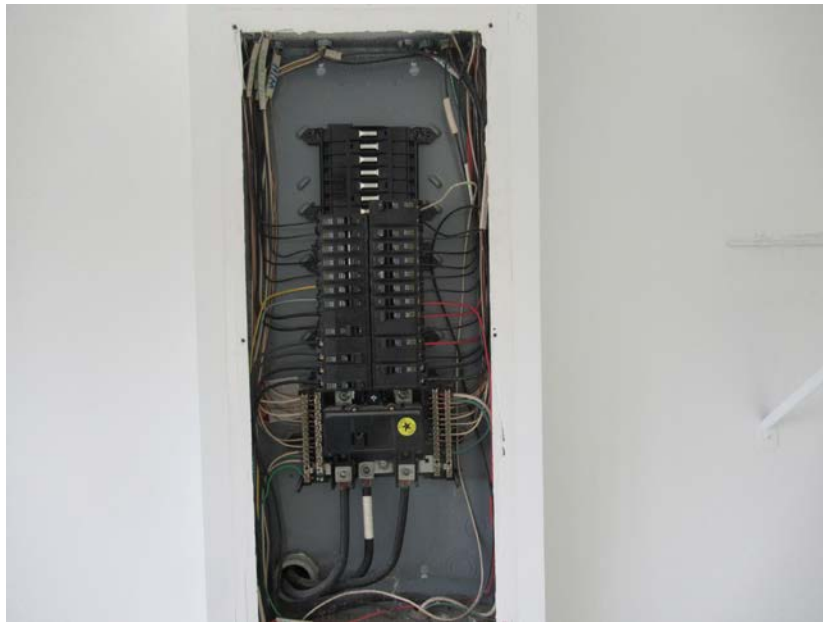
Photo # 11

The electrical system is in good condition

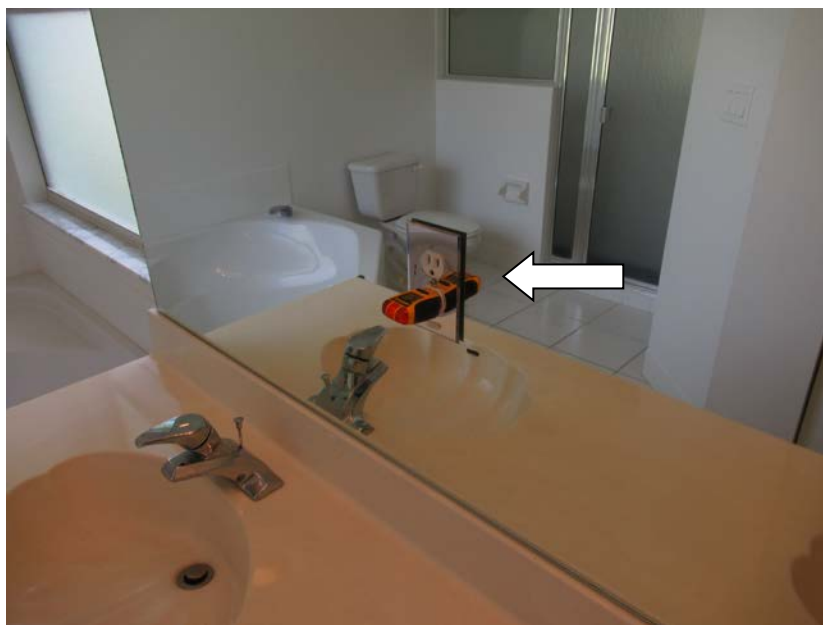
Photo # 12

EVIDENCE OF UNPROFESSIONAL WIRING MODIFICATIONS TO ORIGINAL WIRING		NO
EXHAUST OR CEILING FANS NOT FUNCTIONING		NO
MISCELLANEOUS		NO
Comments:		
<ol style="list-style-type: none"> 1. The convenience outlet in the mirror of the master bathroom is loose and the hot and neutral wires have been reversed. Cost - \$ 150 - \$ 200 2. There are several light bulbs missing or burned out in the fixtures. This is a maintenance item.

The outlet in the master bathroom is loose and the hot and neutral wires are reversed

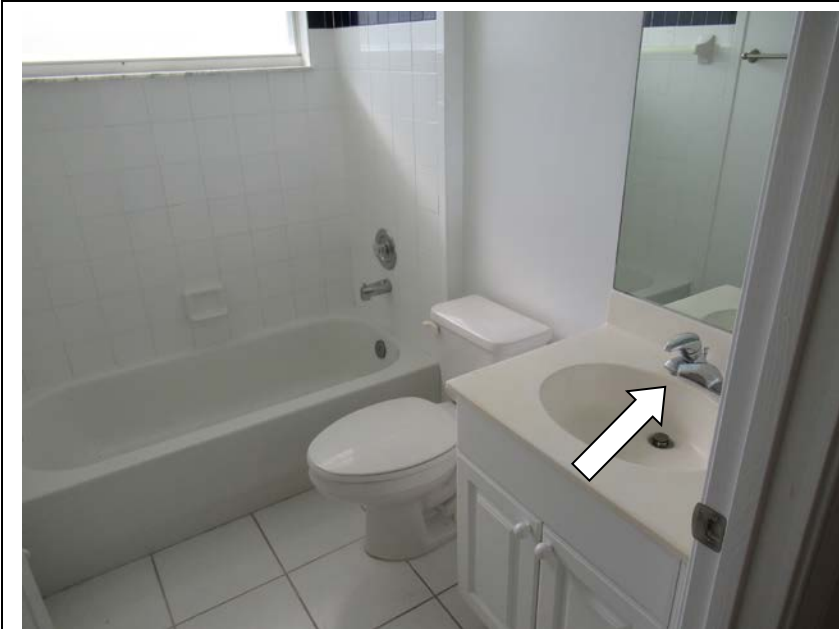
Photo # 13

Plumbing fixtures are in good condition

The aerator nozzle in the guest bathroom sink fixture needs to be cleaned or replaced. Water sprays over the counter

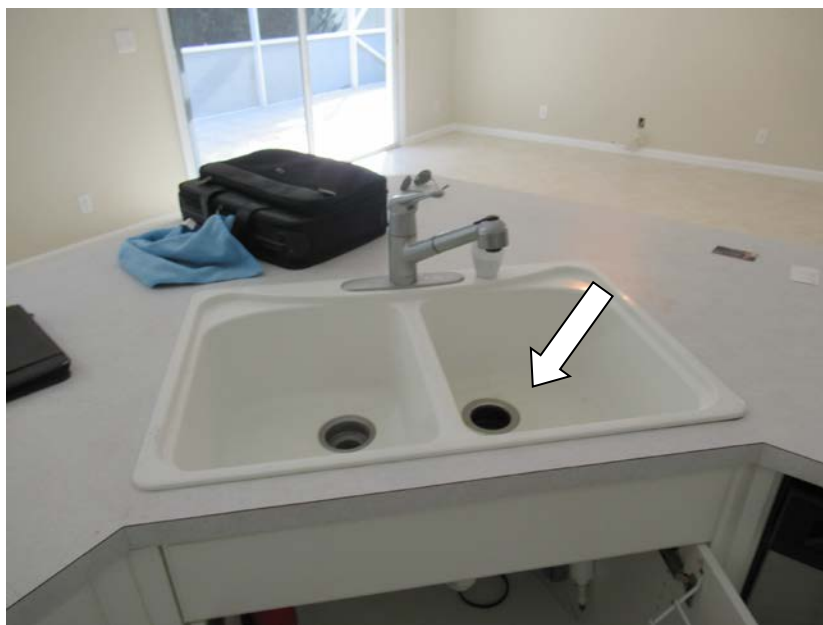
Photo # 14

Debris needs to be removed from the kitchen sink disposal

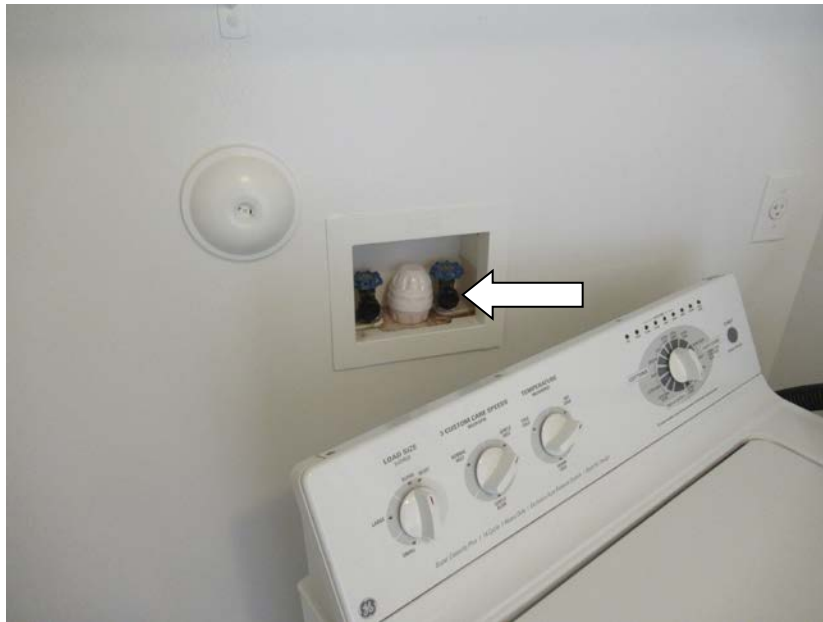
Photo # 15

The valves for the clothes washing machine leak and need to be repaired

The drier is missing

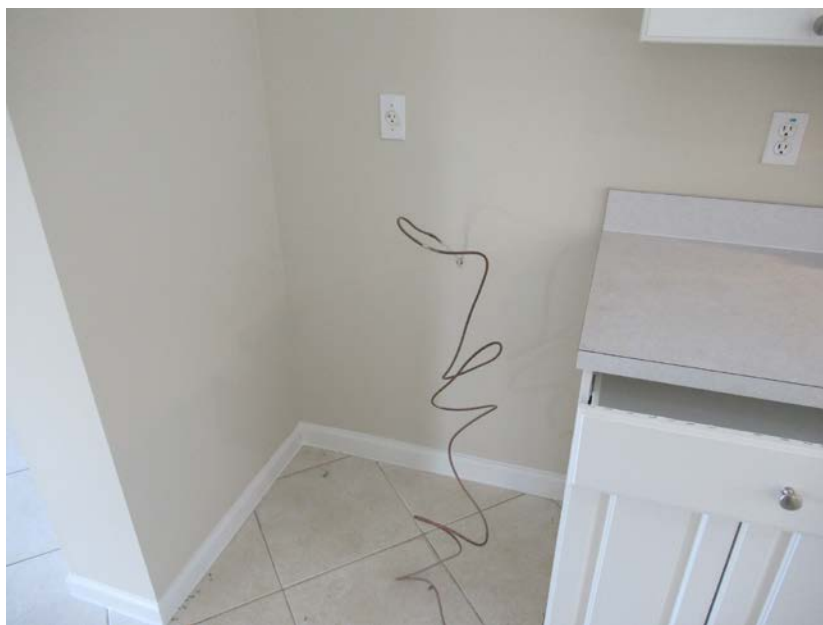
Photo # 16

The refrigerator is missing

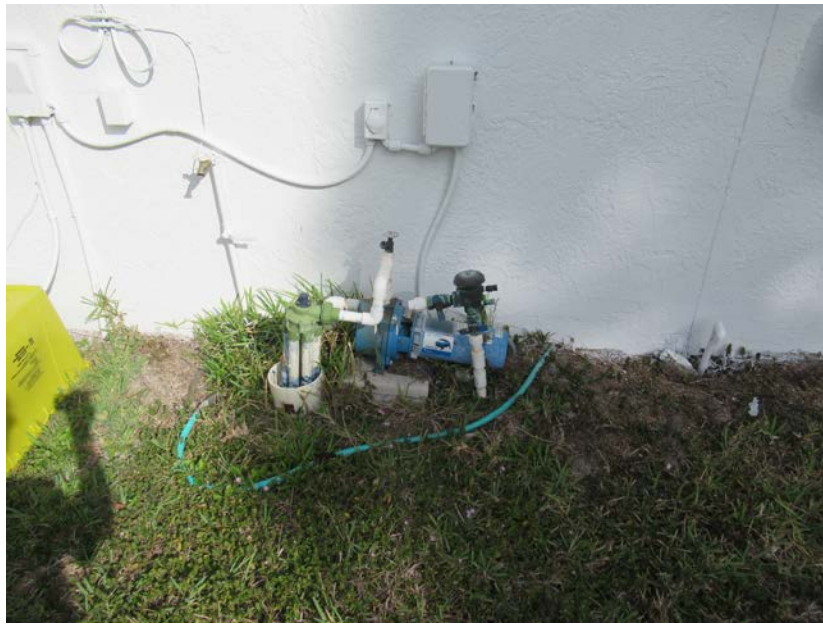
Photo # 17

The irrigation pump needs repair

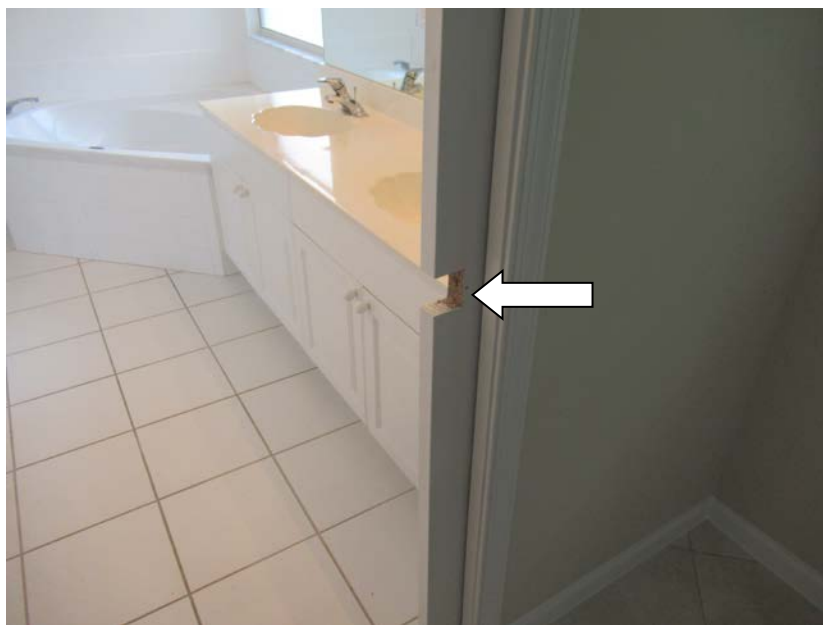
Photo # 18

Hardware is missing on the pocket door to the master bathroom

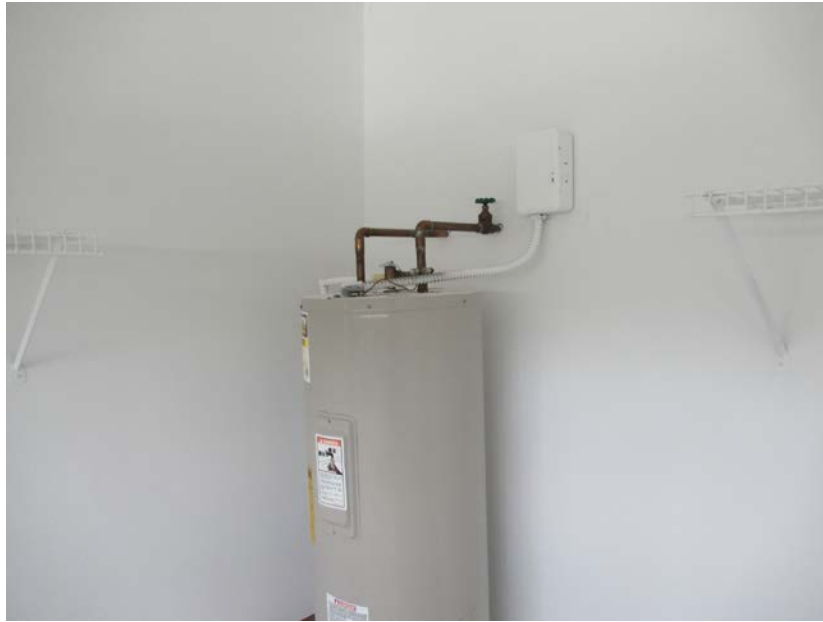
Photo # 19

Hot water tank with PTV
valve
