## Standard Home Inspection Report

**Subject Property:** Aventura, FL 33160  
**Client:** Ms. Wolf  
**Status of Property:** occupied  
**Type of Property:** Town Home  
**Square Footage:** 2000± Total SF (Property Appraiser's data)  
**Age of Home:** 2002± (Property Appraiser's data)  
**Date of Inspection:** 02/19/2019  
**Time of Inspection:** 10:00 AM  
**Weather conditions today:** 81° F, Partly Cloudy  
**Recent weather conditions:** light precipitation over last 48 hours

**Inspector:** Craig P. Milliken, PE # 32779  
**Phone:** (561) 866 9956

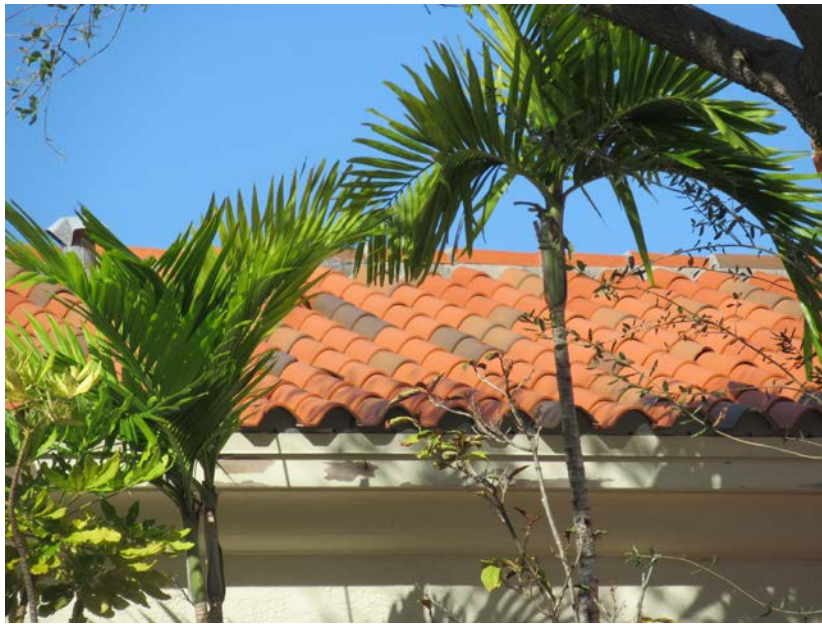
Photo # 1

It is assumed that the HOA maintains the roof. it appears to be in good condition and water tight

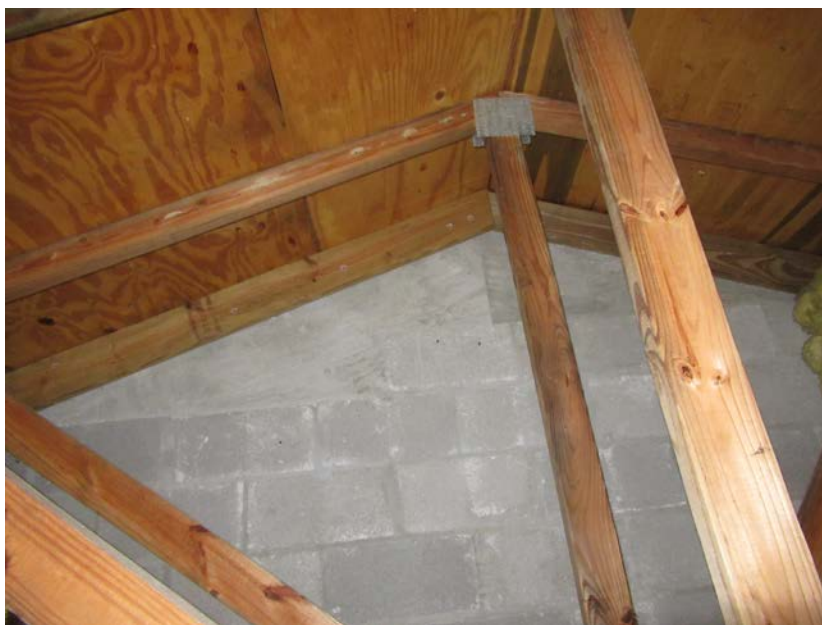
Photo # 2

No signs of leaks in the attic area

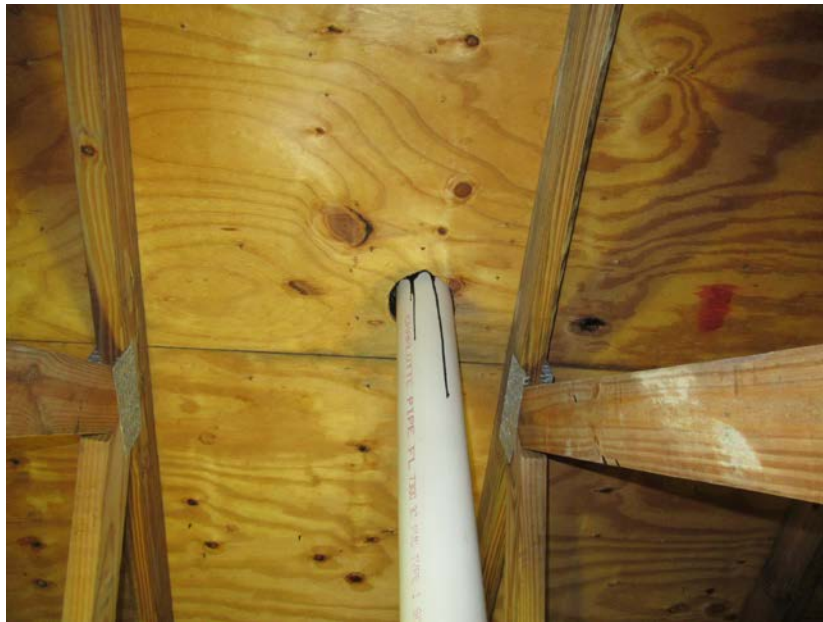
Photo # 3

Roof penetrations are water tight

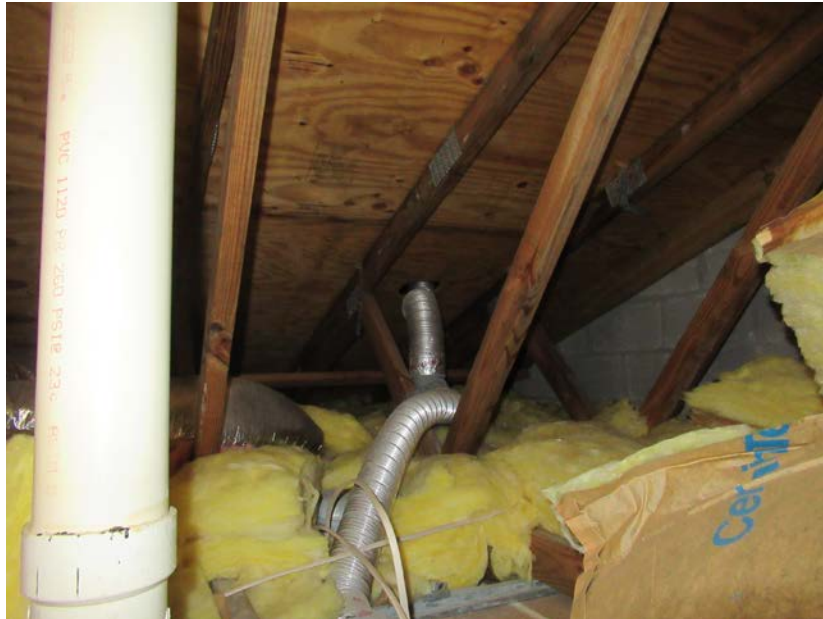
Photo # 4

The attic is well insulated

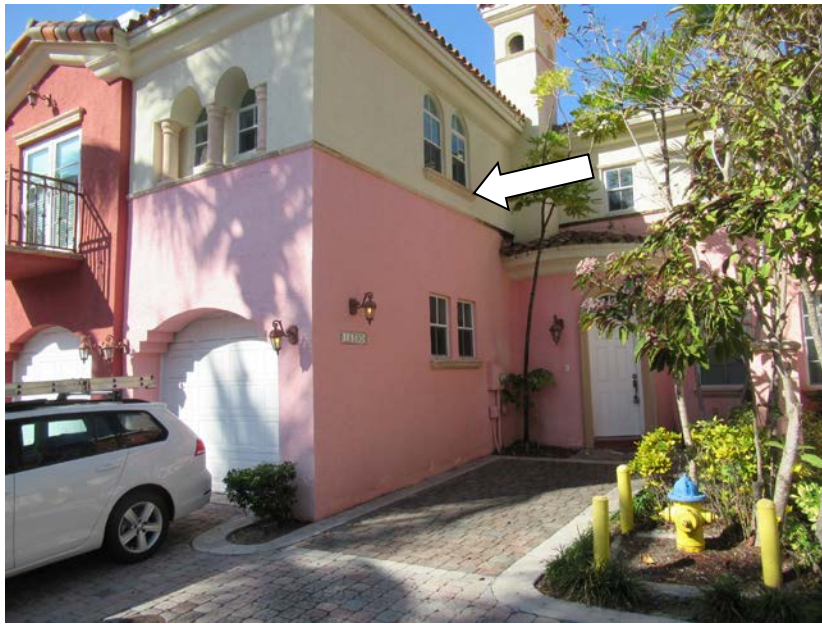
Photo # 5

This concrete window sill trim is cracked and needs to be repaired

- **The broken concrete trim under the two windows facing north in the 2<sup>nd</sup> floor east guest bedroom needs to be repaired immediately. The HOA should be notified in writing that it is an unsafe condition for pedestrian traffic near the front entrance door.**
- There was no visible evidence of active mold or moisture problems noted in this home
- There was no visible evidence of termites or other wood boring insects within this home.
- There was no evidence of wood rot caused by fungi and moisture noted within this home

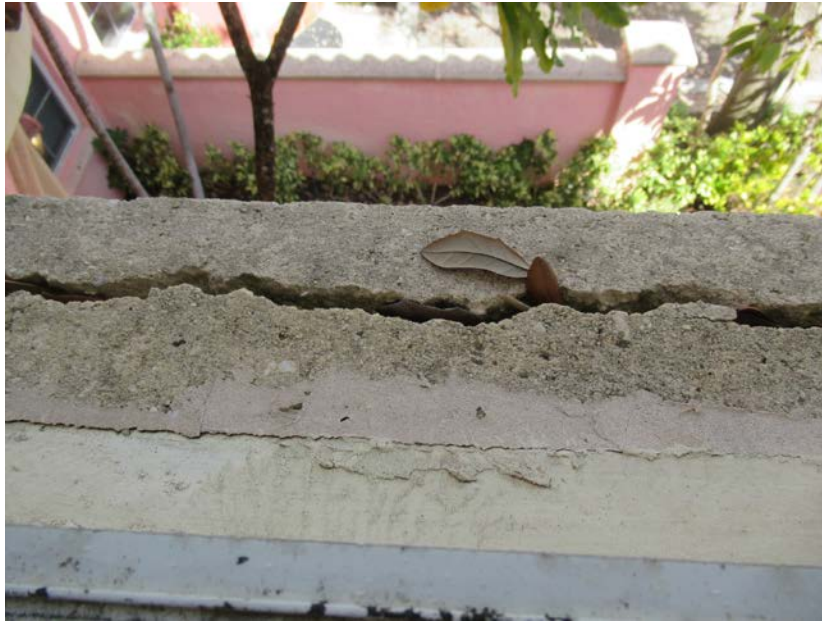
Photo # 6

The loose concrete may fall if not repaired

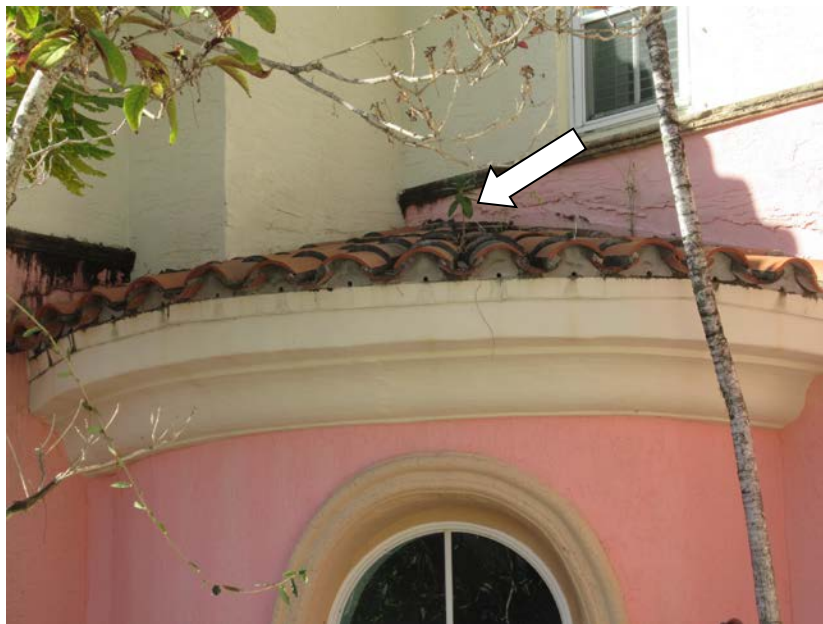
Photo # 7

Plants have taken root in the tiles over the front entrance

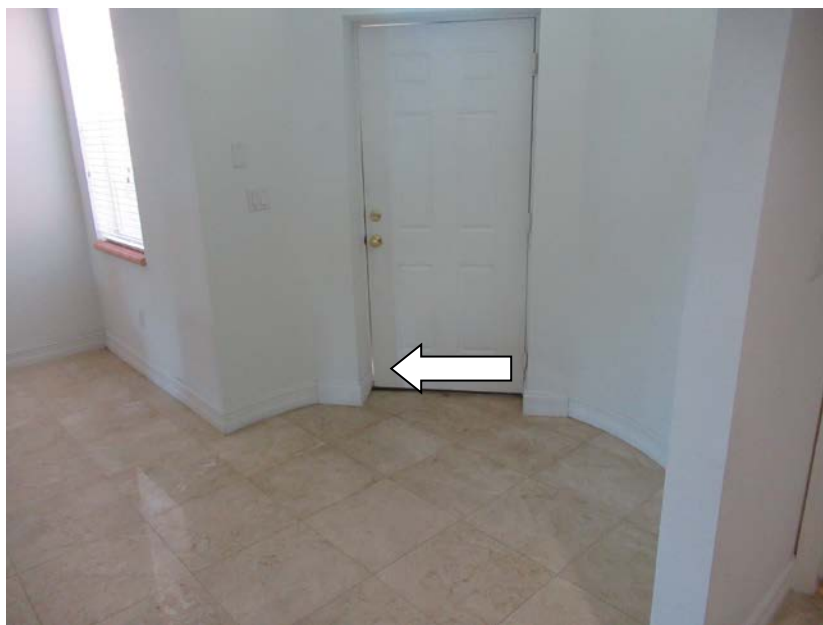
Photo # 8

Wood rot and weather stripping needs repair in the front door

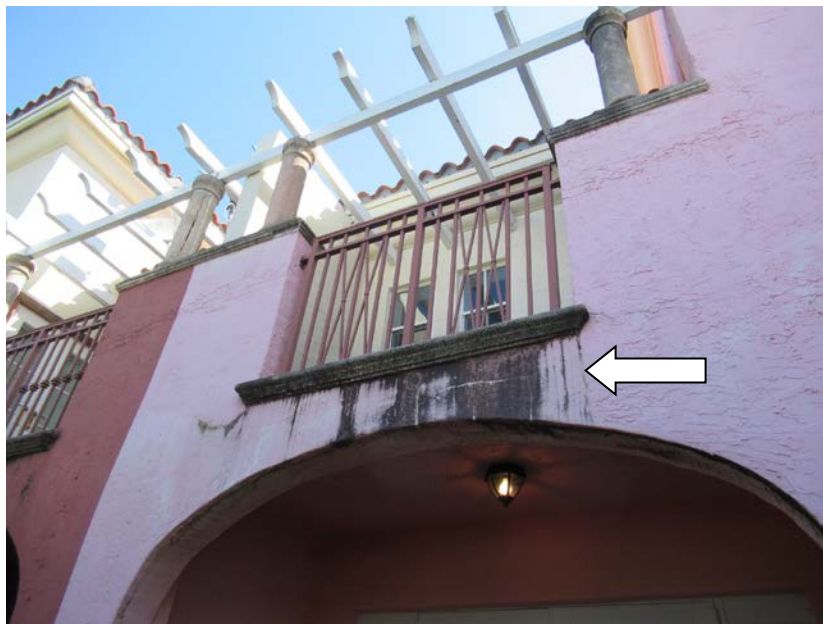
Photo # 9

The rear of the building is stained and needs pressure cleaning and new paint

The trellis and fascia trim board needs paint

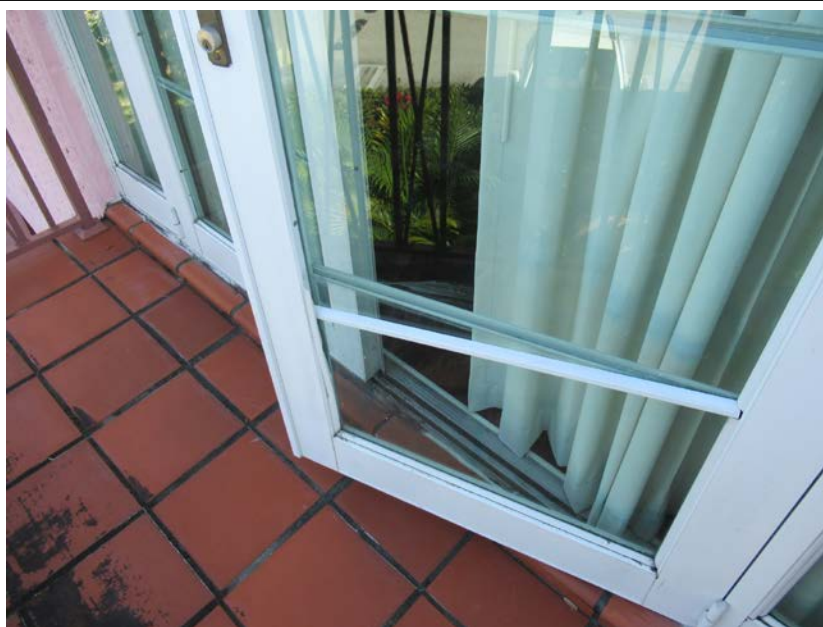
Photo # 10

Trim on balcony door needs repair

One of the doors is stuck and won't open

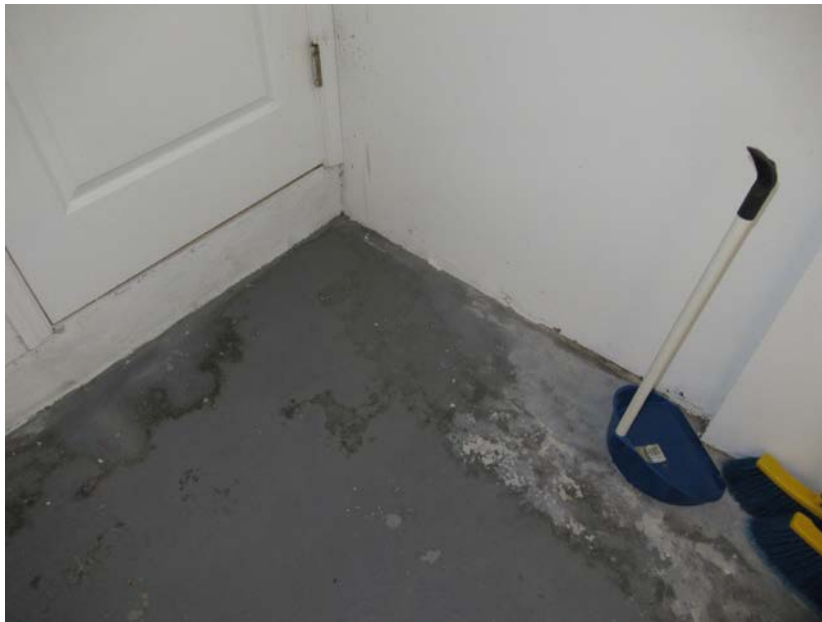
Photo # 11

Staining on the garage floor was from the clothes washing machine

The stains were dry during our test of the machine

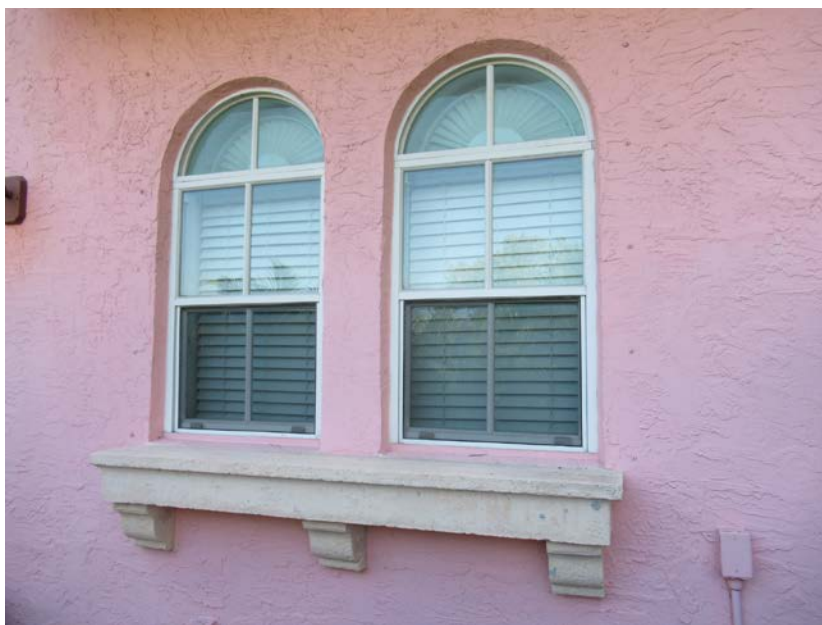
Photo # 12

All windows need servicing

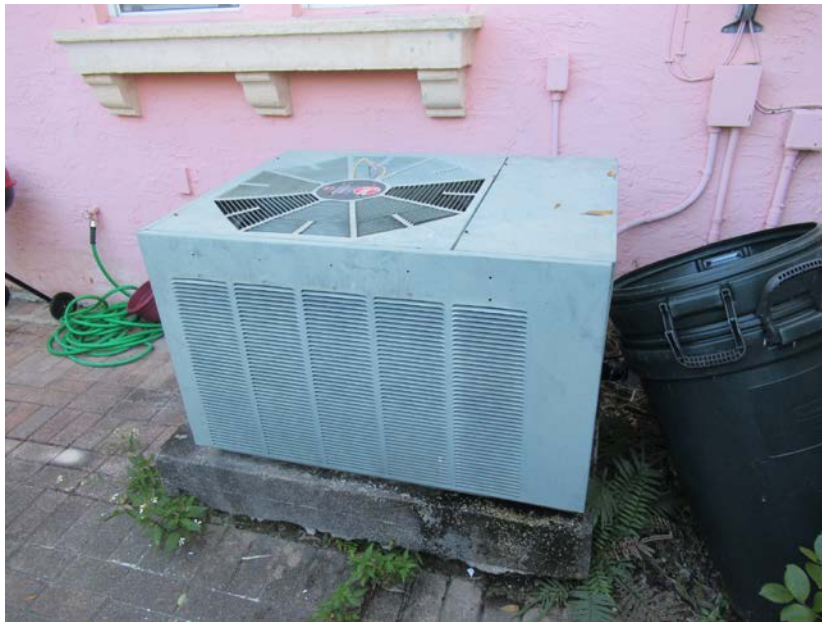
Photo # 13

<p>Residential A/C systems typically have a reliable service life expectancy of 15 years if properly maintained. Systems older than 10 years should be regularly serviced by an A/C service technician. Factory warranties usually expire after 5 years.</p>

The A/C system is 16 years old

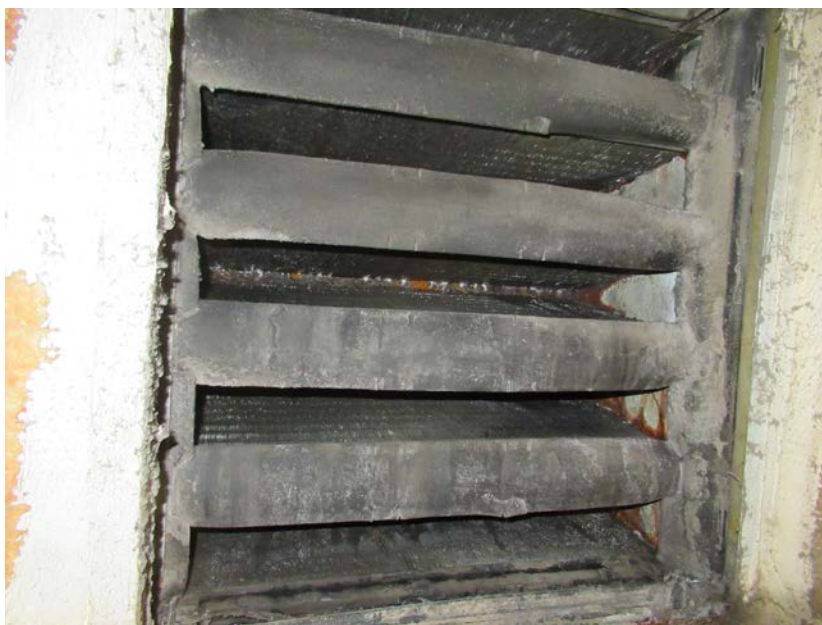
Photo # 14

The evaporator coil in the air handler is corroded and dirty

There was no air filter in front of it when we opened the grill on the stairway

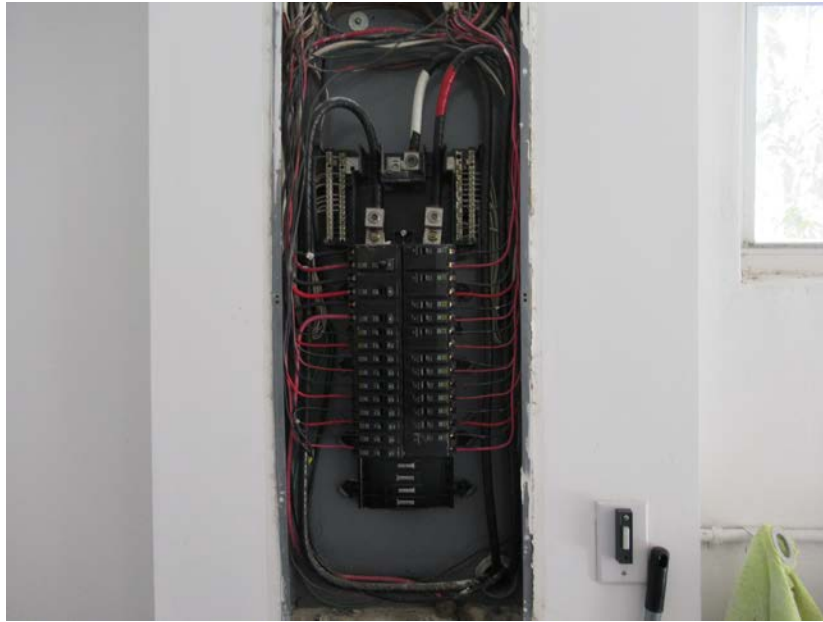
Photo # 15

The electrical system is in good condition

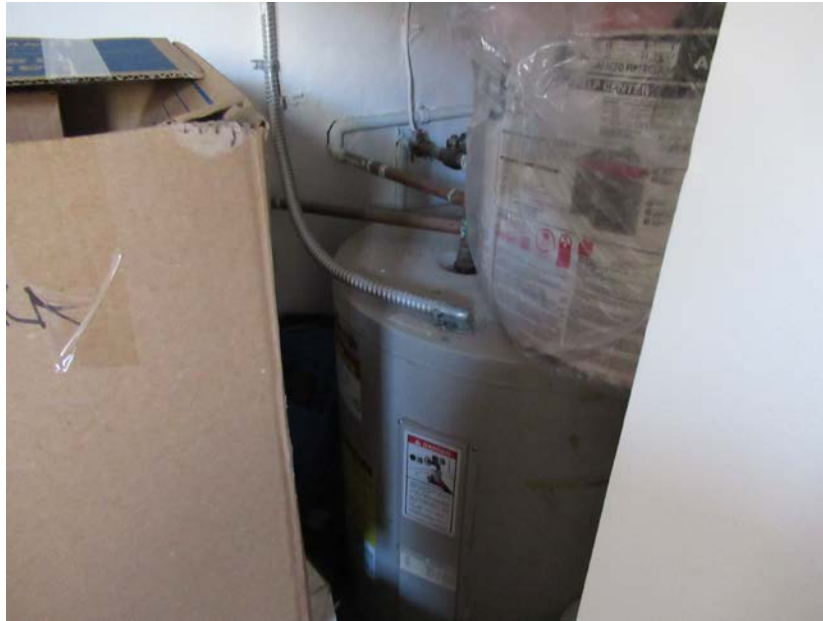
Photo # 16

The hot water tank was manufactured in 2002

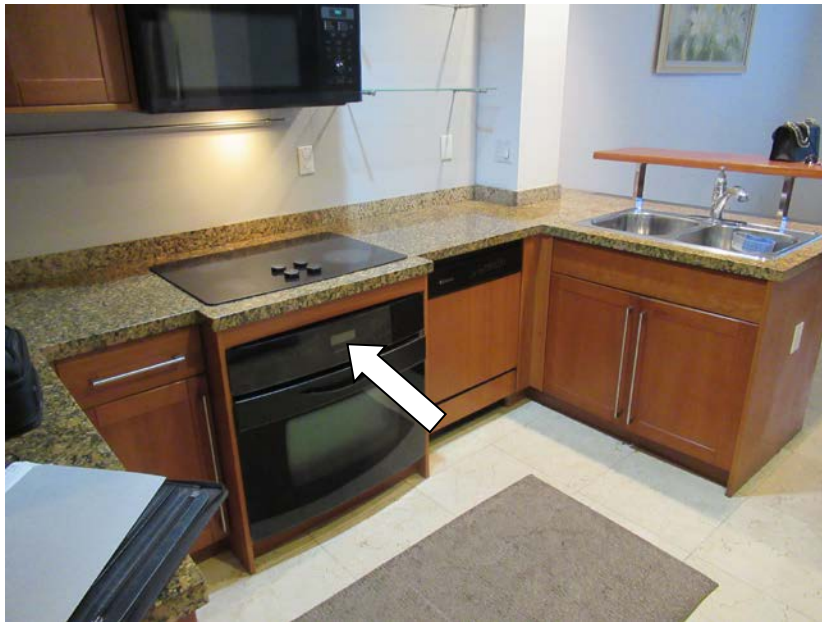
Photo # 17

The control panel on the oven did not illuminate when tested

The oven door did not latch properly

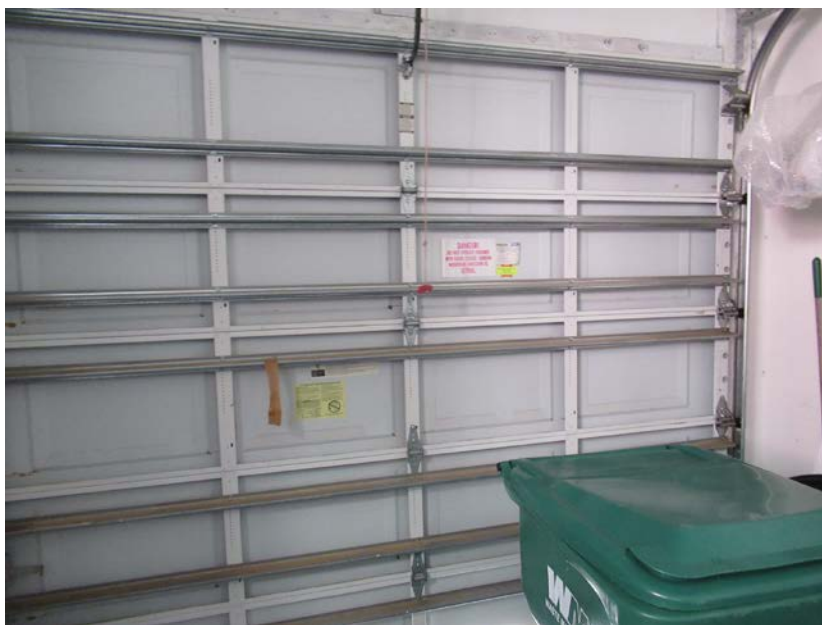
Photo # 18

The garage door opener needs servicing to align the electric eye safety mechanisms
